High Ling Bank, Cumbria

Ecological Constraints Study; 2024

AVISON YOUNG VERSION 2 Final

7 August 2024

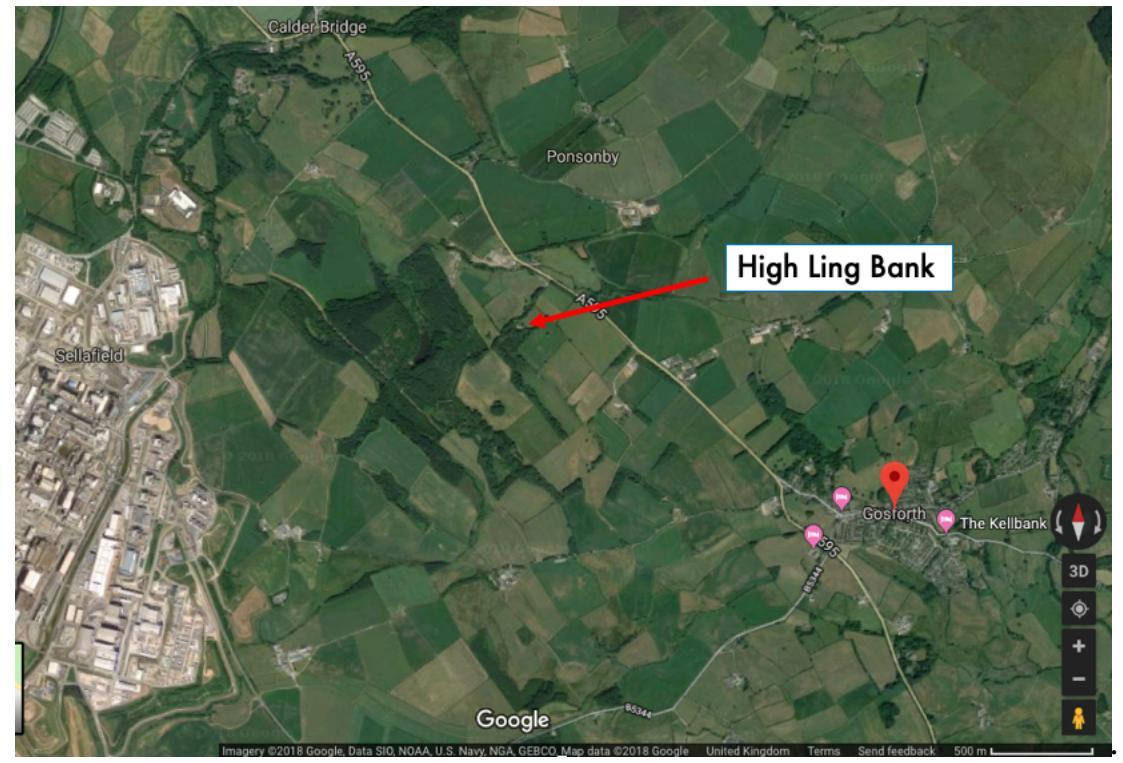
BiOME Consulting Ltd was commissioned by Avison Young in November 2018 to undertake a Preliminary Ecological Appraisal (PEA) (including a desk study)¹ of a property proposed for remedial works. This property, High Ling Bank (the 'site'), Cumbria, is centred on National Grid Reference NY 05133 04486 (Figure 1). Following this PEA, dedicated bat² surveys were completed with update surveys in 2023³.

The site is located between the village of Gosforth and Sellafield Nuclear Power Station, in western Cumbria (Figure 1).

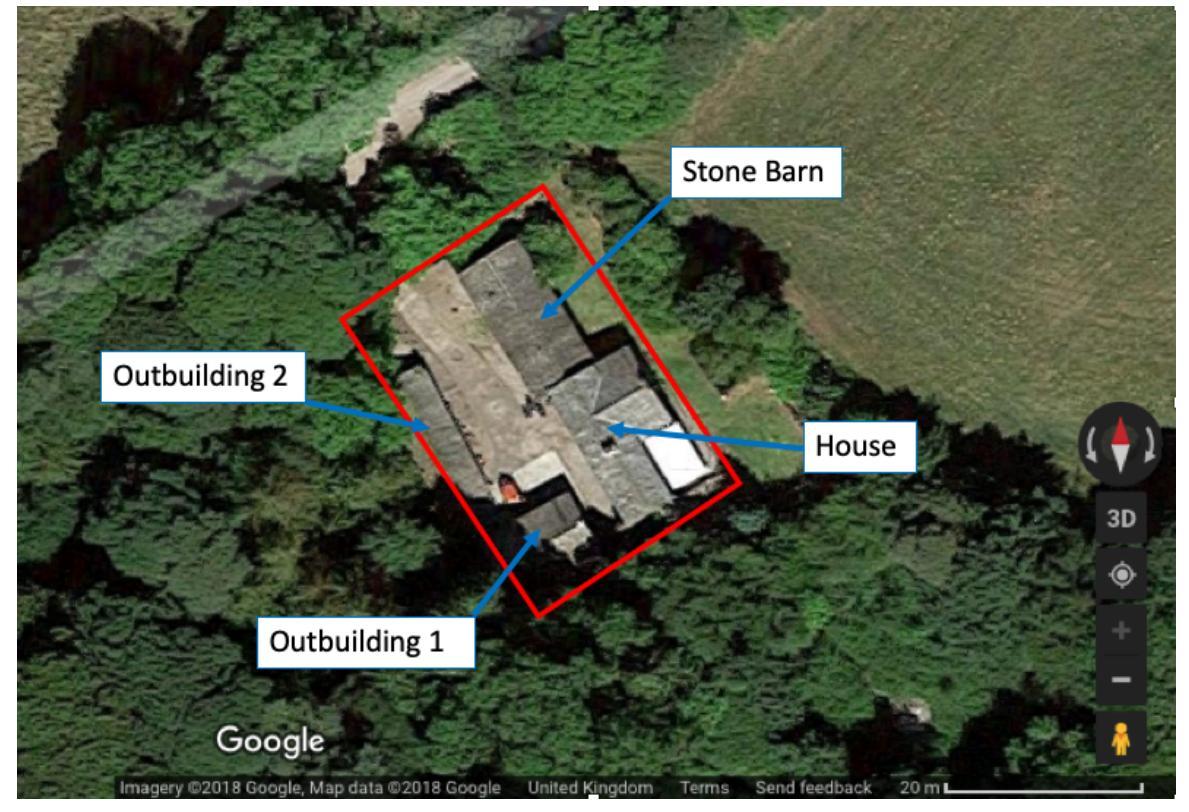
The site layout is shown on Figure 2, four buildings were present within the site:

- House: located in the southeast of the site, had rendered walls with the exception of the southern gable end which was stone and mortar. A small stone lean-to outbuilding was present at the southern gable. It had a pitched slate roof, with a glazed conservatory present adjoining the south-eastern corner.
- Stone barn; located in the north of the site and was constructed in stone and mortar, with a pitched slate roof which exhibited holes/slipped tiles in places.
- Outbuilding 1; located in the southern corner of the site, was constructed of stone and mortar with a pitched slate roof.
- Outbuilding 2; located adjacent to the western boundary, was constructed in stone and mortar with a pitched slate roof. The northern end of this building was enclosed, with an open-fronted store at its' southern end.

The buildings were accessed via a driveway to the north and enclosed a gravel/concrete yard area. Gardens/amenity grassland were present to the east, associated with the house. Further out, mixed woodland predominated to the south and west, with improved grassland fields present to the east and north (over a minor road).

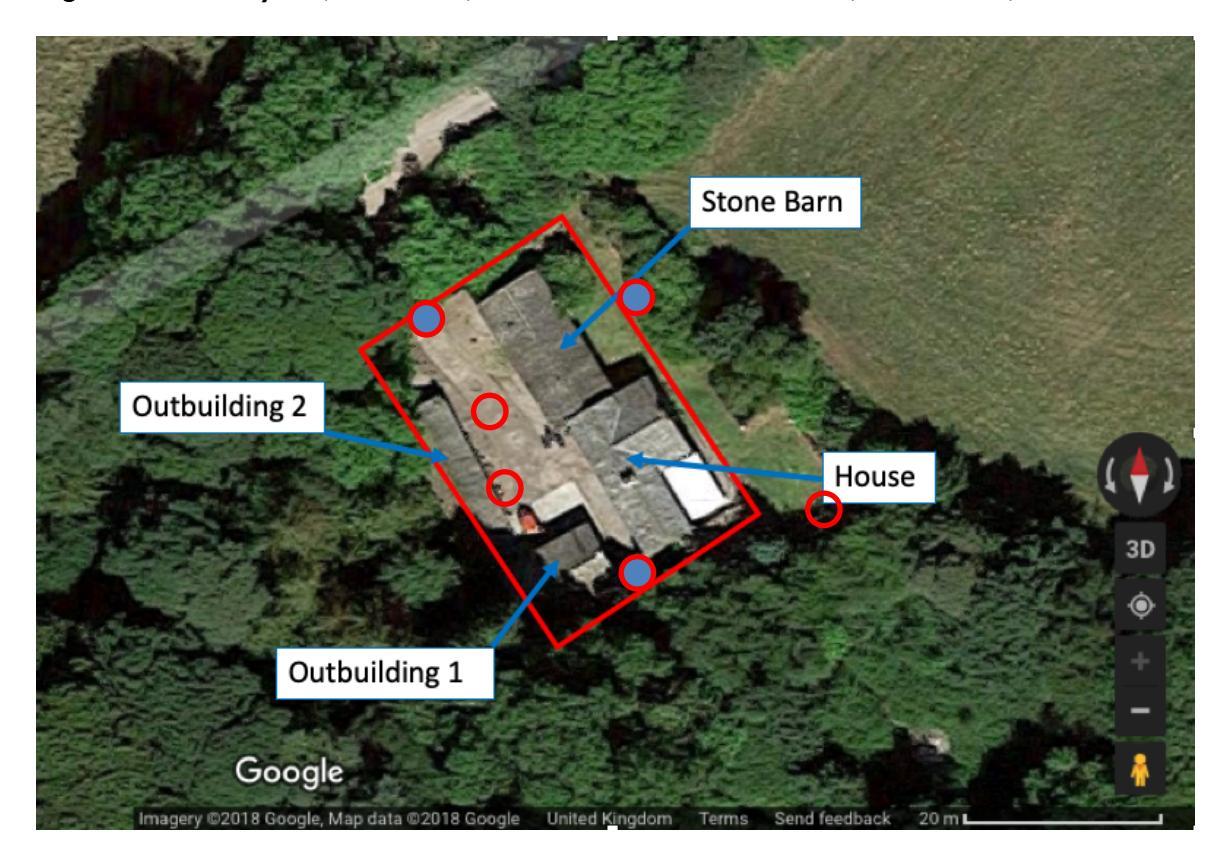
Figure 2. Surveyor (blue dots) and IR camera locations (red circles)

One update nocturnal emergence survey was completed (**Table 3**). To ensure coverage of all areas which could support roosting bats the survey was completed from six survey locations, overseen by three surveyors (**Figure 2**).

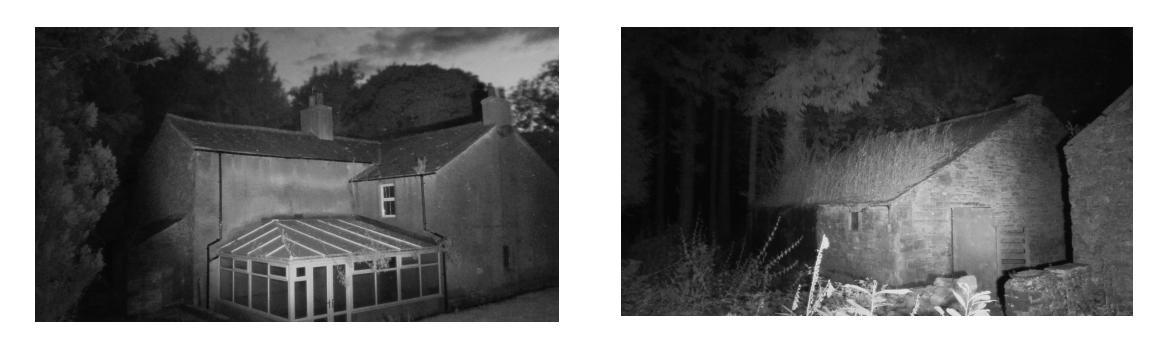
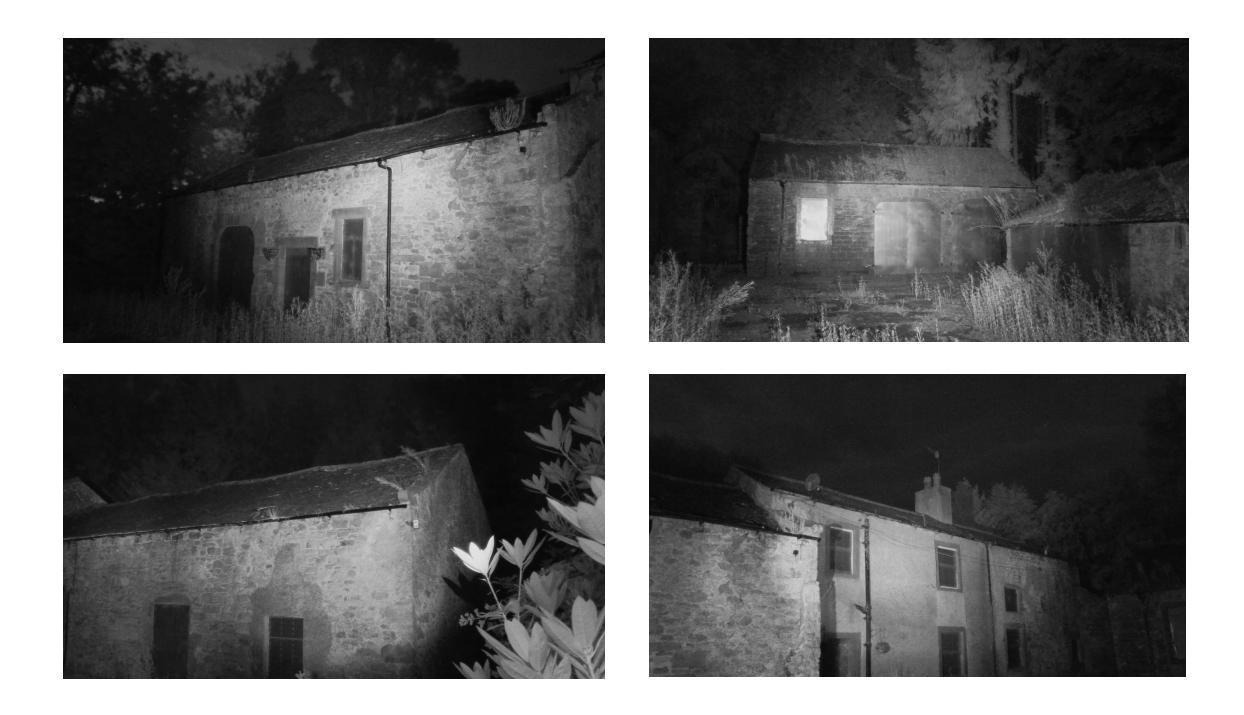
Plate 1. View from each infrared camera at survey end

Electronic bat detectors (EM Touch Pro 2) and infrared cameras were deployed at each survey location. Sound files were analysed with appropriate bat analysis software (Kaleidoscope) once the surveys were completed. Infra-red cameras (Canon XA60) and additional infrared lighting (Nightfox XB5 IR and flood lamps) were used, with cameras positioned to ensure that all areas that may be impacted directly or indirectly were covered. Following the survey, recorded footage was analysed.

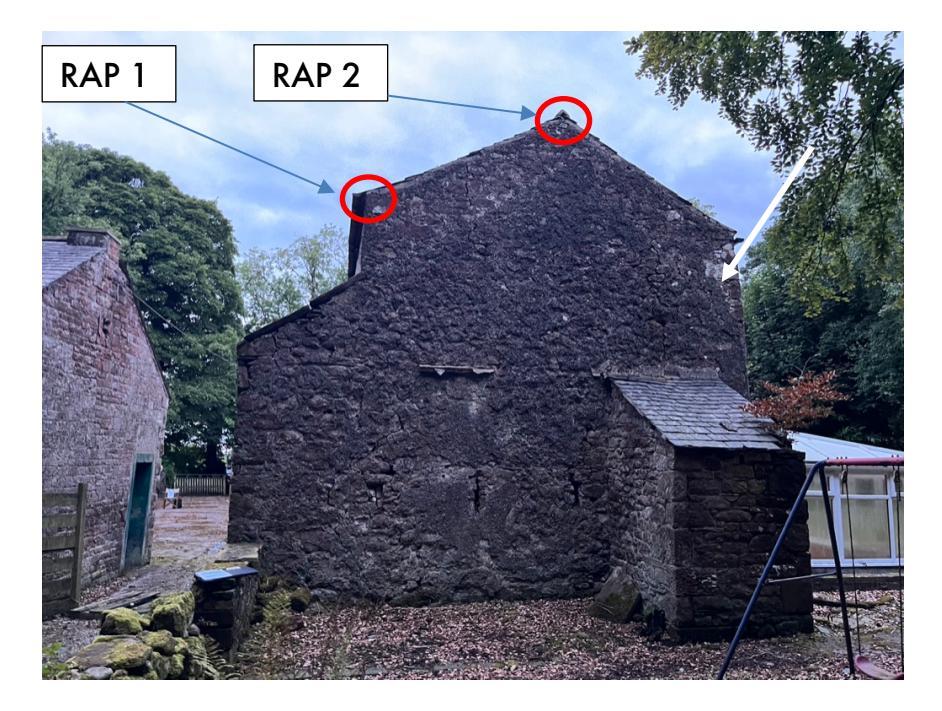
Photograph 1. RAP 1 and 2

- Two roosted at the eaves on the southern gable (singles at Roost Access Point (RAP) 1 and RAP 2 – Photograph 1); and
- One roosted within a wall crack on the eastern façade (RAP 5, Photograph 2).

It is considered highly likely that these bats roosted in close proximity to their emergence points.

Any works that could destroy/modify a bat roost/access point or disturb⁹ roosting bat/s will require a Natural England licence to enable the works to be completed legally.

No works that may disturb roosting bats or prevent access to a potential bat roost should be completed until a licence is in place.

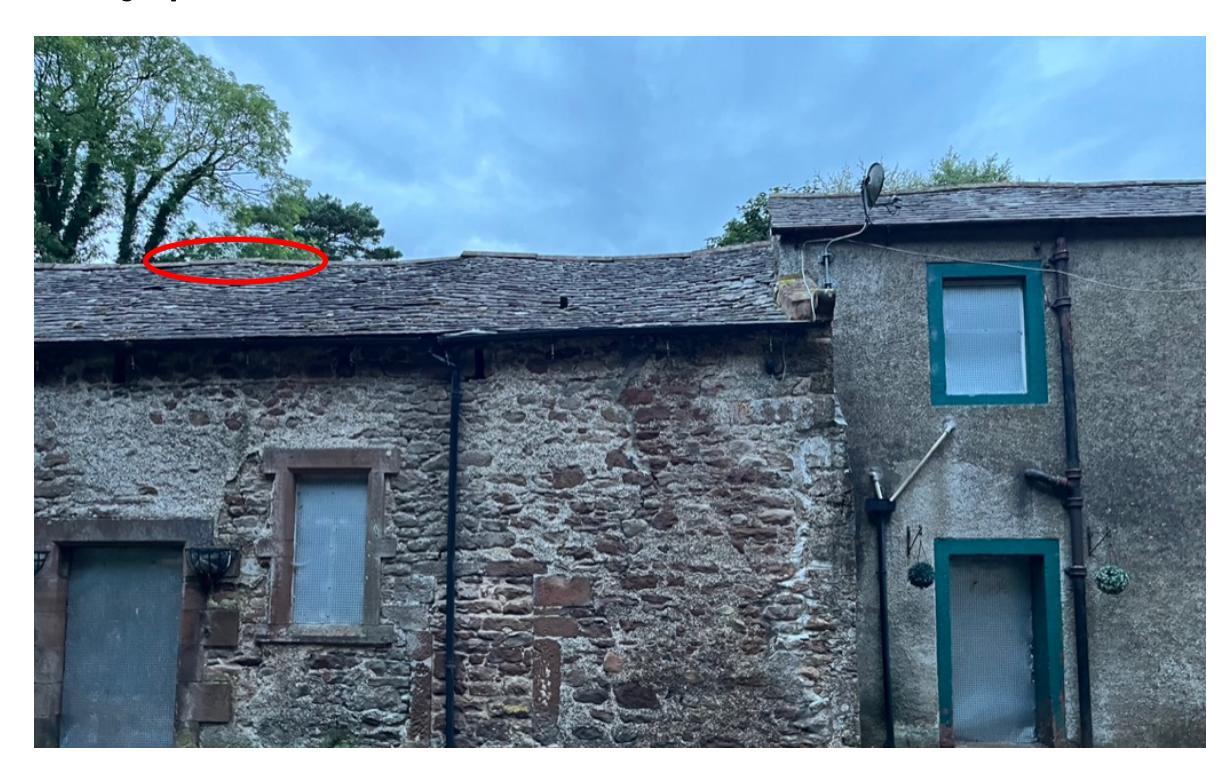
Photograph 3. RAP 5

Stone Barn: Two Brown Long-eared Bats emerged from day roosts within the stone barn via RAP 5. The roost location of these bats was not determined
