## Preliminary Building Assessment – Bats

# West Cumberland Infirmary Buildings 3, 4 & 5

Prepared for North Cumbria University Hospitals NHS Trust

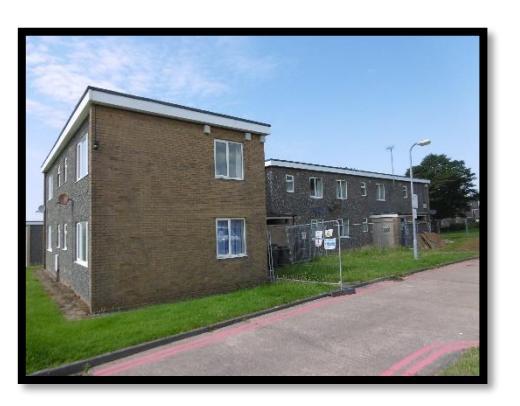
Plate 1: Building 3.

Building 3 is a two-storey building of brick and render construction, with soffit boxes and a flat felt roof. Several features that provide bat roosting opportunities were recorded. These comprised of gaps at the wallhead (plate 2), gaps in roof boarding (plate 3) and gaps in soffit boxes (plate 4).

Building 3 has been assigned a low level of suitability to support roosting bats. Internal access could not be gained therefore only an external inspection was carried out.

Building 3 recorded multiple features suitable for use by bats. However, it is not considered that these features could support a large roost or roost of specific conservation concern. When considered in conjunction with the surrounding environment, building 3 recorded a low level of suitability to support roosting bats.

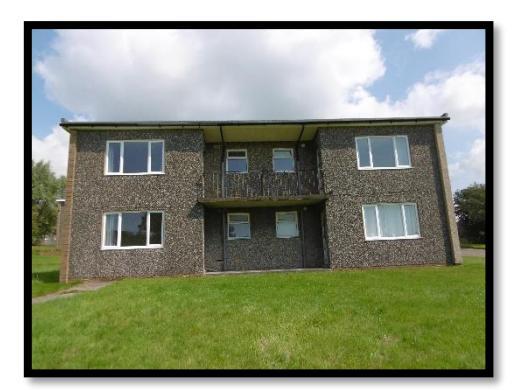
Plate 5: Building 4.

Building 4 is a two-storey building of brick and render construction, with soffit boxes and a flat felt roof (plate 1). A single feature was recorded comprising a hole in a wooden ceiling which could offer a potential roosting opportunity for bats (plate 2). This feature was inspected at the time of survey and there was no evidence to suggest it is used by bats.

Building 4 has been assigned a negligible level of suitability to support roosting bats. Internal access could not be gained therefore only an external inspection was carried out.

Building 4 recorded a 'negligible' level of suitability to support roosting bats. Only one single potential roosting feature could be found on the building. As the feature could be fully inspected and no evidence was found of past or existing use by bats, it is deemed unlikely that a bat would use this area to roost. As a result, no further survey is required for building 4.

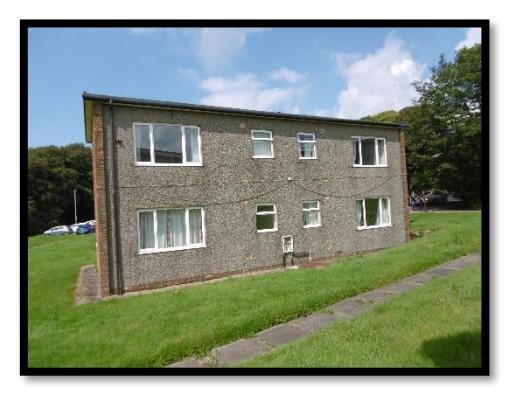
Plate 7: Building 5 (S. aspect).

Building 5 is a two-storey building comprised of brick and render construction with soffit boxes and a flat felt roof (plates 3 & 4).

Building 5 recorded multiple gaps within the buildings structure, at a height and aspect that is favourable for bat use. The physical condition of these features, however, does not suggest that they could support a large roost or roost of specific conservation concern. When considered in conjunction with the surrounding environment, building 5 recorded a low level of suitability to support roosting bats.

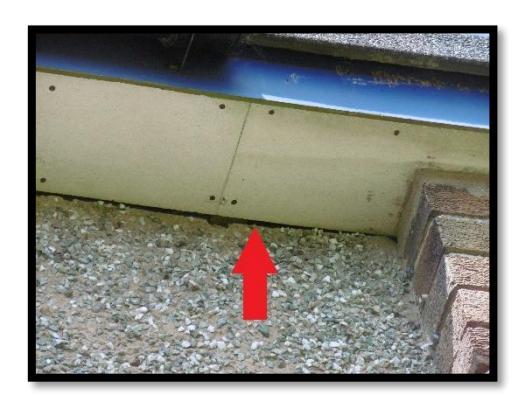
Plate 9: Gaps along wallhead.

Several features that provide bat roosting opportunities were recorded. These comprised of gaps in soffit boxes and gaps at the wallhead (plates 5 & 6).

Further survey is required to ascertain as to whether any of the features recorded are indeed being used by bats to roost. It is recommended that a minimum of one activity survey should be carried out, during the 2019 bat activity season (May - September inclusive), on buildings 3 and 5. Following this further survey, an accurate assessment can be made as to what the impact will be on roosting bats.
