GEOINVESTIGATE LIMITED Coal Mining Risk Assessment (CMRA)

LOCATION	Land Adjacent to 53 Mill Street, Frizington CA26 3SL
ISSUE DATE	30 June 2022
FOR	Laurie Crayston
CLIENT REF.	
OUR REF.	G22250a

SUMMARY FINDINGS	
	Yes. Owing to the nearby proximity of a coal mine shaft to the development the client has been advised to carry out longer term monitoring in specially installed gas wells as part of the further shallow geoenvironmental investigation of the site. This work is scheduled to be carried out in the next few weeks at the property.
OUTCOME MITIGATION REQUIRED	In our opinion even if the gas monitoring results are favourable the new dwelling should as a precaution be fitted with basic gas protection measures commensurate with Characteristic Situation CS2 of CIRIA publication C655 – 'Assessing risks posed by hazardous ground gases to buildings'. In our opinion in this instance the design should preferably incorporate suspended floor with a passively vented under floor void and gas proof membrane.
NO/YES	This CMRA has shown that surface ground stability at the site is not impacted by the presence of historical mine working below it or the presence within the property of a capped mi

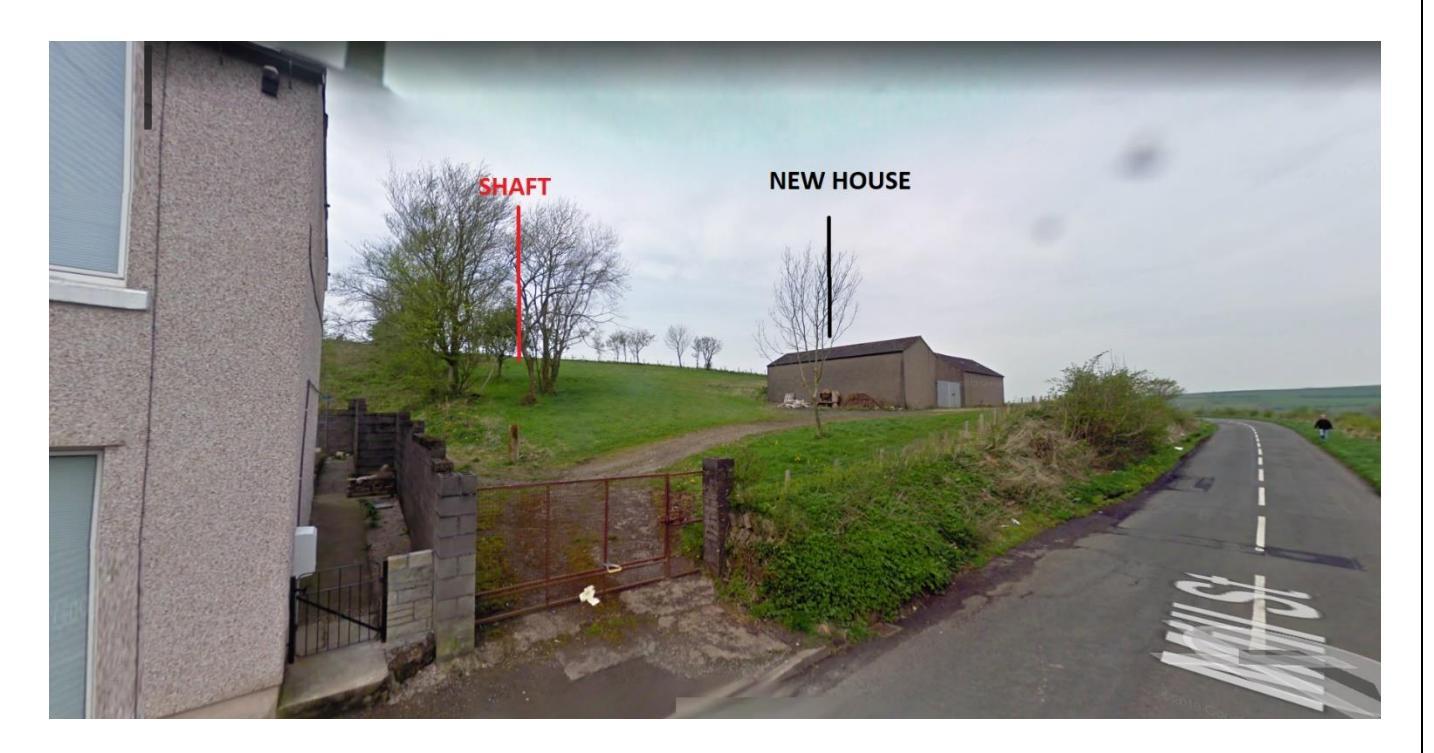
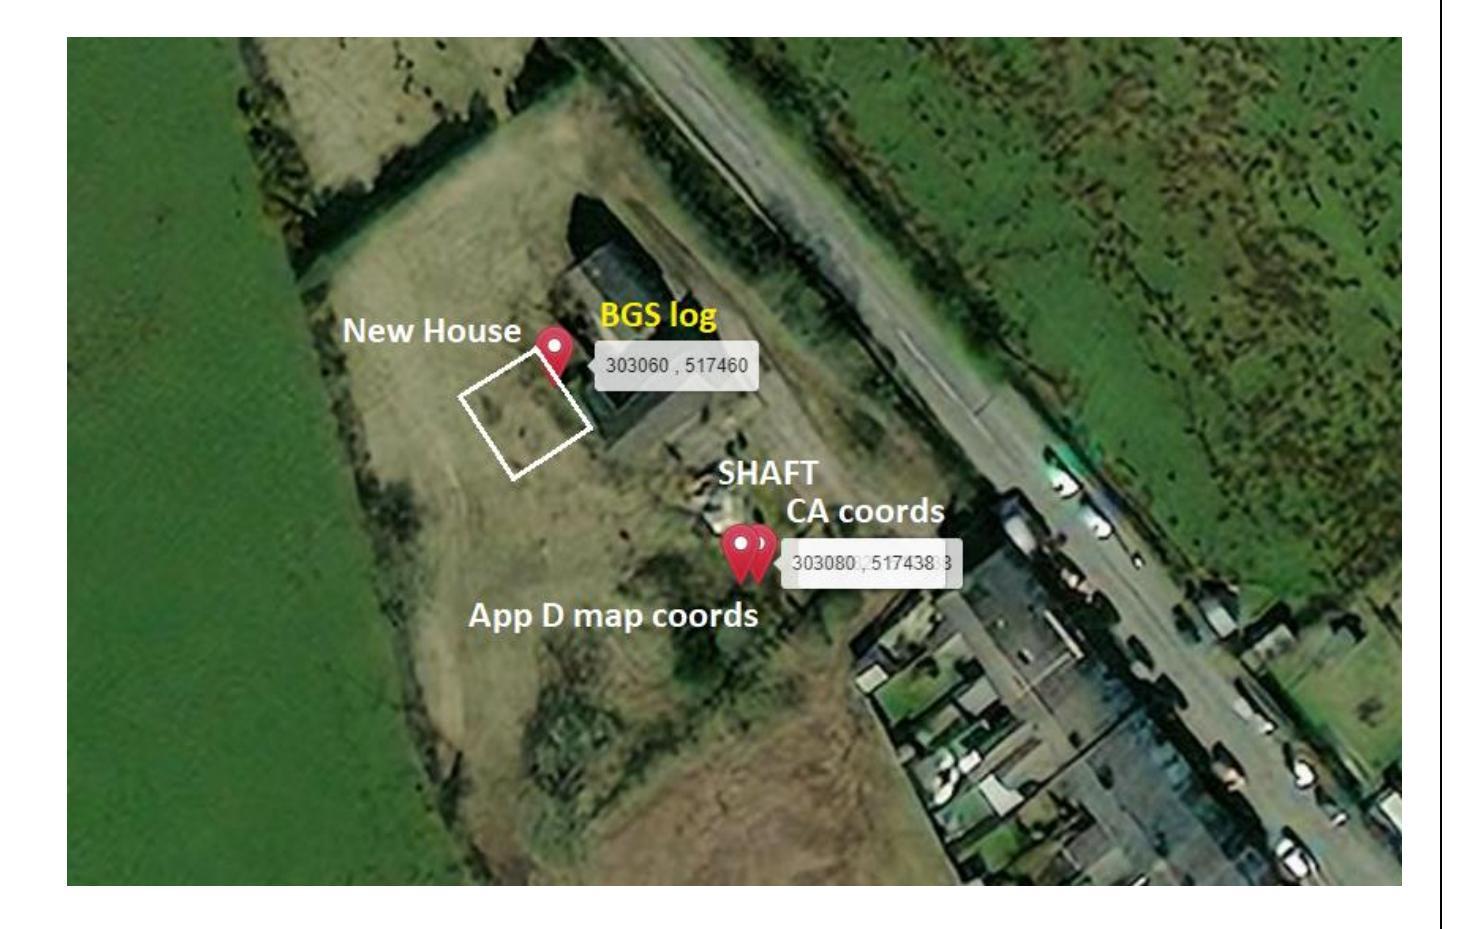
APPENDIX B SITE IMAGES

Google Satellite and Street View imagery shows the site comprises a benched/platformed grassy slope including two existing barns located on flatter ground. The property includes a short section of hedge, a few small trees, and an access track from Mill Street. Existing row housing is present to the south of the site (See images in Appendix B).

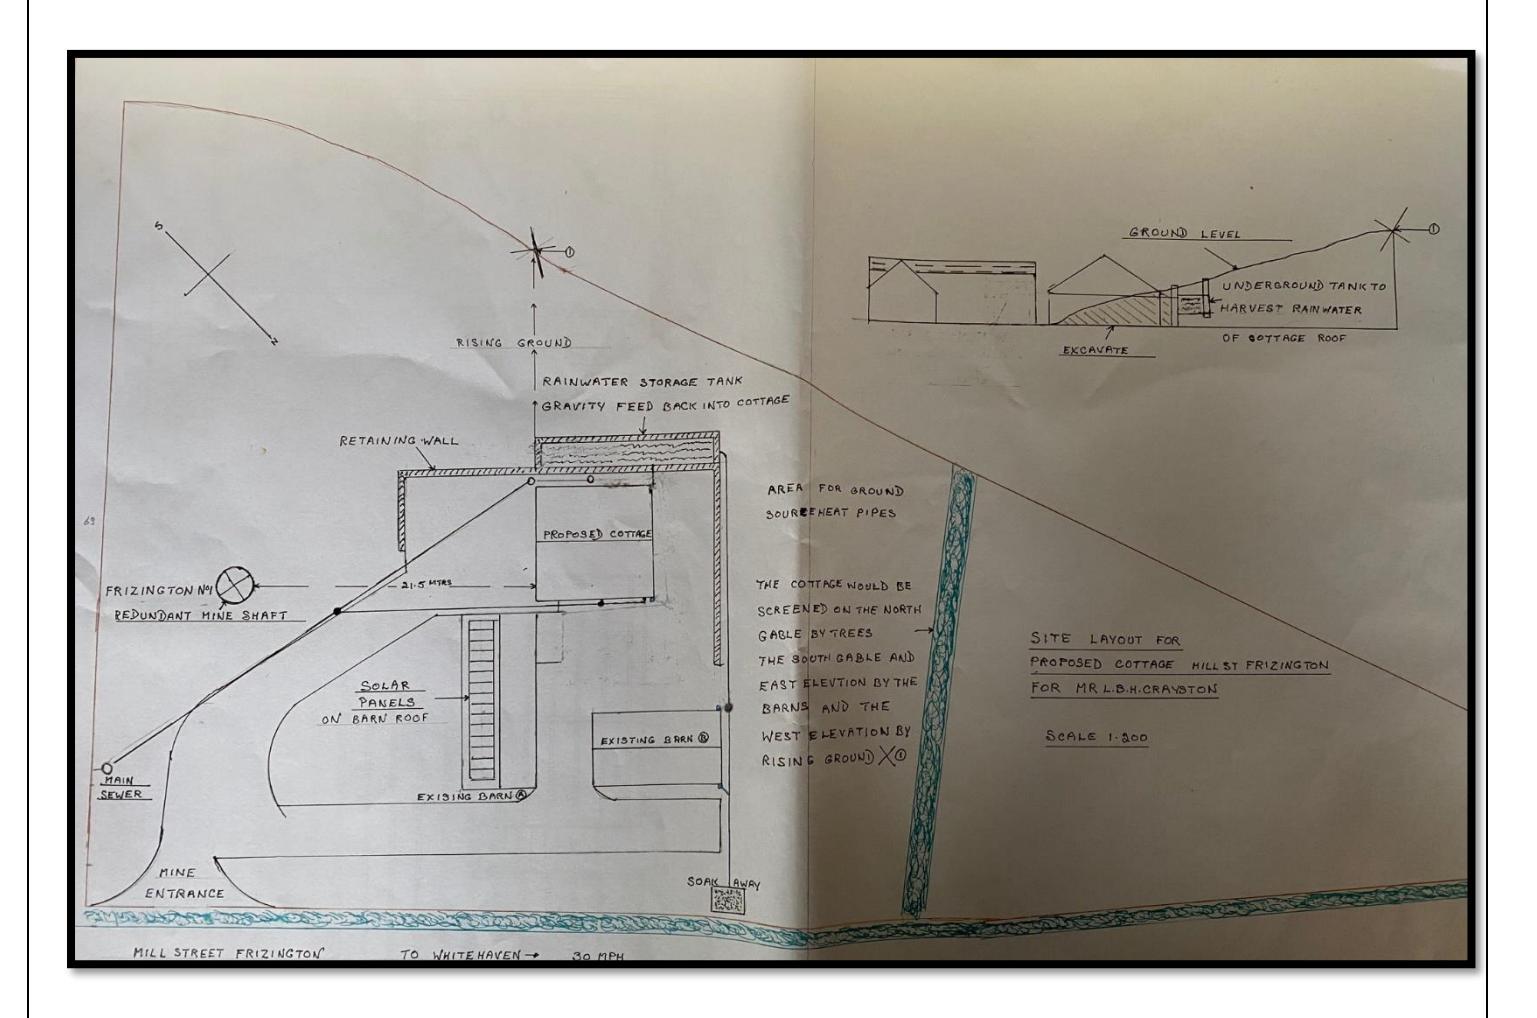
APPENDIX C PROPOSED DEVELOPMENT PLAN

It is proposed to erect a new single cottage/bungalow dwelling upslope to the north-west of the existing barns and install solar panels on the roof of one barn. Excavation of the slope to a depth of around 3m or so is required to provide space for the new dwelling. Site location and development plans are provided in Appendix C. The plan shows the approximate position of Frizington No 1 Coal Mine Shaft (capped in 2013) in relation to the proposed development. According to this plan the new house lies some 21.5m from the shaft. It is understood that Laurie Crayston's father (a former miner) assisted in the capping of the shaft in 2013 and the clients know more or less exactly where the shaft is located on their property. Geoinvestigate has no reason to doubt this.

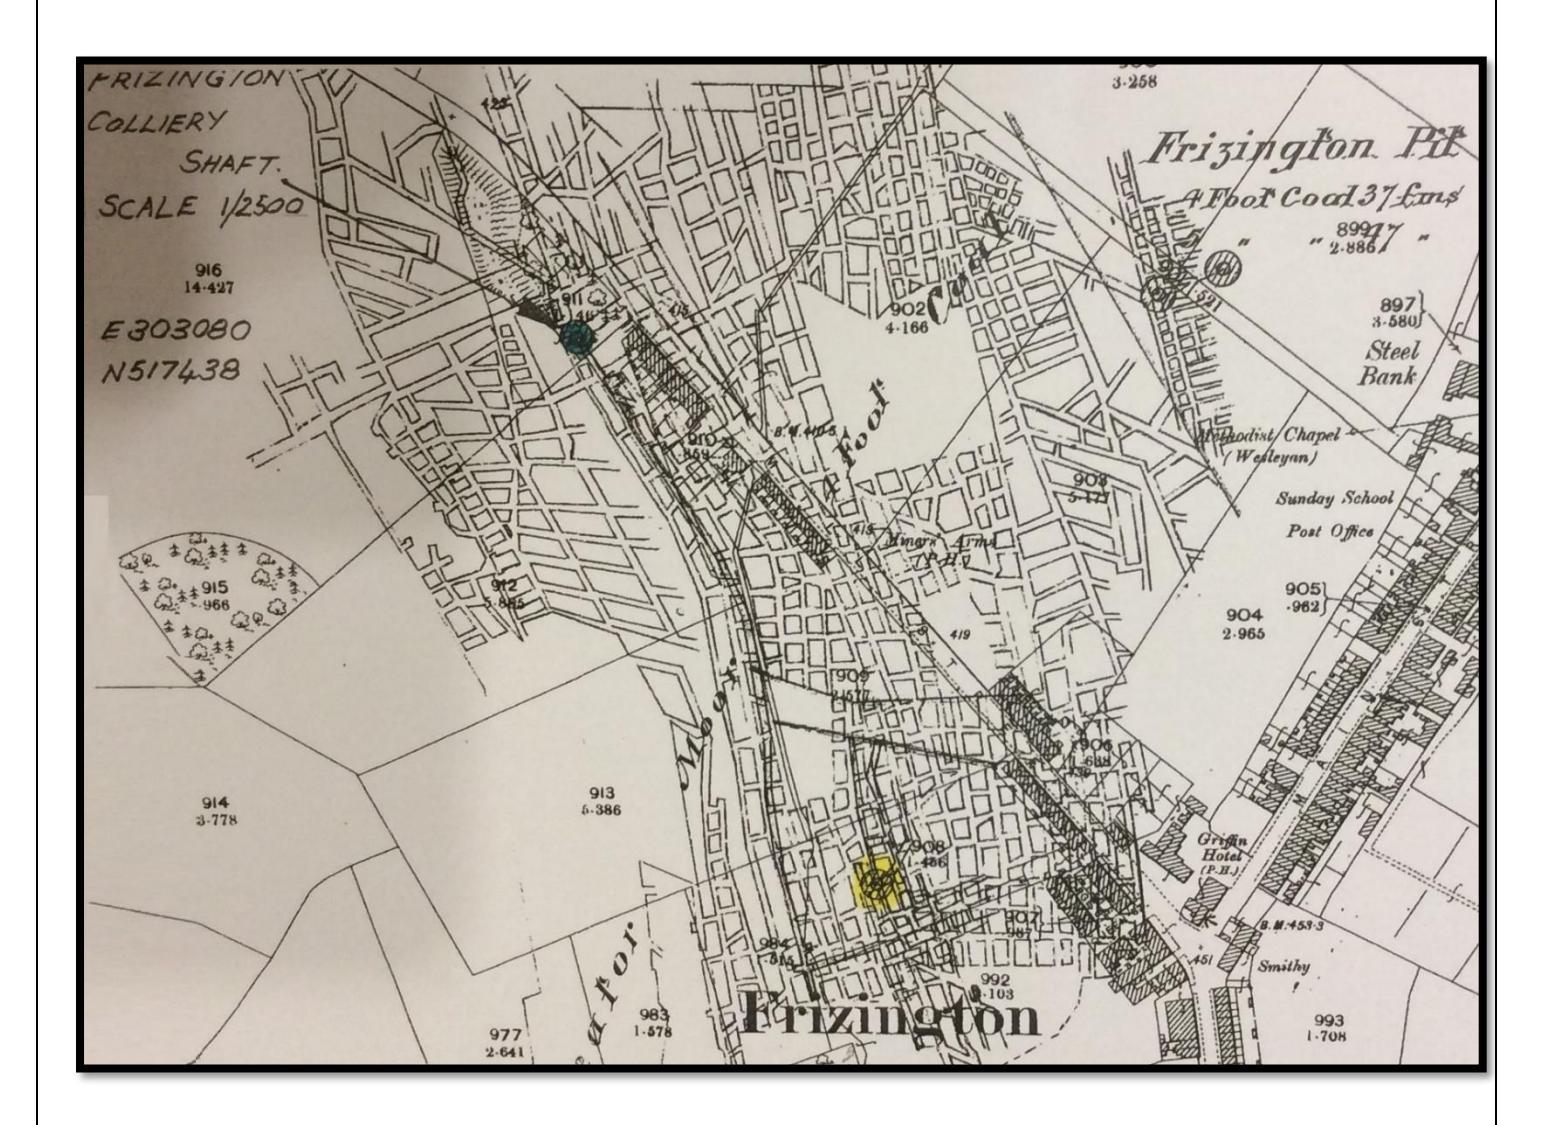
APPENDIX D EXTRACT OF HISTORICAL MINE PLAN

An extract of an historical mine plan provided by Laurie Crayston showing Frizington Colliery Shaft within the site at coordinates E 303080, N 517438 is presented in Appendix D. The site and this shaft are shown in the top right corner of the plan. The plan records the 4 Foot & 5 Foot Coals at Frizington Pit to the east of the property at 37 & 47 fathoms respectively or 67.7m and 86m depth.

The plan appears to indicate the presence of recorded underground working in the 'Cleator Moor 4 Foot Coal' below the site. The spoil heap and a single barn are shown on the plan within the site. The date of the plan is unknown.

The CA report identifies a single mine shaft (303517-007) towards the southern margin of the property at grid reference 303082, 517438. The mining plan in Appendix D places the shaft a little further upslope. According to the CA report this shaft was located and capped at rock-head by Egremont Mining Co Ltd in 2013. The 6m by 0.6m thick cap was comprised of steel beams, mesh reinforcement and concrete.

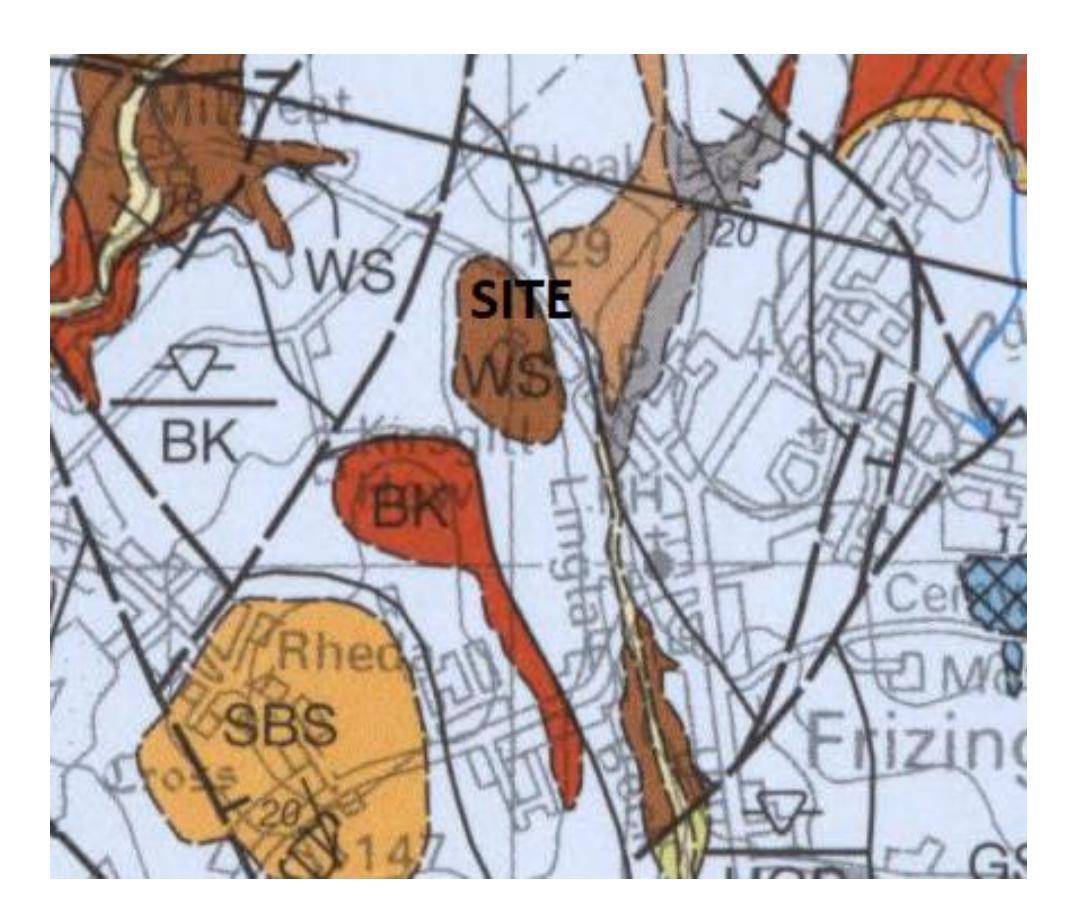
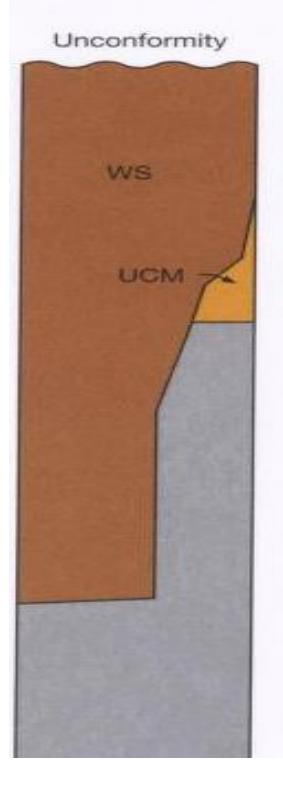
APPENDIX E EXTRACT OF BGS GEOLOGY MAP

The location of the site is shown on the extract of the BGS geological map presented in Appendix E. The tentative elevation of the site relative to the vertical geology column is shown below the map. The drift/soil horizon above the solid geology bedrock is not shown on the column.

The geology map shows the site is underlain by Whitehaven Sandstone of unknown thickness. The map suggests that drift/soil cover is largely absent, bedrock lying at or near surface at this locality perhaps below thin soil cover.

Tentative elevation of site relative to vertical geology section

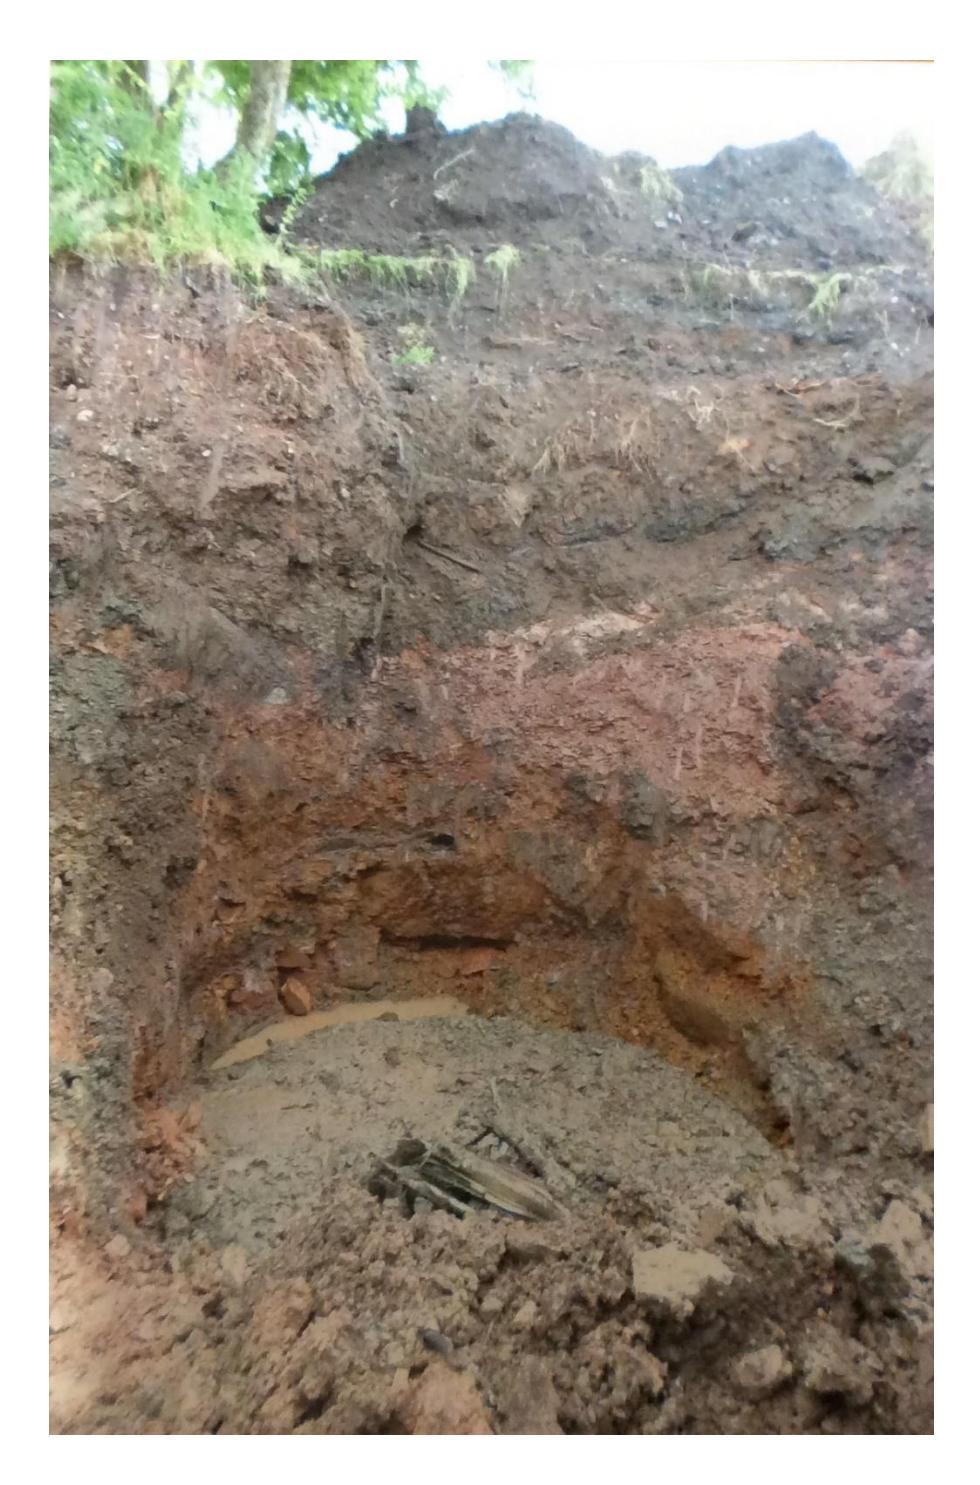
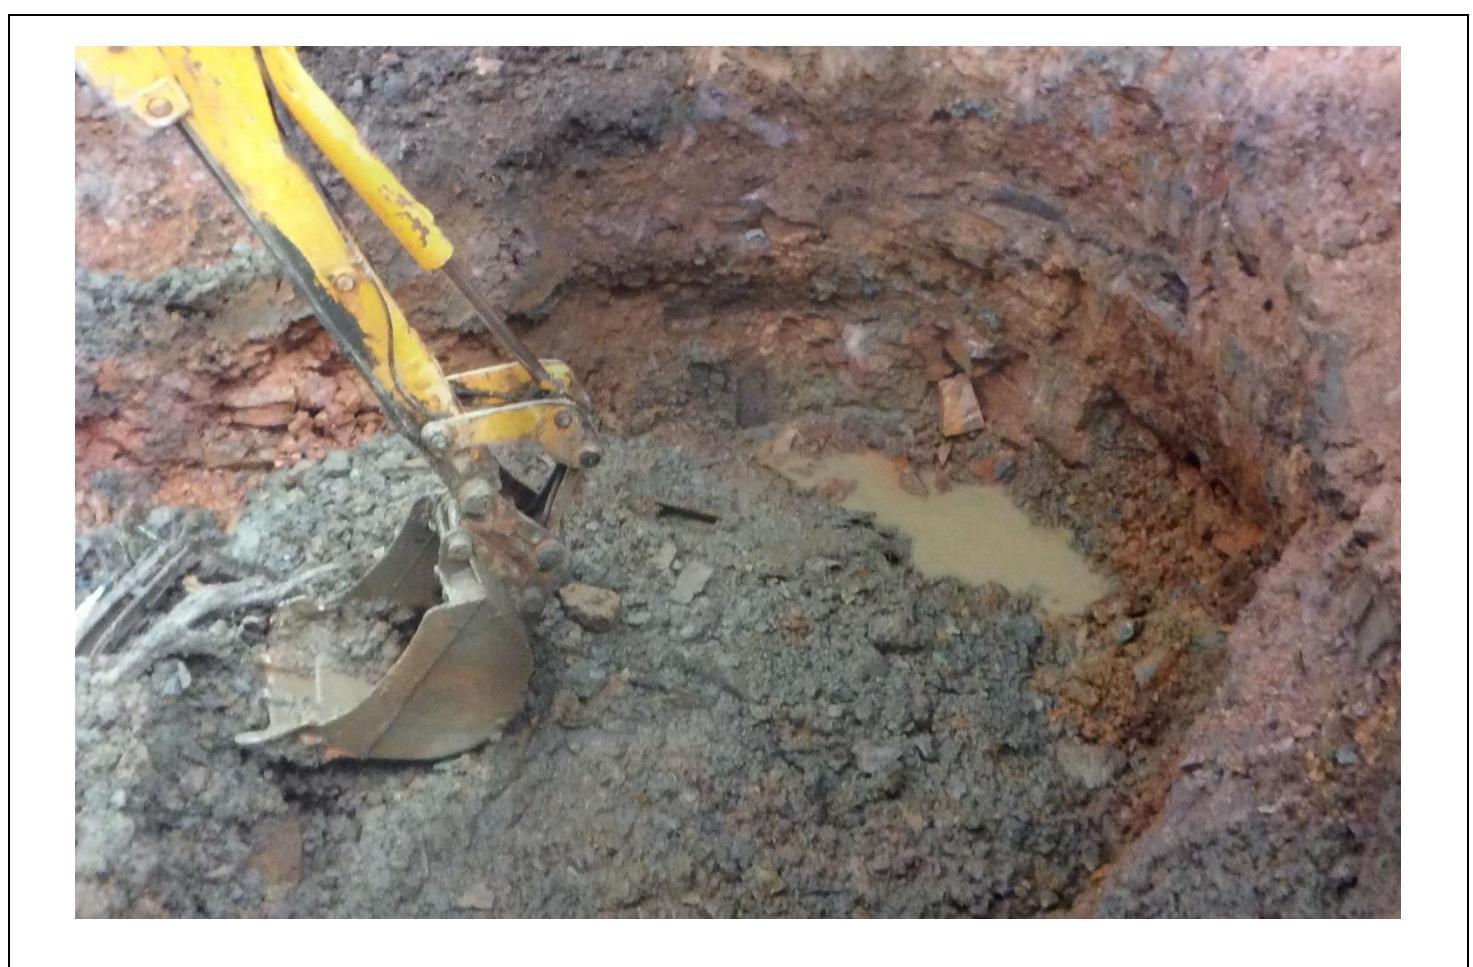
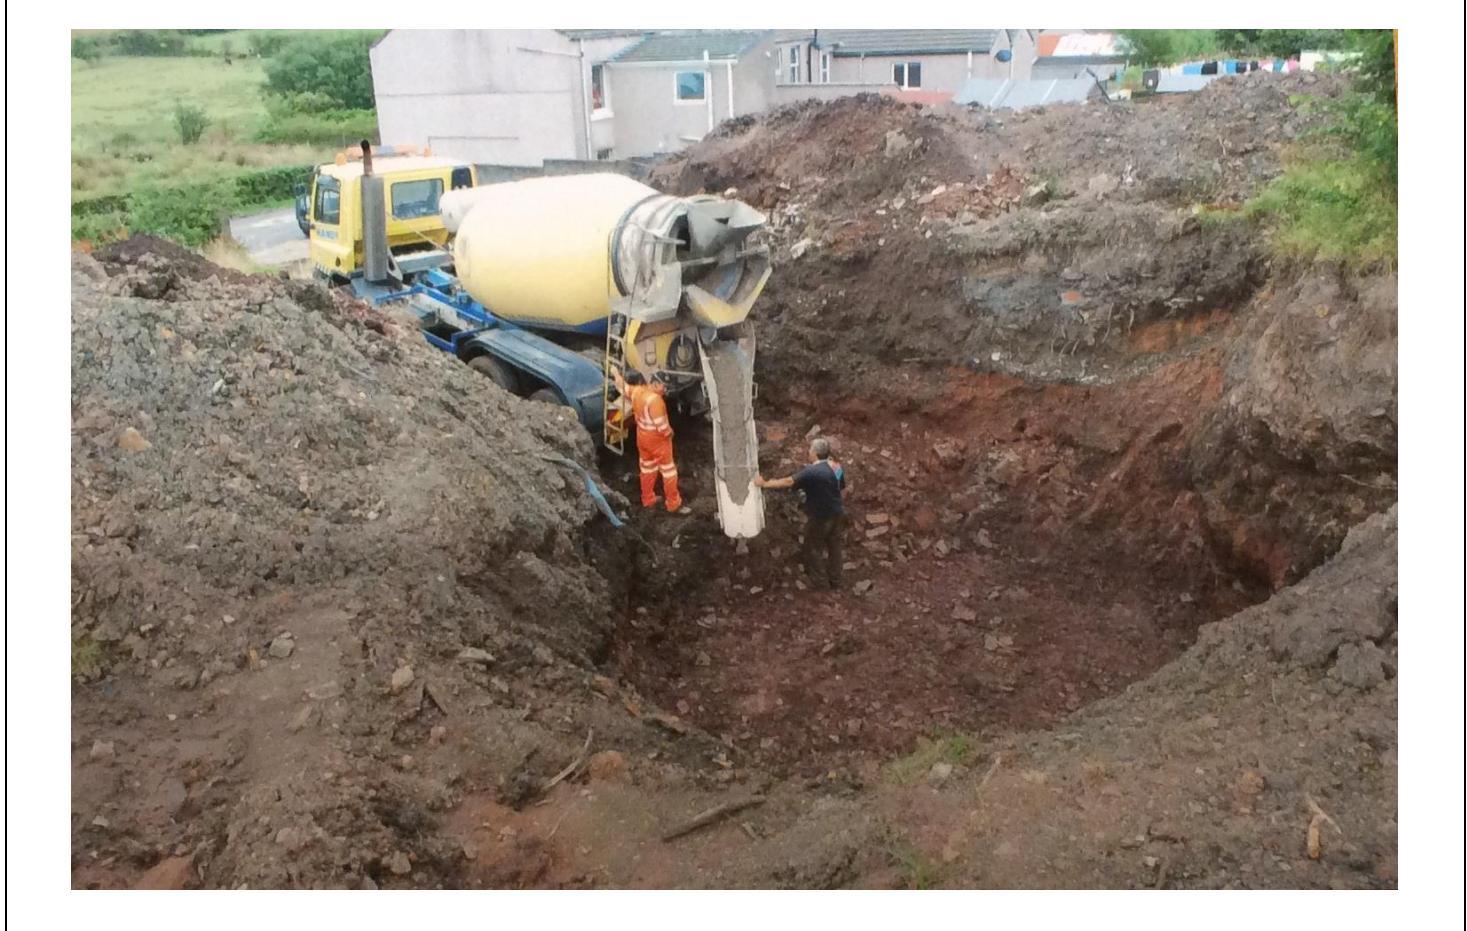
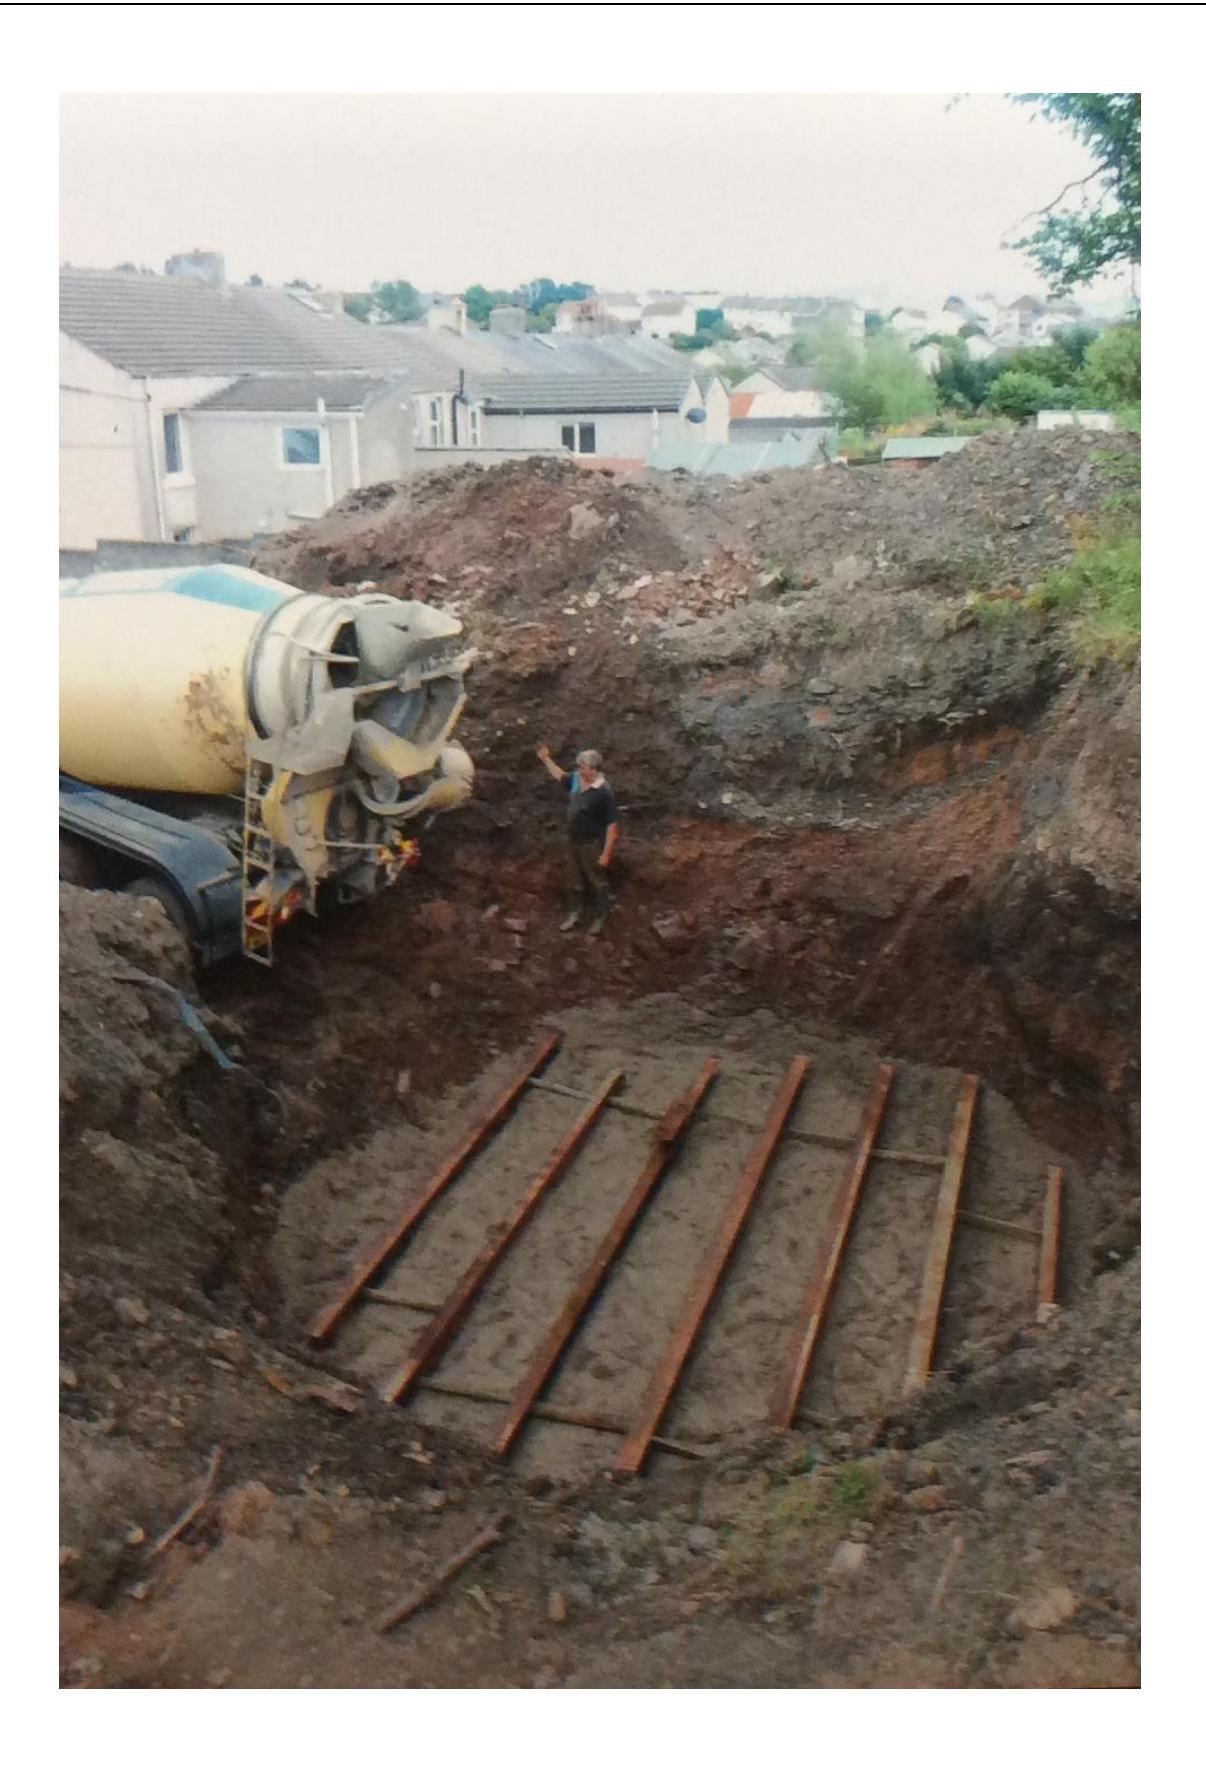
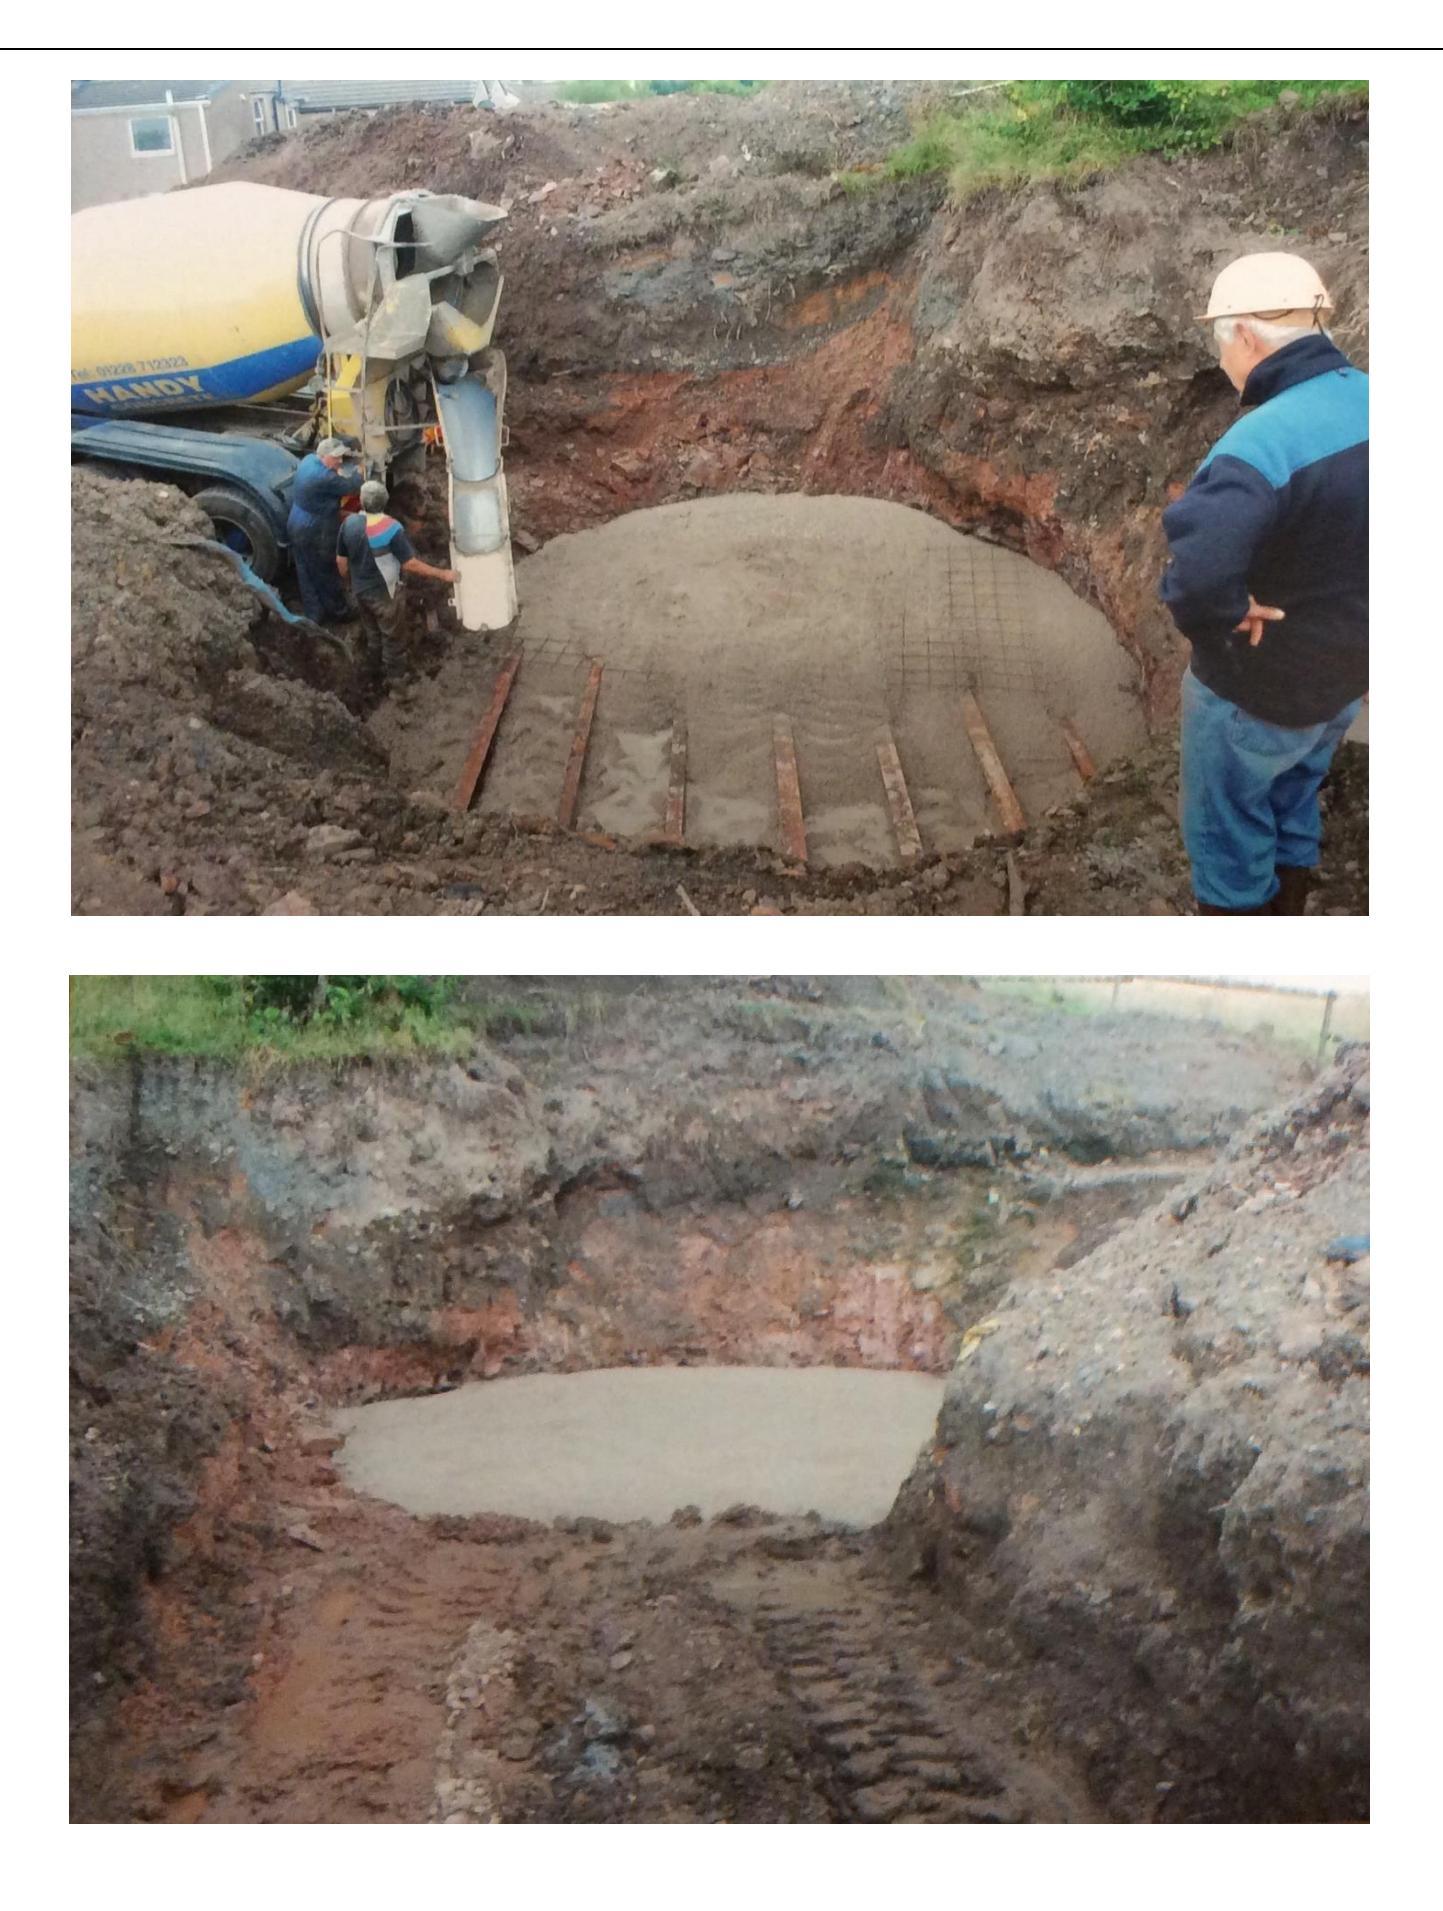
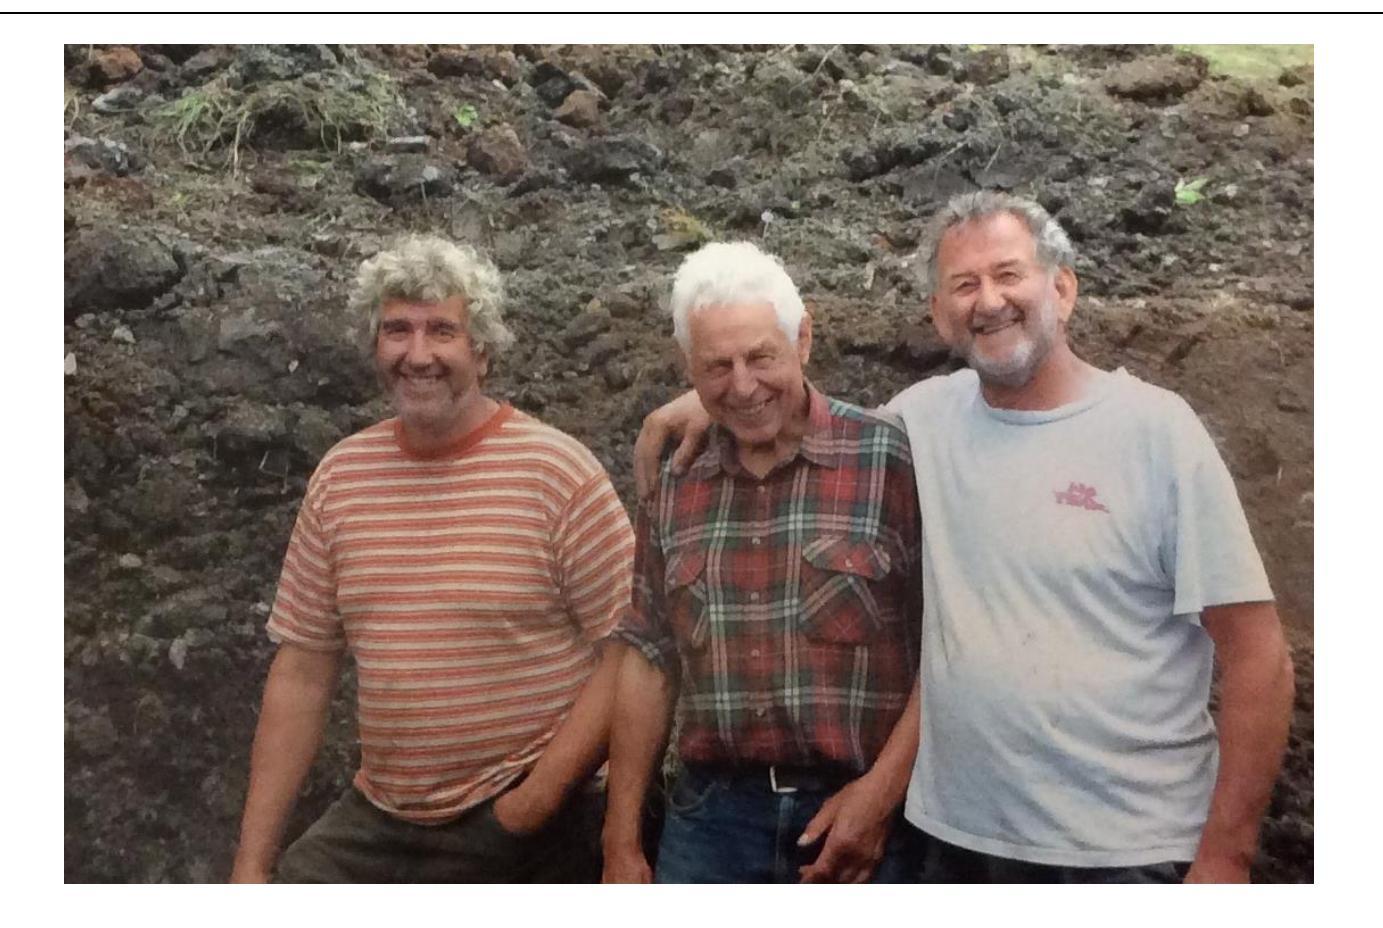
APPENDIX G IMAGES OF 2013 SHAFT CAPPING WORKS

On receiving further information from the clients including photographs of the 2013 capping works and confirmation that the works had been designed and carried out under the supervision of (Mister) Gilbert Finlinson a renowned and highly respected mining engineering expert Geoinvestigate advised the clients to once again petition the CA to accept the 2013 shaft capping works and ask them to revise their records accordingly.

Photographs of the capping works provided by the client are included in Appendix G. Gilbert Finlinson is shown watching the pouring of the concrete and middle in last image.

However, the 2013 mine shaft capping images suggest the concrete cap was not fitted with a gas vent pipe.

However, in our opinion in this instance the mine gas risk is raised owing to the close proximity of a coal mine shaft providing a potential pathway to surface for mine gas and the absence of a gas vent pipe through the cap.

Owing to the perceived raised gas risk Geoinvestigate has previously advised the client to carry out longer term monitoring in specially installed gas wells as part of the shallower geoenvironmental investigation of the site. This work is scheduled to be commenced in the next few weeks.

In our opinion even if the gas monitoring results are favourable the new dwelling should as a precaution be fitted with basic gas protection measures commensurate with Characteristic Situation **CS2 of CIRIA publication C665** – **'Assessing risks posed by hazardous ground gases to buildings'.** In our opinion in this instance the design should preferably incorporate suspended floor with a passively vented under floor void and gas proof membrane.

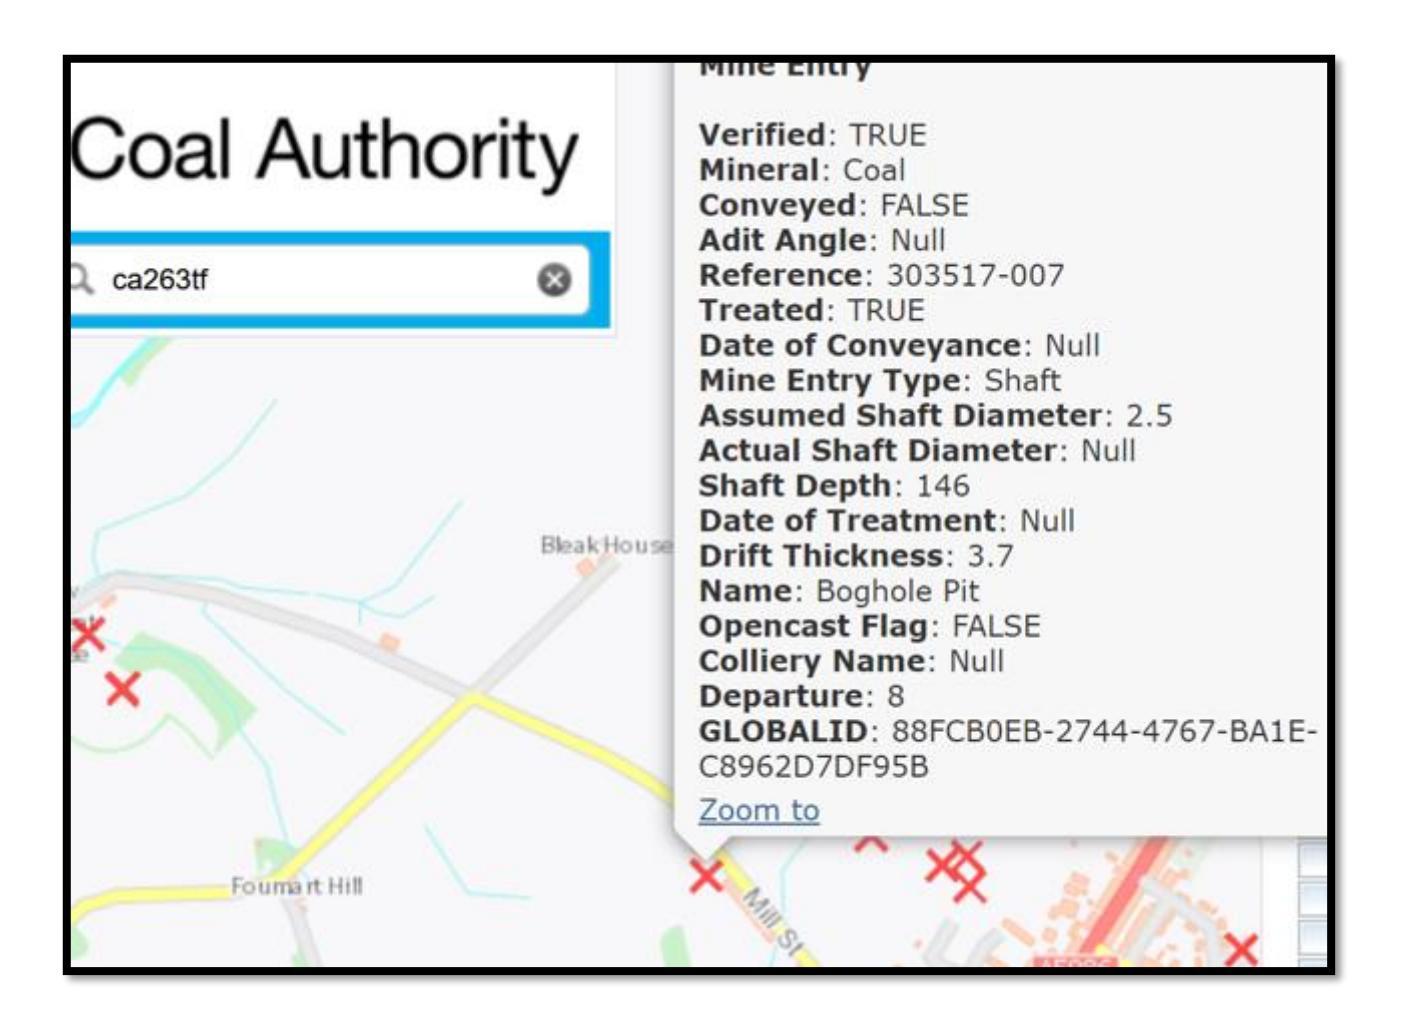
JANUARY 2022 – CA ONLINE SHAFT DETAILS

It is understood that the treatment description for shaft 007 has recently been changed by the CA in 2022. Previously in January 2022 when Geoinvestigate were initially contacted by the client it is understood that owing to a dispute/misunderstanding between the parties the CA would not recognise the shaft capping works carried out in 2013 by Laurie Crayston's father and the Egremont Mining Company. Previously the CA had allocated the shaft a departure/positional uncertainty of 8m though the exact position of the shaft was known to the clients who had found and capped it themselves.

According to Laurie Crayston the shaft departure has subsequently been reduced by the CA from 8m in January 2022 to 3m currently though the CAs online record still has to be adjusted in this respect. Extracts of the CAs earlier and current online information on the shaft is presented in Appendix H.

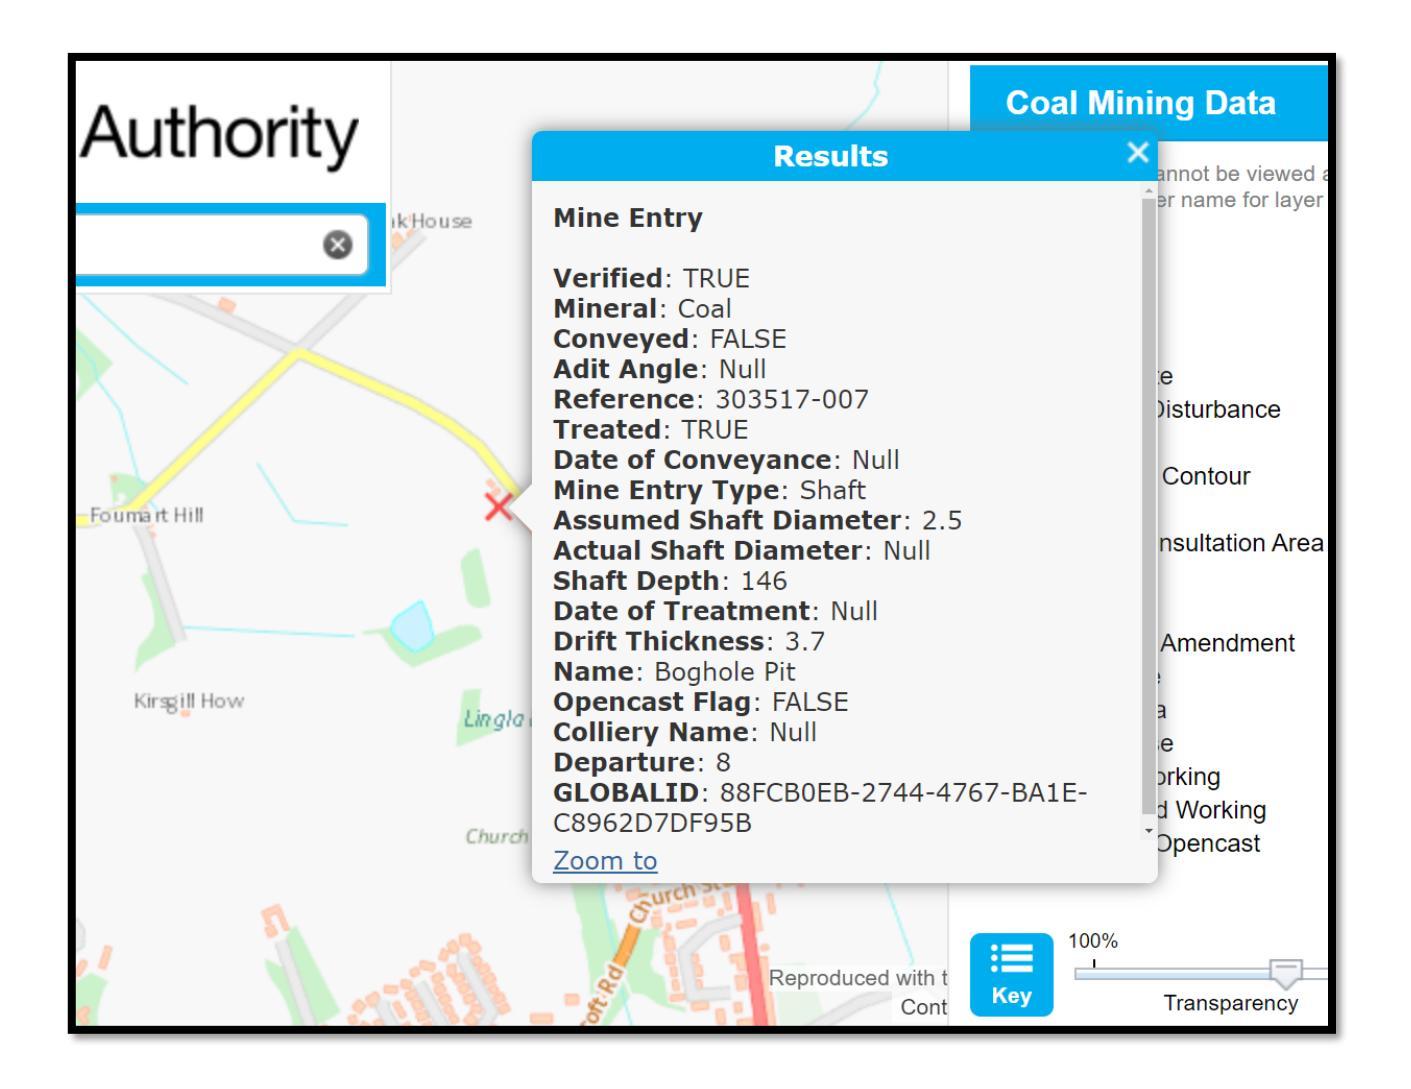
CURRENT – CA SHAFT DETAILS 29/06/2022

The current revised CA report now describes the capping works carried out in 2013 by the Egremont Mining Company.

Other remaining contradictions regarding the CAs current online shaft information appear to include its depth of 146m whereas the original shaft sinking journal records 86m while the actual circular shaft diameter measured in 2013 is 10 feet or 3.05m rather than the 2.5m assumed by the CA. However, the drift depth of 3.7m recorded by the CA agrees with the 9 feet of the shafting sinking log 158 obtained from the BGS record. Perhaps these differences still need to be reviewed by the CA.
