# PRELIMINARY COAL MINING RISK ASSESSMENT

PROPOSED REDVELOPMENT OF LAND EAST OF TANGLIN, EARL STREET

CLEATOR MOOR

<u>Report Ref:</u>	2021-4724
Report Date:	10.08.2021
<u>Report Type:</u>	CMRA v1
Report Tracking:	11.08.2021 – Report v1 Issued for design team review
Prepared By:	Curtis Evans BSc (Hons), FGS – Geo Environmental Engineer/Director
Checked By:	James Brock BSc (Hons), M.Sc – Geo Environmental Engineer/Associate
<u>Client:</u>	Linda Taylor
Consultant:	Green Swallow Ltd

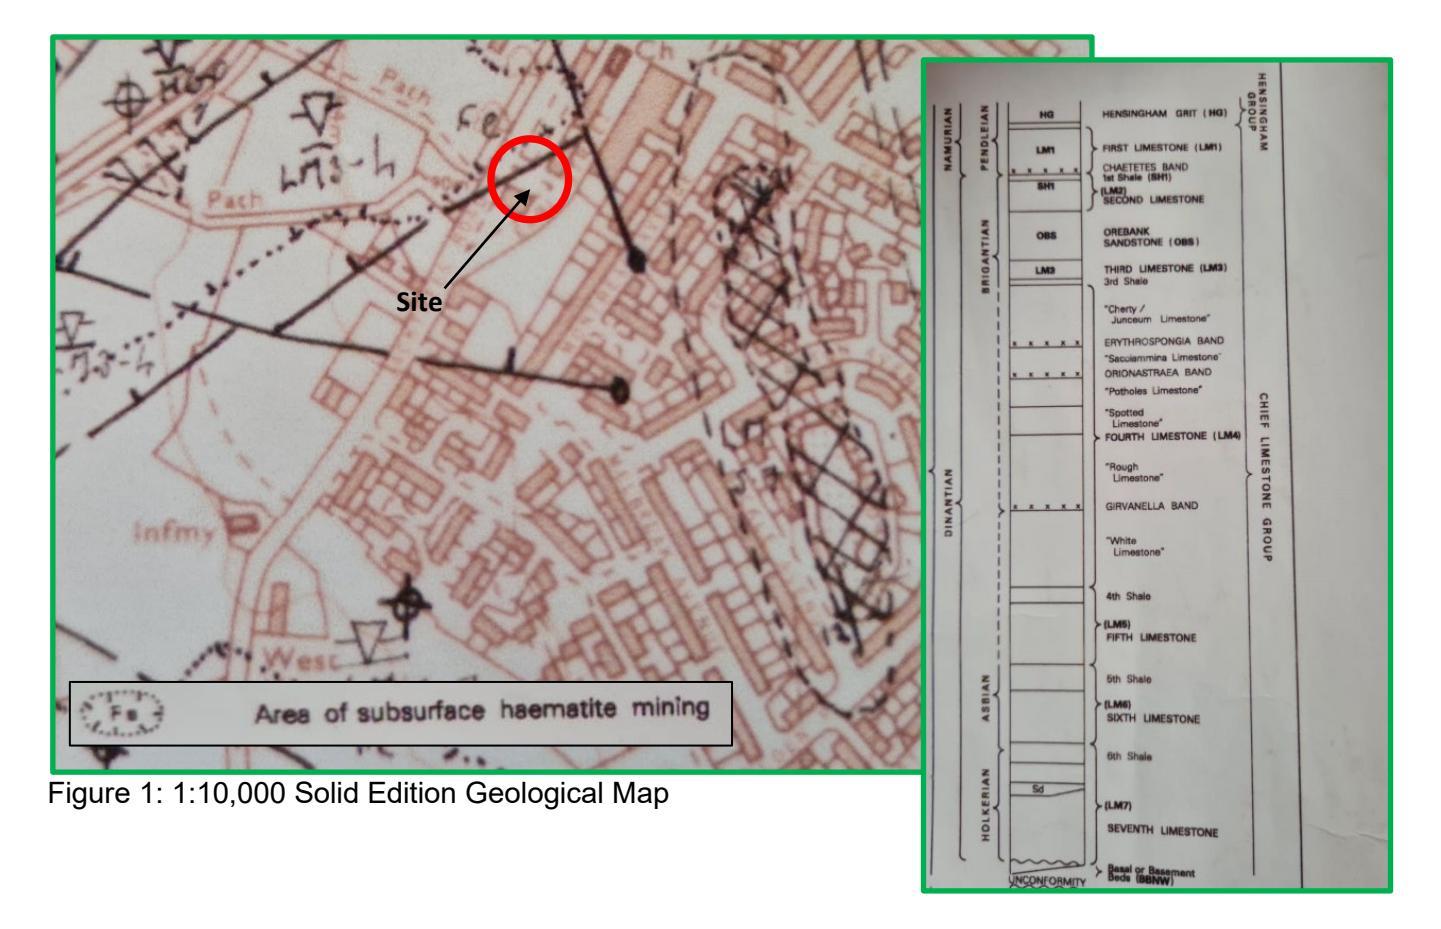
Sheet NY01SW, 1:10,000 scale (See Figure1 and 2).

A review of the BGS geological map extract indicates that the site is underlain by Glacial Till deposits. These typically comprise firm and stiff gravelly clays with layers of sand and gravel. Frequent to abundant cobbles and boulders may be present. The geological maps do not indicate the thickness of the drift deposits; however, it is anticipated that they will be at least 5m deep.

The geological map indicates that the site is underlain by solid strata of the Frizington Limestone Formation. This stratum comprises buff to dark grey, bioclastic, sandy grainstone to packstone and fenestral lime mudstone, displaying tabular or cross bedding, containing stromatolites and coral colonies. This stratum is recorded as being between 50m and 100m in thickness.

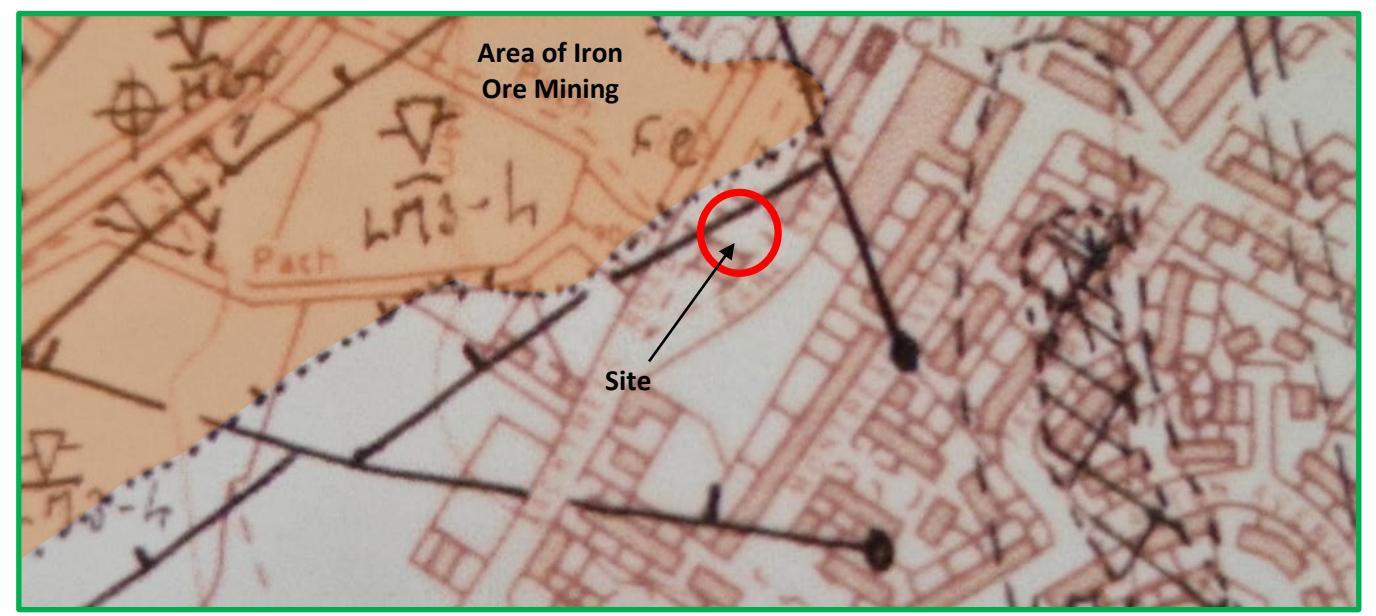
However, iron ore mining is recorded in the general area. The 1:10,000 scale geological plan (NY01SW) indicates that iron ore mining was present to the north-west of the site, denoted on the below extract as a dashed line with the reference "Fe".

Figure 2: 1:10,000 Solid Edition Geological Map - "Fe" denoting "area of subsurface haematite mining".

Whilst there is a history of iron ore mining in the general area, the published geological plan (NY01SW) indicates that subsurface iron ore (haematite) mining has occurred close to, but not beneath the site. Therefore, when taking into consideration the desk-based information, the site is not considered to be at significant risk of subsurface iron ore mining and no intrusive ground investigations or remedial measures relating to historical iron ore mining are considered necessary at this time.
