COACH ROAD, WHITEHAVEN

BAT INSPECTION SURVEY REPORT

Prepared for: United Utilities

Report Reference: JN00466/D01

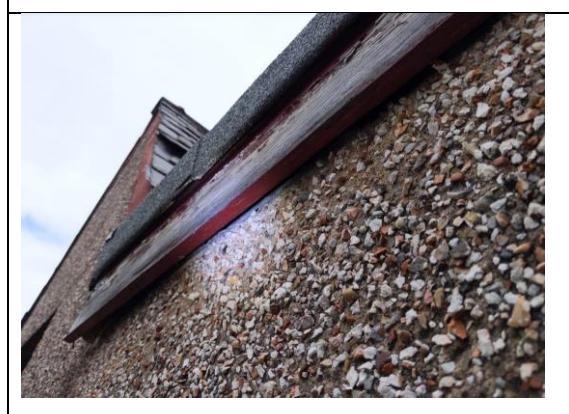
- 4.8 Externally, the elevations provide little potential for bats, as they are rendered throughout, leaving no gaps for bats to access the walls. At the wall tops however, there are often gaps between the rendered elevations and the overlying roof structure. This is most apparent at the north-eastern end, where a gap exists between the wall and the flat roof. No droppings were observed on this wall but the gap is large enough for bats to access and roost.

Photograph 5: Crevice at wall top of flat roof

- 5.2 The property therefore has potential to provide roosting locations for bats and it is recommended that evening emergence or dawn re-entry surveys be carried out to establish the presence or likely absence of bats in the property.

- 5.3 The property is considered to have moderate potential for bats. Therefore, in accordance with the Bat Surveys for Professional Ecologists (BCT 2016) it is recommended that at least two activity surveys are carried out during the recommended survey period (May- September).

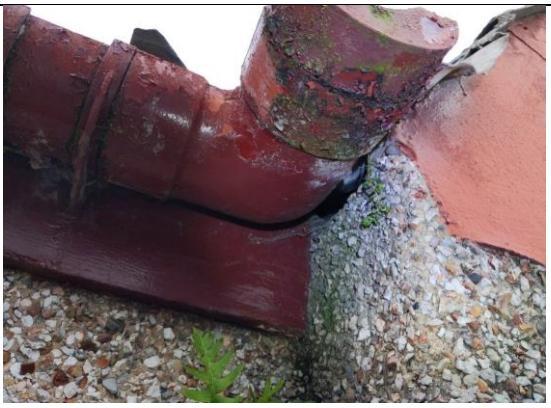
Photograph 6: Crevice at wall top of eaves
