PHASE 1: DESK TOP STUDY REPORT

(PRELIMINARY ENVIRONMENTAL RISK ASSESSMENT)

PROPOSED RESIDENTIAL DEVELOPMENT:

LAND ADJACENT TO SEABREEZE LODGE

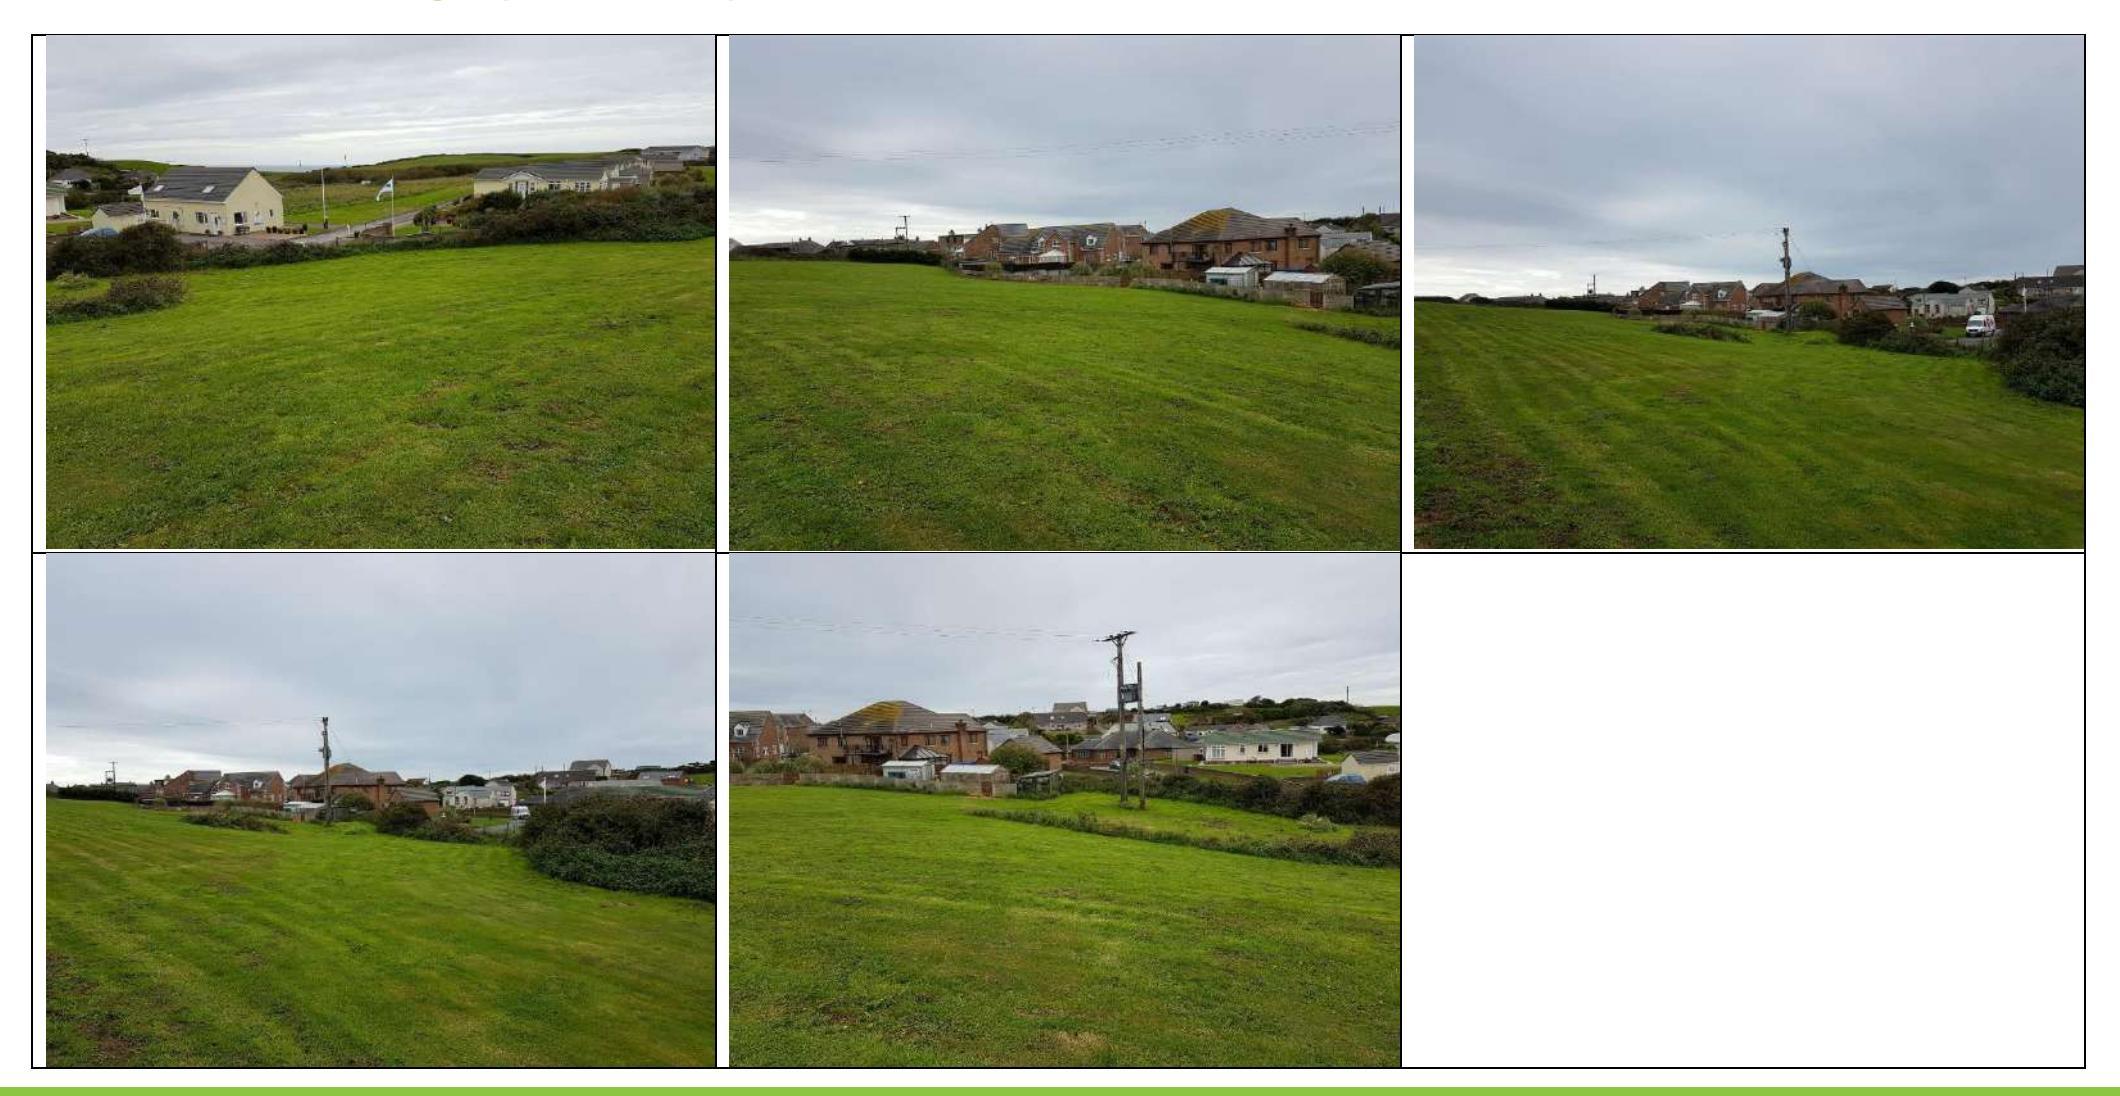
GEO2018-3238: Site Images (October 2018)

The site forms agricultural fields and at the time of the walkover vegetative surfacing was noted, possibly used as a paddock or for grazing. Some small garden sheds were present on site which did not appear to contain any asbestos containing materials. No areas of hard-standing were noted.

At the time of the walkover the site was in an acceptable condition in terms of housekeeping. There was no visual evidence of bonfires, fly-tipping or bulk fuel/chemical storage.

Overhead cables were noted to be present across the site.

From the walkover, the site was noted to generally slope to the west.

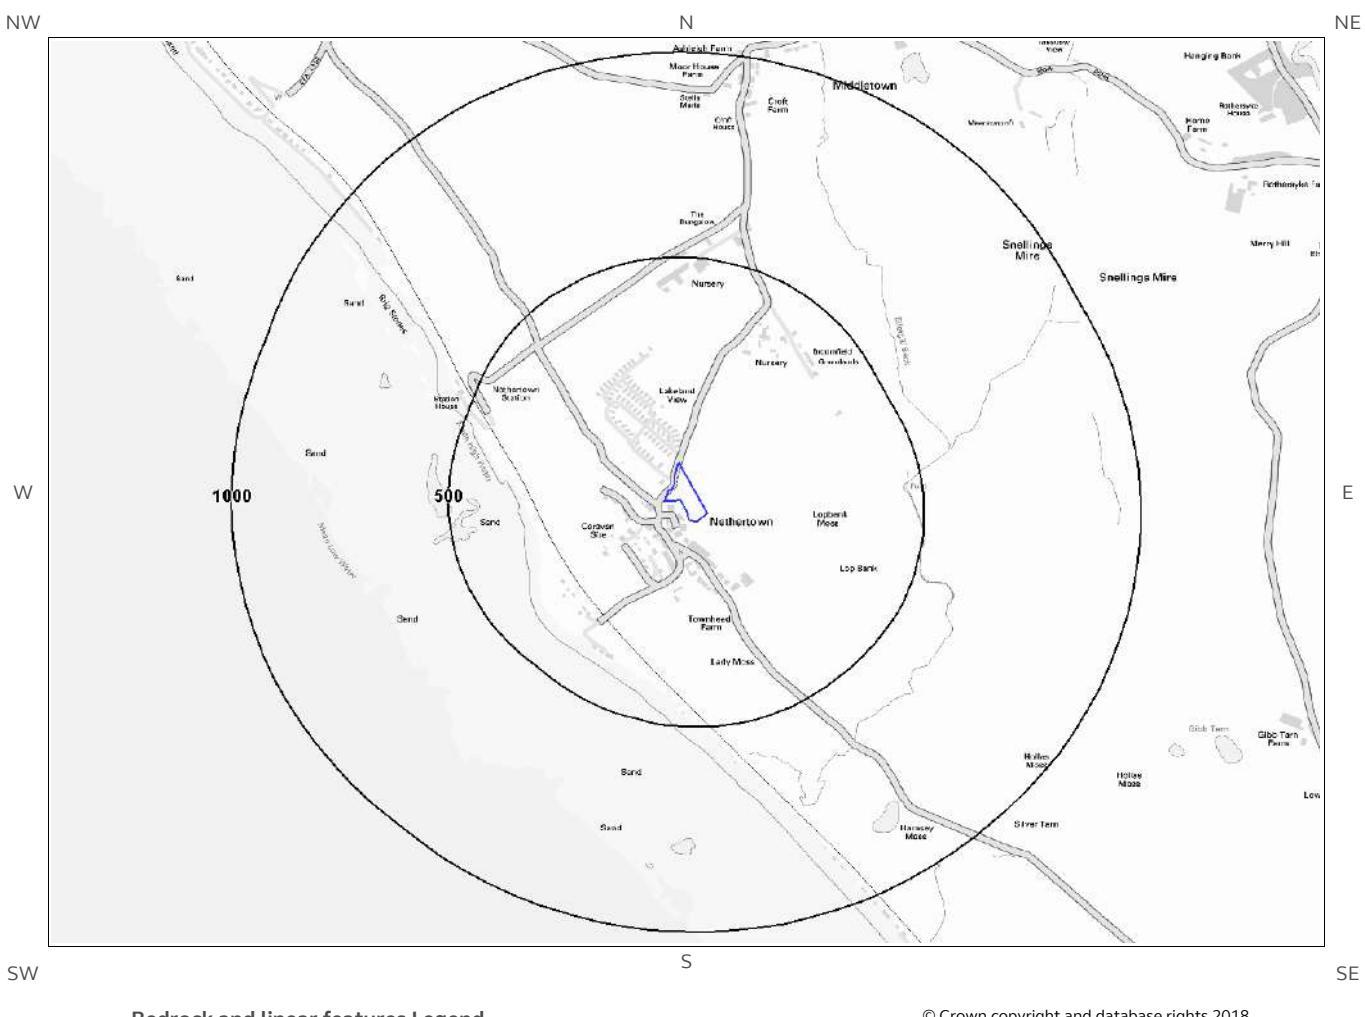
1.3 Bedrock and linear features map (1:10,000 scale)

Solid geological deposits across the development site are indicated by the BGS as the St Bees Sandstone Formation. The BGS and GSR do not record any subcropping coal seams beneath or close to the site. The GSR Geoinsight (Section 4.3) indicates a *negligible* hazard rating with respect to ground dissolution of soluble rocks and recommends the following:

A geological structural fault is inferred below the site, trending in a northwest – southeast direction with further faults noted in the surrounding area. The presence of fault lines have the potential to act as a conduit for the migration (horizontally and vertically) of potentially harmful ground gases (if present).

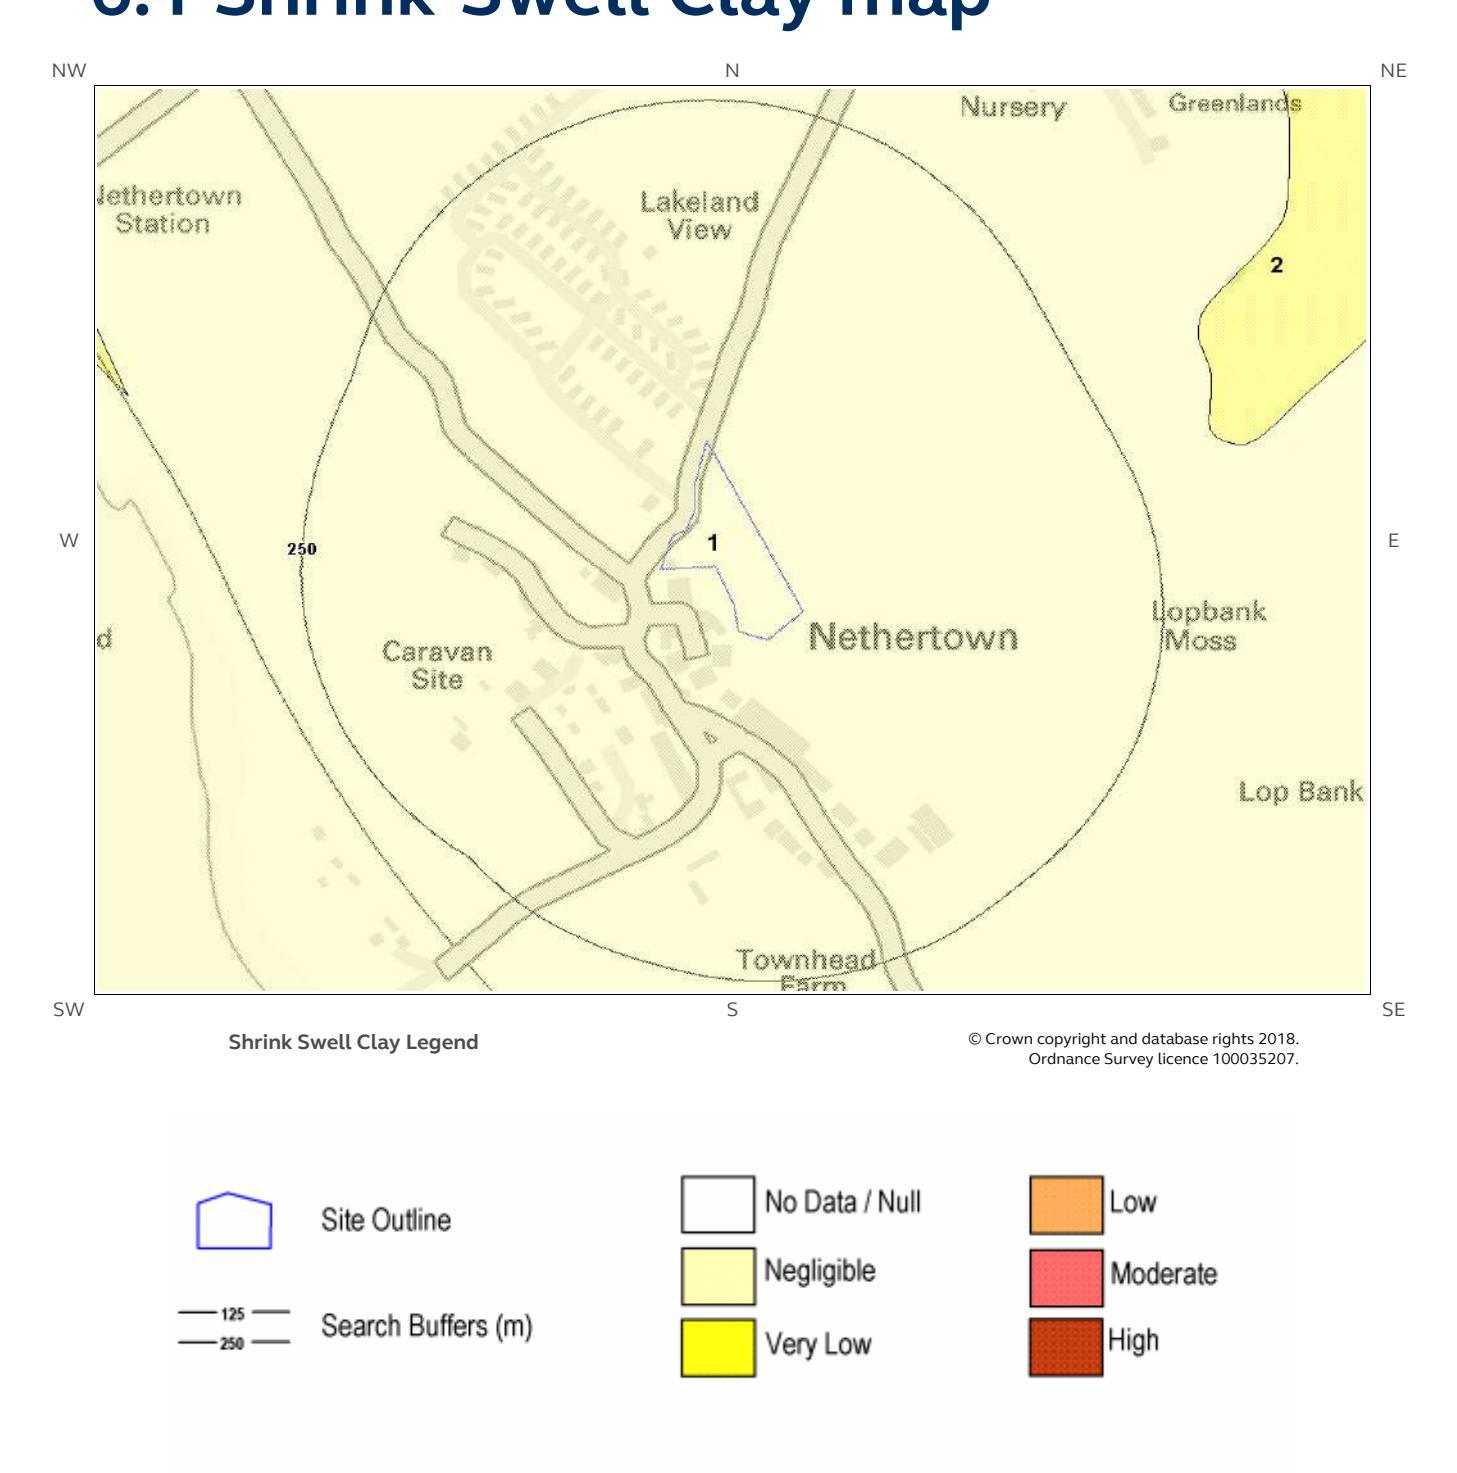
6 Natural Ground Subsidence 6.1 Shrink-Swell Clay map

ID	Distance (m)	Direction	Hazard Rating	Details
1	0.0	On Site	Negligible	Ground conditions predominantly non-plastic. No special actions required to avoid problems due to shrink-swell clays. No special ground investigation required, and increased construction costs or increased financial risks are unlikely likely due to potential problems with shrink-swell clays.

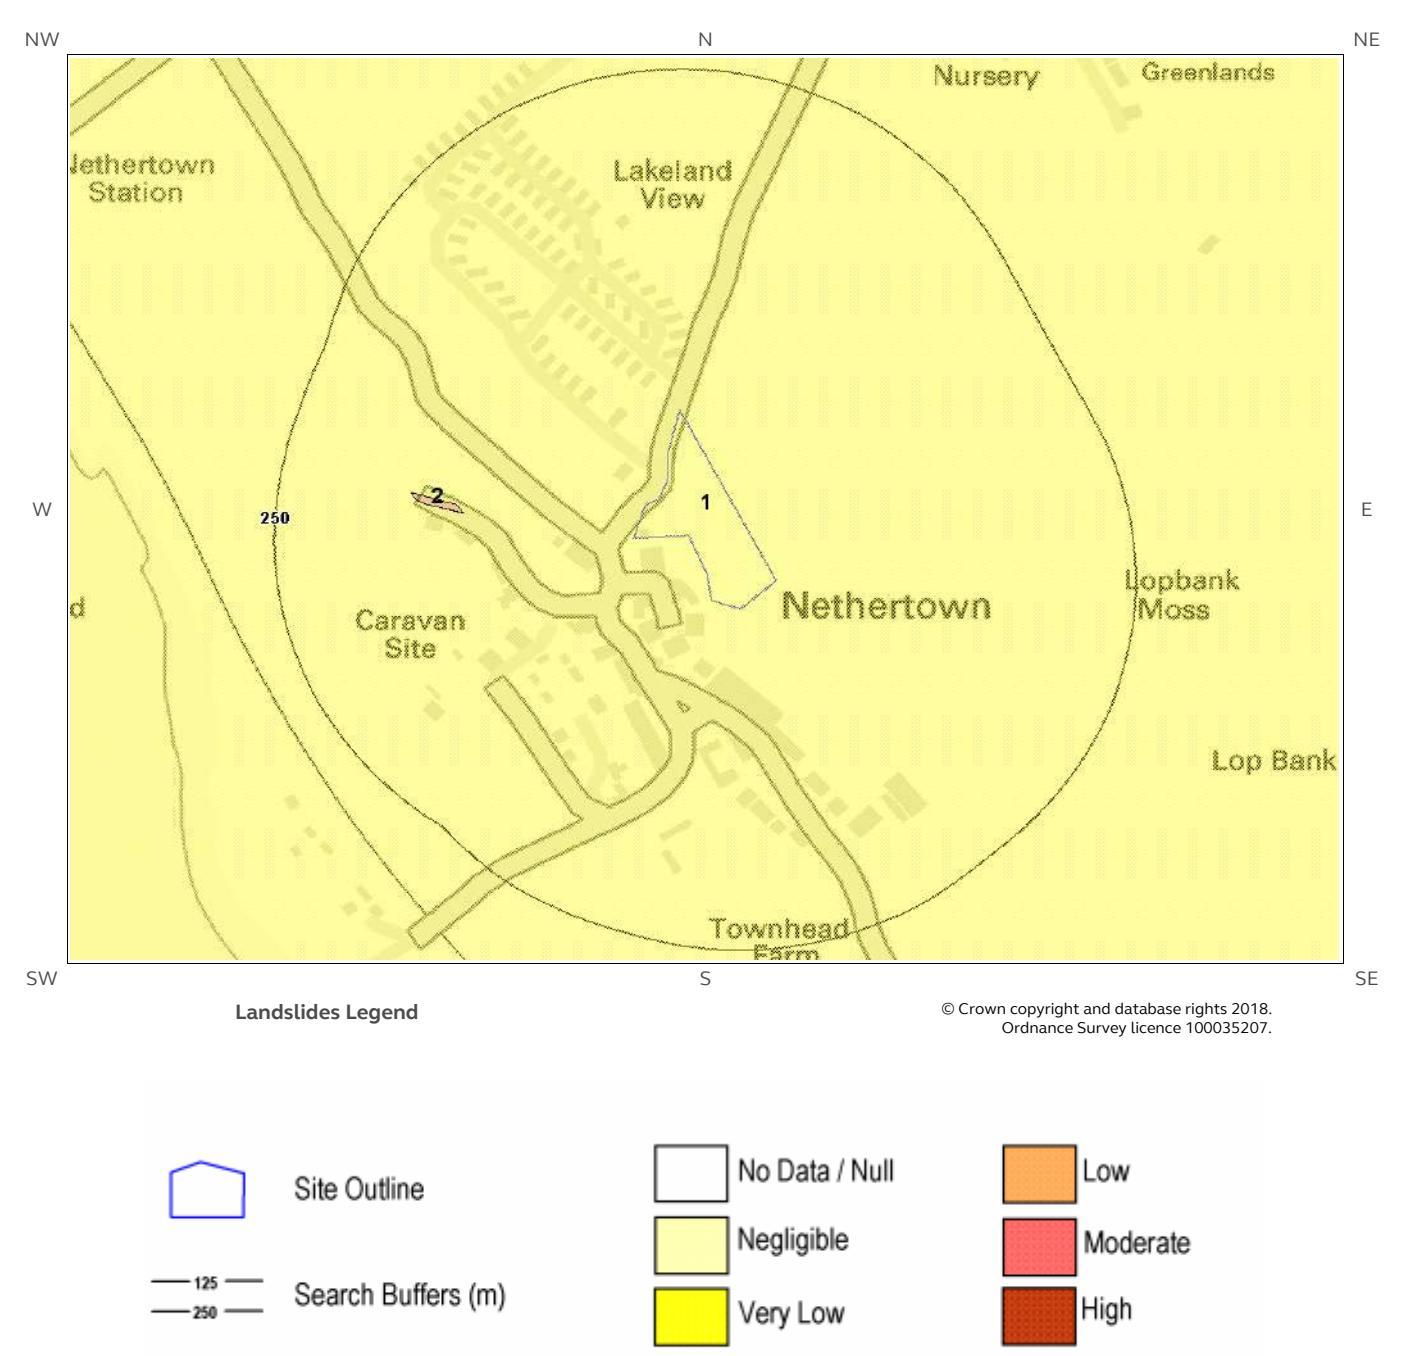
6.2 Landslides map

ID	Distance (m)	Direction	Hazard Rating	Details
1	0.0	On Site	Very Low	Slope instability problems are unlikely to be present. No special actions required to avoid problems due to landslides. No special ground investigation required, and increased construction costs or increased financial risks are unlikely due to potential problems with landslides.

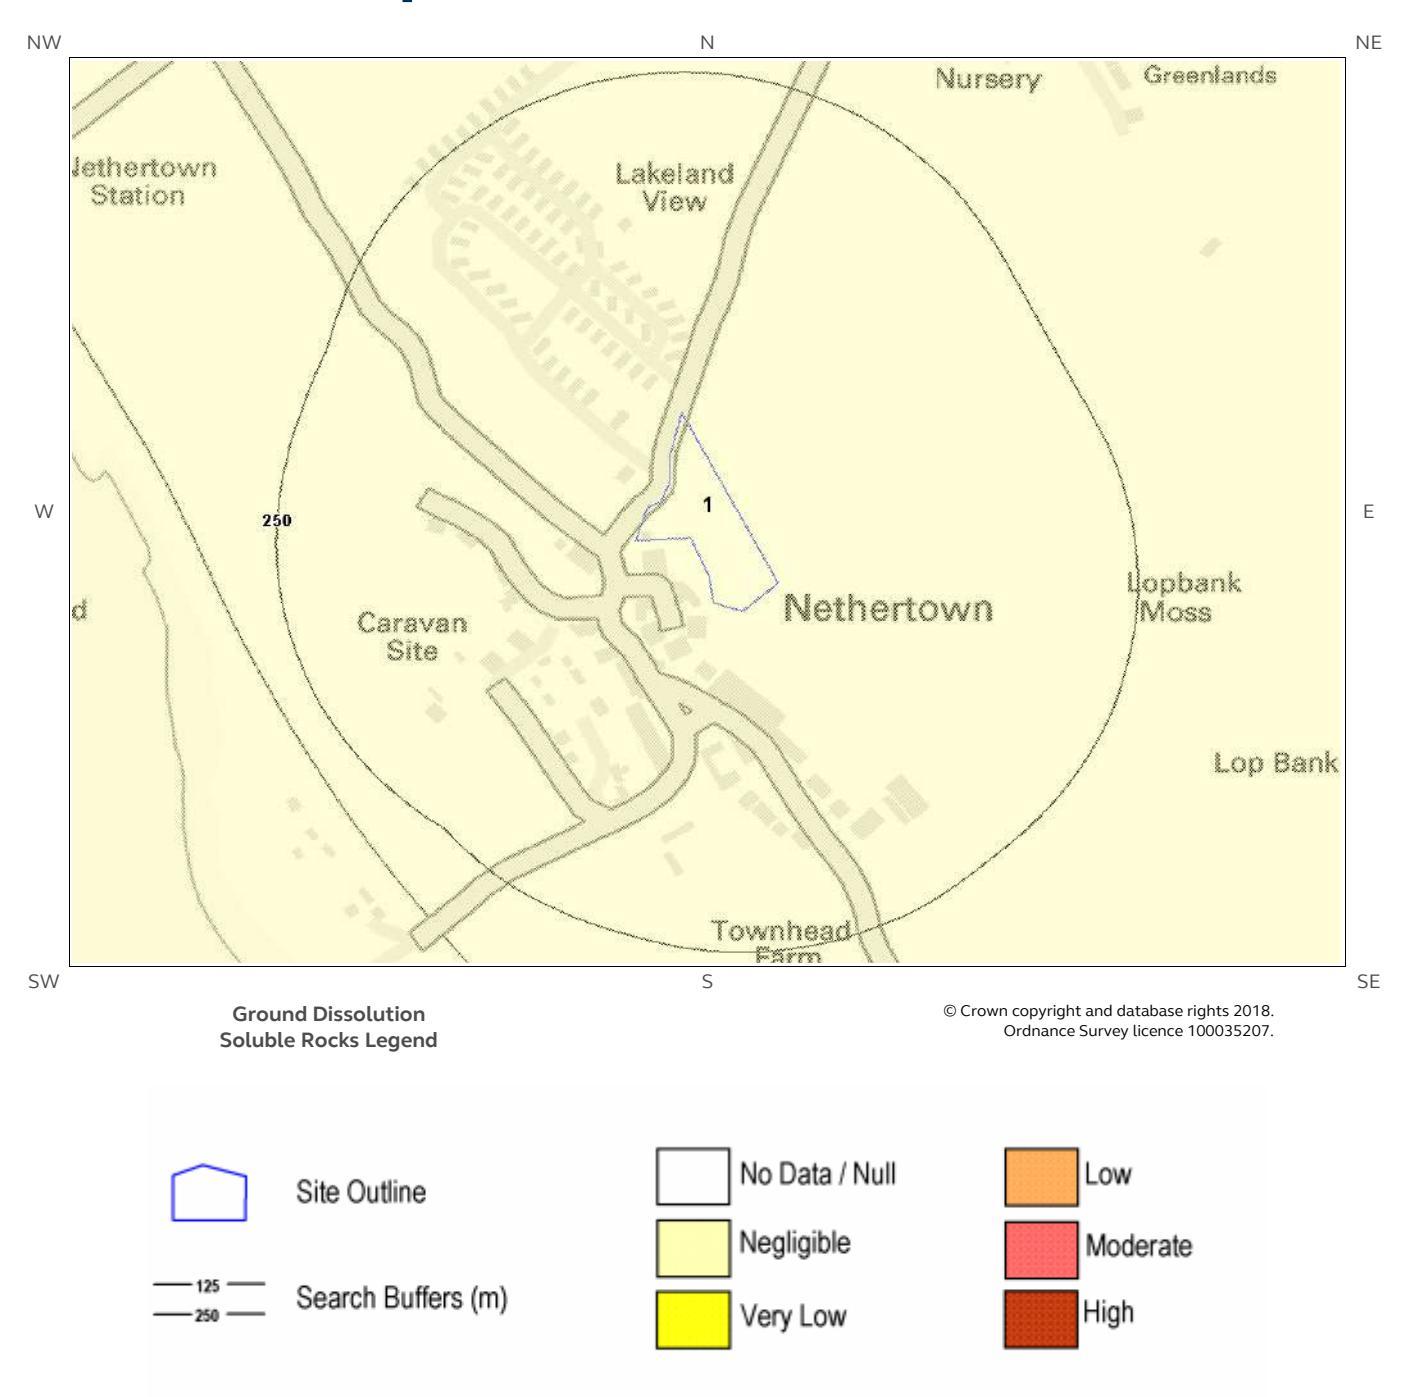
6.3 Ground Dissolution of Soluble Rocks map

ID	Distance (m)	Direction	Hazard Rating	Details
1	0.0	On Site	Negligible	Soluble rocks are present, but unlikely to cause problems except under exceptional conditions. No special actions required to avoid problems due to soluble rocks. No special ground investigation required, and increased construction costs or increased financial risks are unlikely due to potential problems with soluble rocks.

"Soluble rocks are present, but unlikely to cause problems except under exceptional conditions. No special actions required to avoid problems due to soluble rocks. No special ground investigation required, and increased construction costs or increased financial risks are unlikely due to potential problems with soluble rocks".

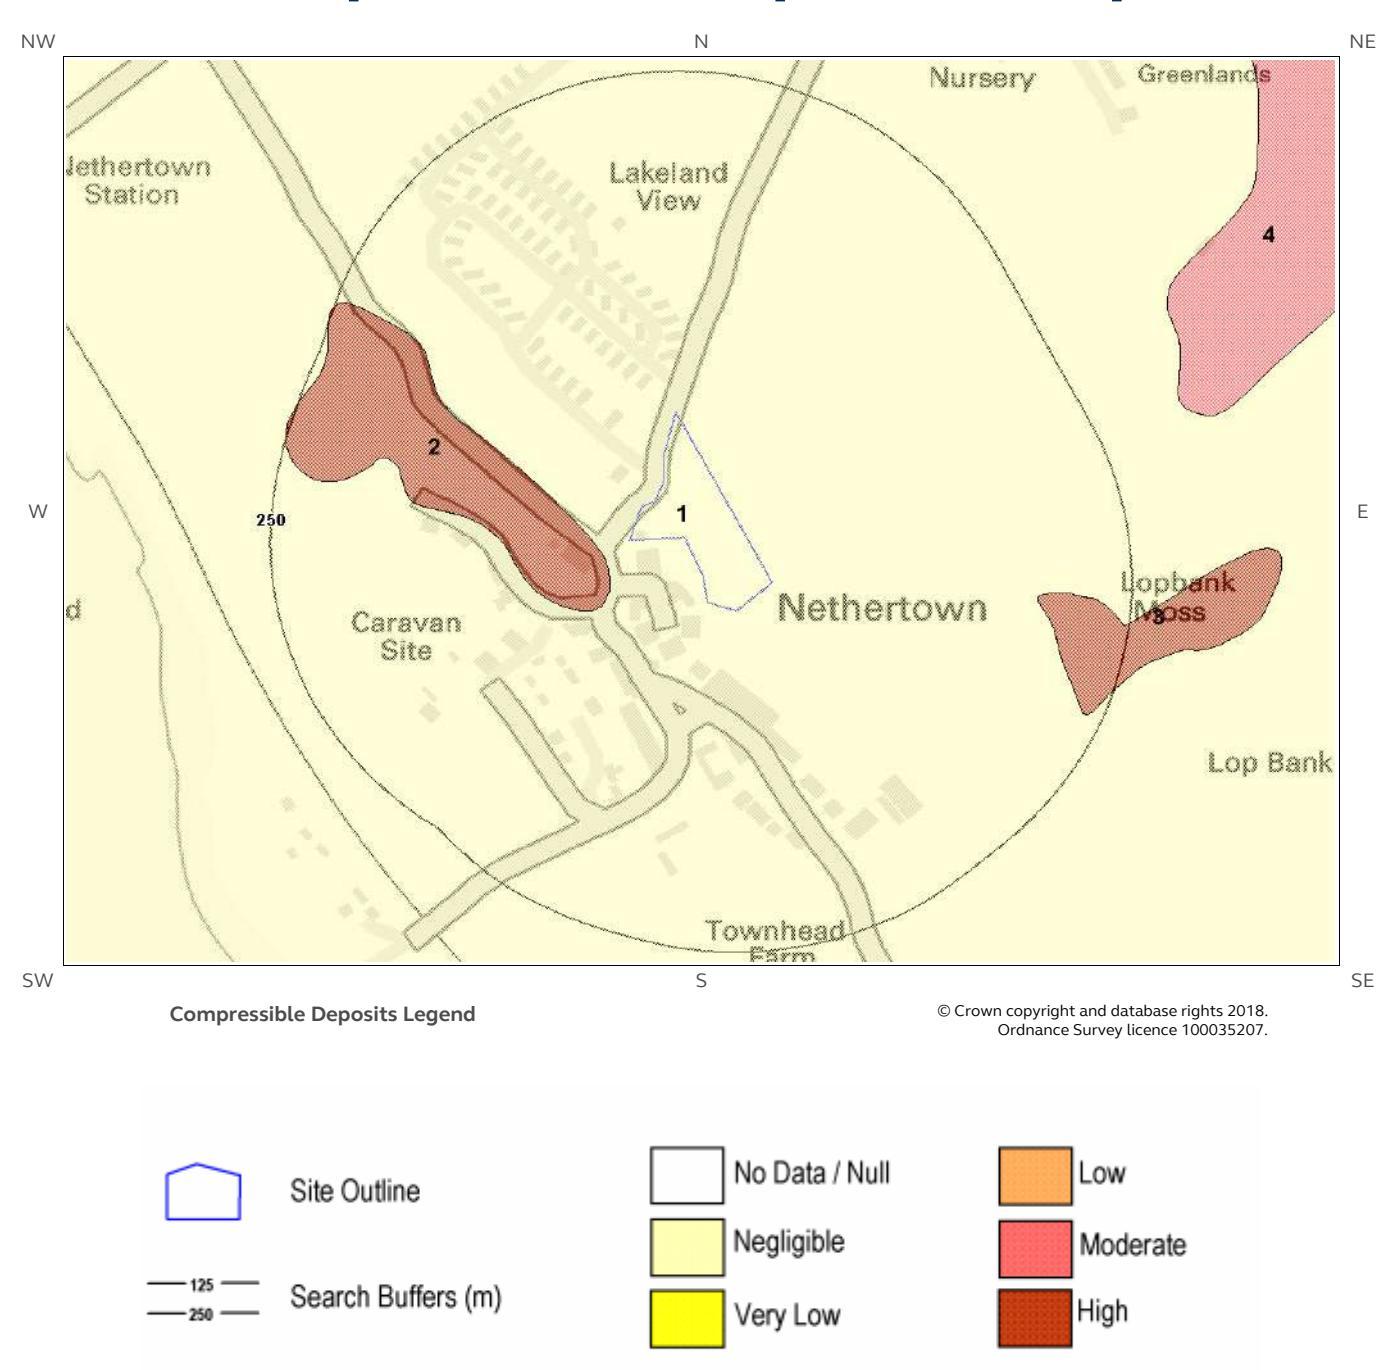
6.4 Compressible Deposits map

ID	Distance (m)	Direction	Hazard Rating	Details
1	0.0	On Site	Negligible	No indicators for compressible deposits identified. No special actions required to avoid problems due to compressible deposits. No special ground investigation required, and increased construction costs or increased financial risks are unlikely due to potential problems with compressible deposits.
2	22.0	SW	High	Very significant potential for compressibility problems. Avoid large differential loadings of ground. Do not drain or de-water ground near the property without technical advice. For new build - consider possibility of compressible ground in ground investigation, construction and building design. Consider effects of groundwater changes. Construction may not be possible at economic cost. For existing property - probable increase in insurance risk from compressibility especially if water conditions or loading of the ground change significantly.

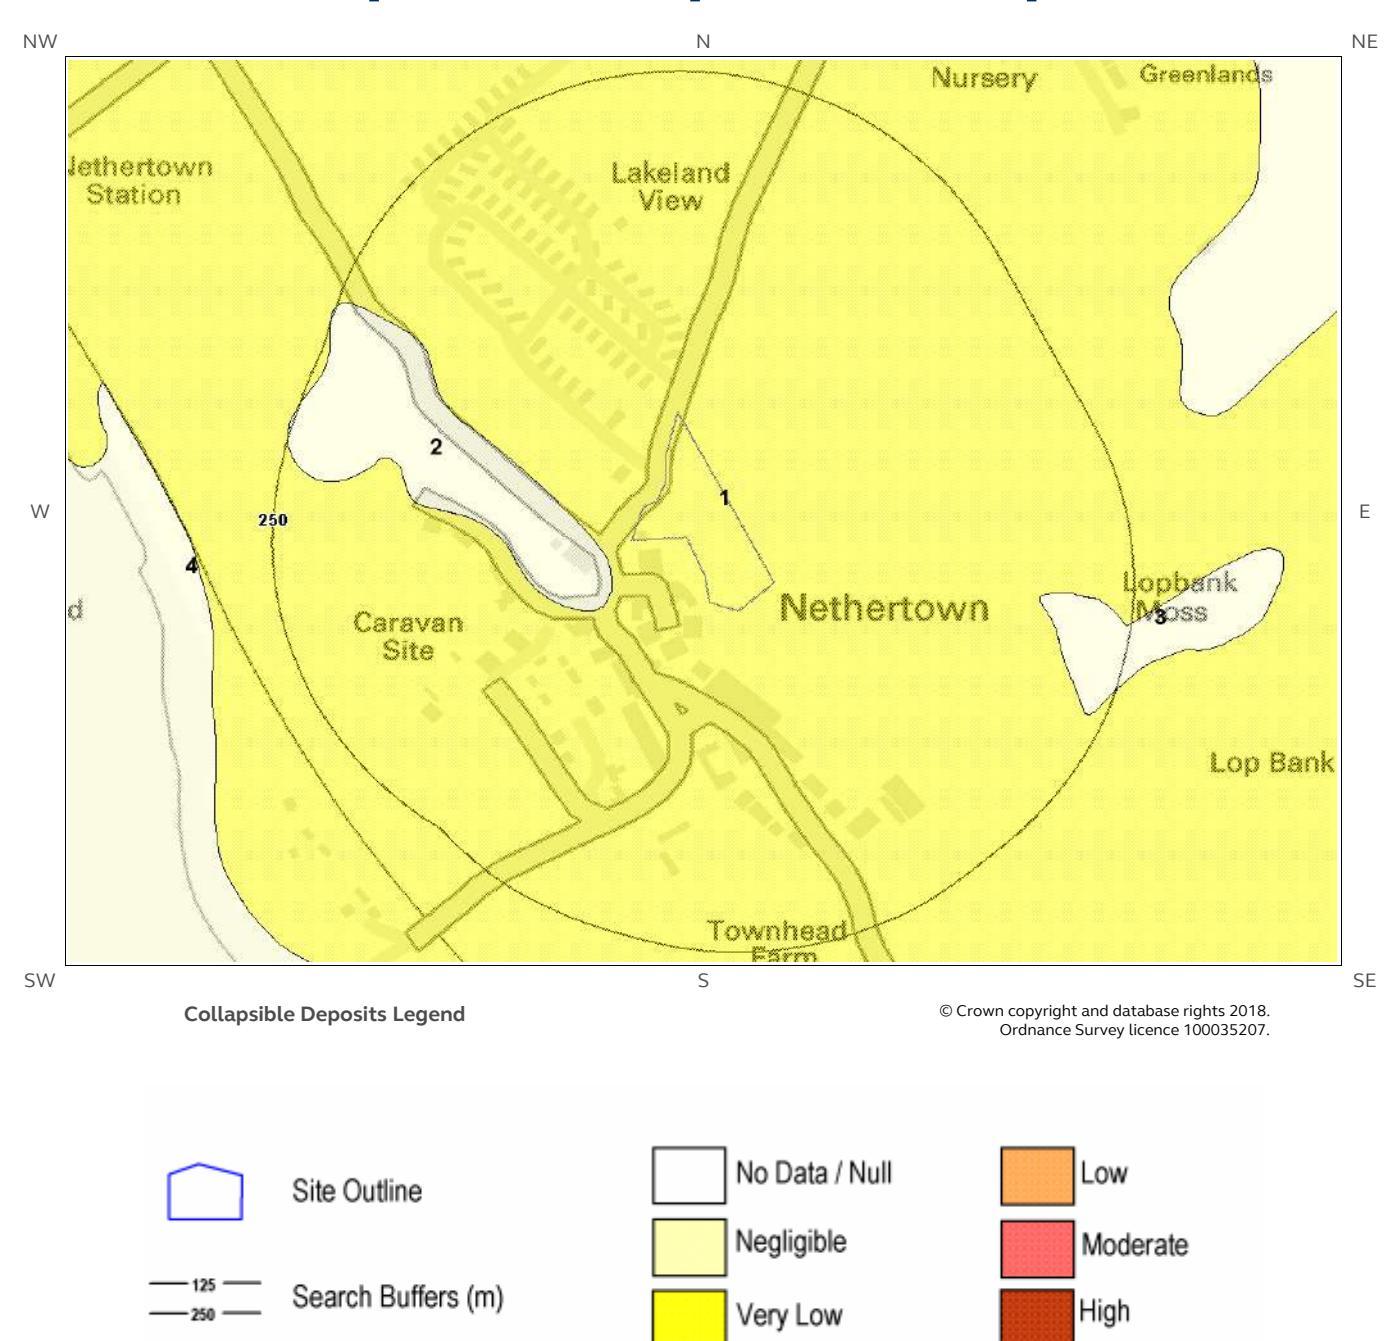
6.5 Collapsible Deposits map

ID	Distance (m)	Direction	Hazard Rating	Details
1	0.0	On Site	Very Low	Deposits with potential to collapse when loaded and saturated are unlikely to be present. No special ground investigation required or increased construction costs or increased financial risk due to potential problems with collapsible deposits.
2	22.0	SW	Negligible	No indicators for collapsible deposits identified. No actions required to avoid problems due to collapsible deposits. No special ground investigation required, or increased construction costs or increased financial risk due to potential problems with collapsible deposits.

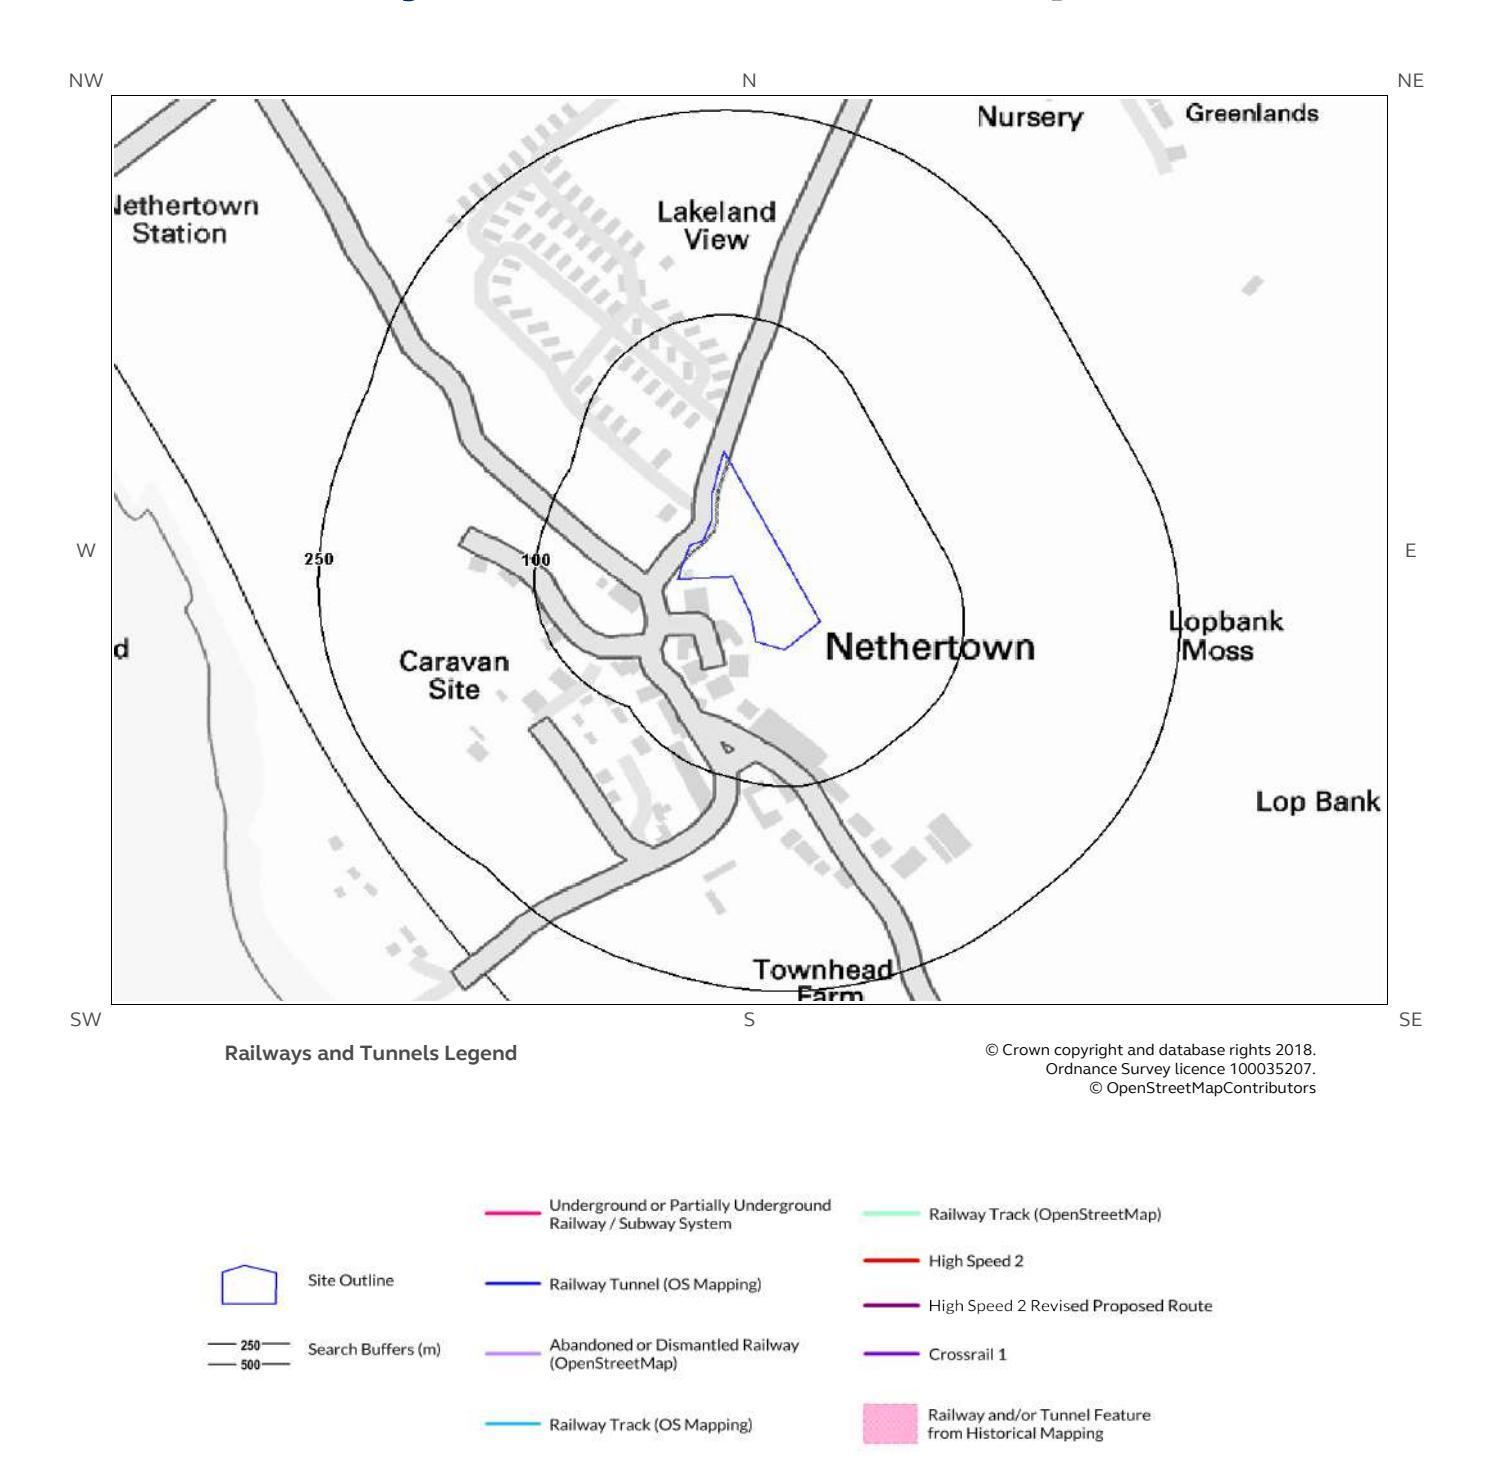
9 Railways and Tunnels map

Have any underground railway lines been identified within the study site boundary?	No
Have any underground railway lines been identified within 250m of the study site boundary?	No
Database searched and no data found.	
Any records that have been identified are represented on the Railways and Tunnels map.

Have any historical railway lines been identified within the study site boundary?	No
Have any historical railway lines been identified within 250m of the study site boundary?	No
Database searched and no data found.	
Multiple sections of the same track may be listed in the detail above Any records that have been identified are represented on the Railways and Tunnels map.	
9.4 Active Railways	
These datasets are derived from Ordnance Survey mapping and OpenStreetMap and provide inform on the possible locations of active railway lines in proximity to the study site.	ation
Have any active railway lines been identified within the study site boundary?	No

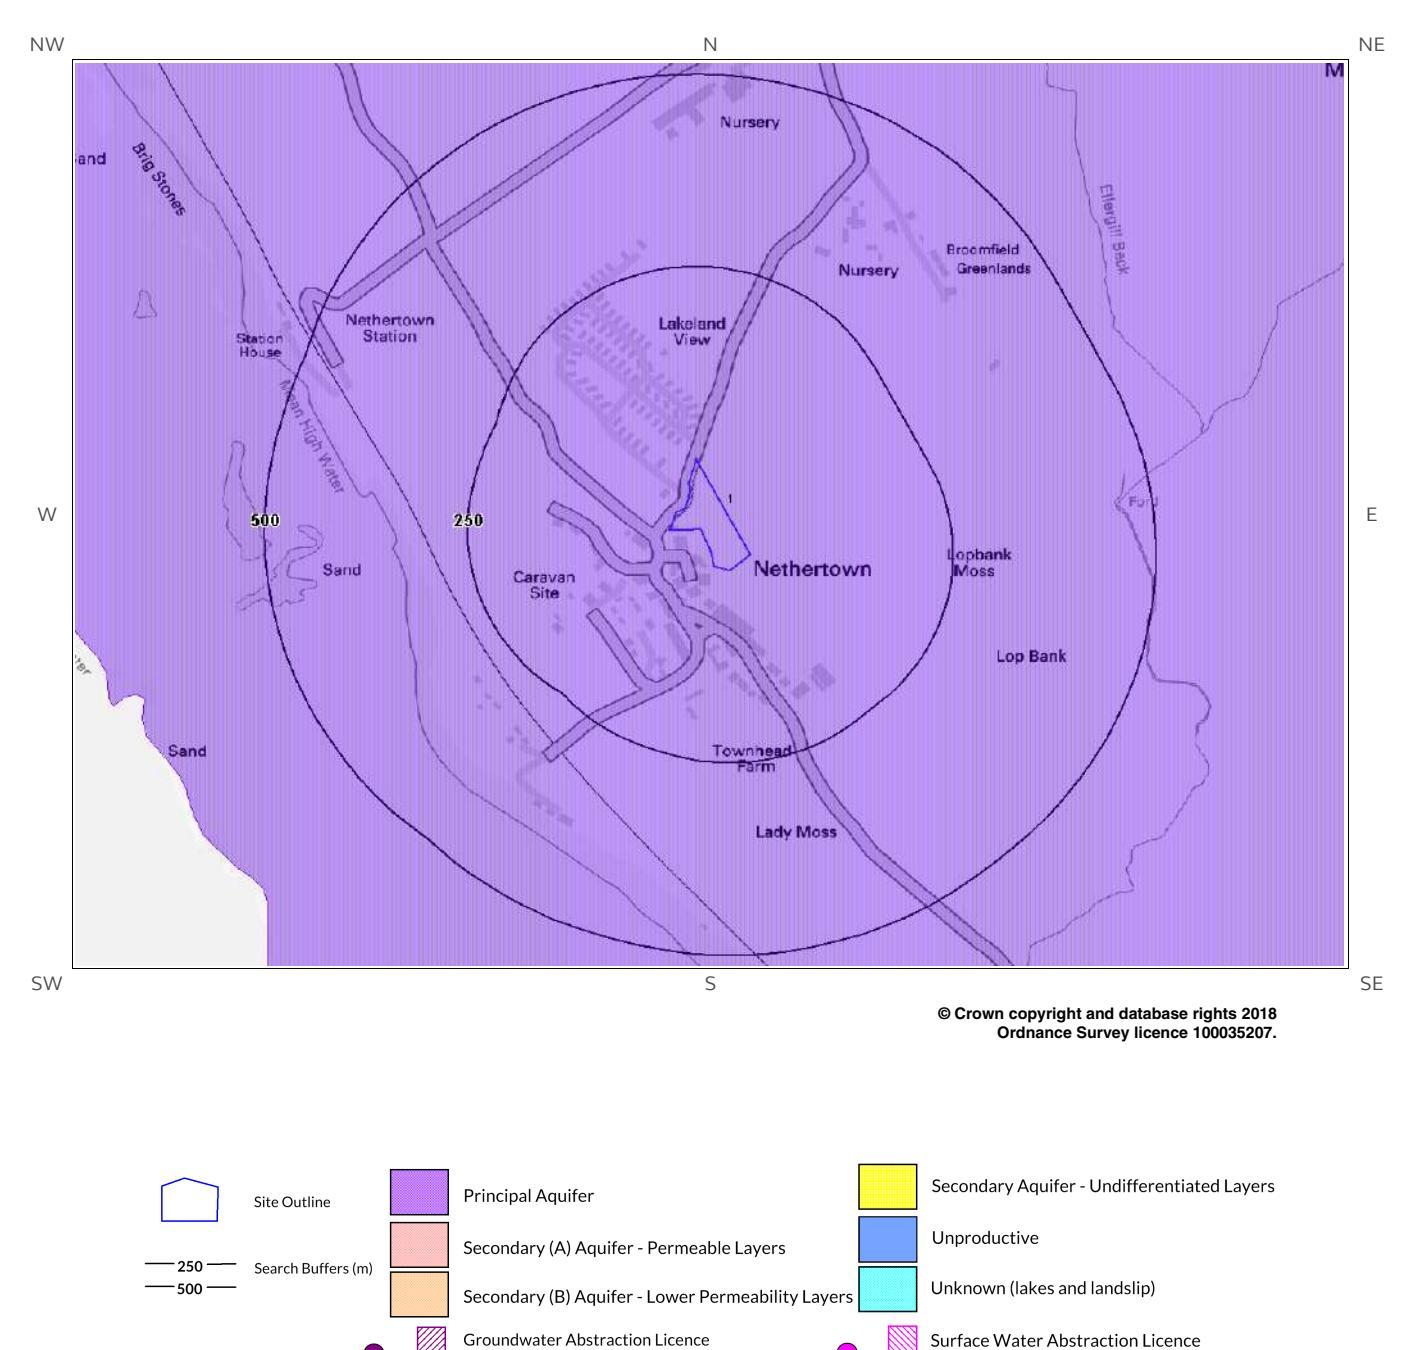
6b. Aquifer Within Bedrock Geology and Abstraction Licences

The following aquifer records are shown on the Aquifer within Bedrock Geology Map (6b):

ID	Distanc e (m)	Direction	Designation	Description
1	0	On Site	Principal	Geology of high intergranular and/or fracture permeability, usually providing a high level of water storage and may support water supply/river base flow on a strategic scale. Generally principal aquifers were previously major aquifers
