PHASE 1: DESK TOP STUDY REPORT

(PRELIMINARY ENVIRONMENTAL RISK ASSESSMENT)

PROPOSED RESIDENTIAL DEVELOPMENT OF LAND AT

ELIZABETH CRESCENT

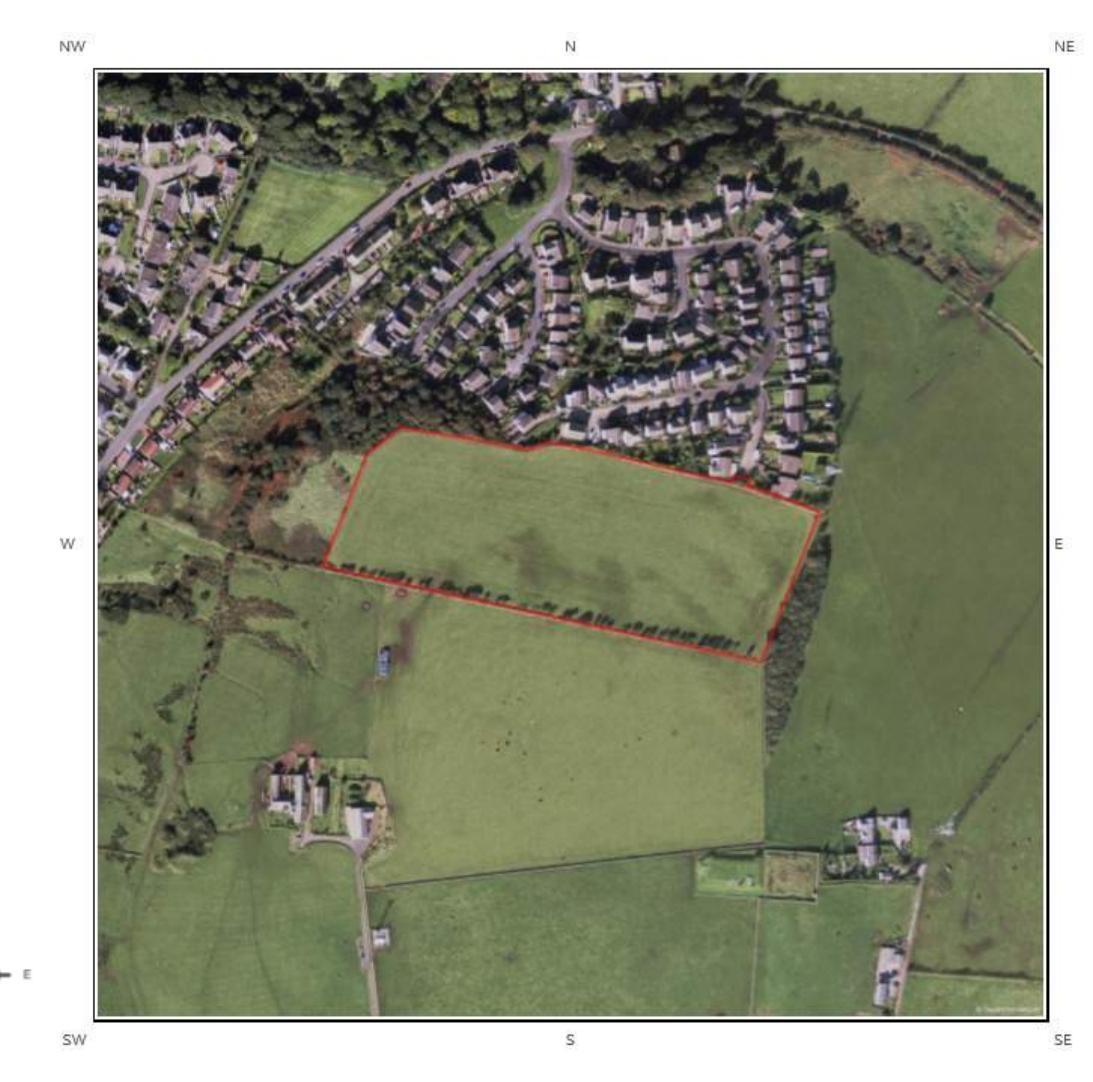
GEO2017-2356: Aerial Photograph Extract

Aerial Photograph Capture date:
 05-Oct-2008

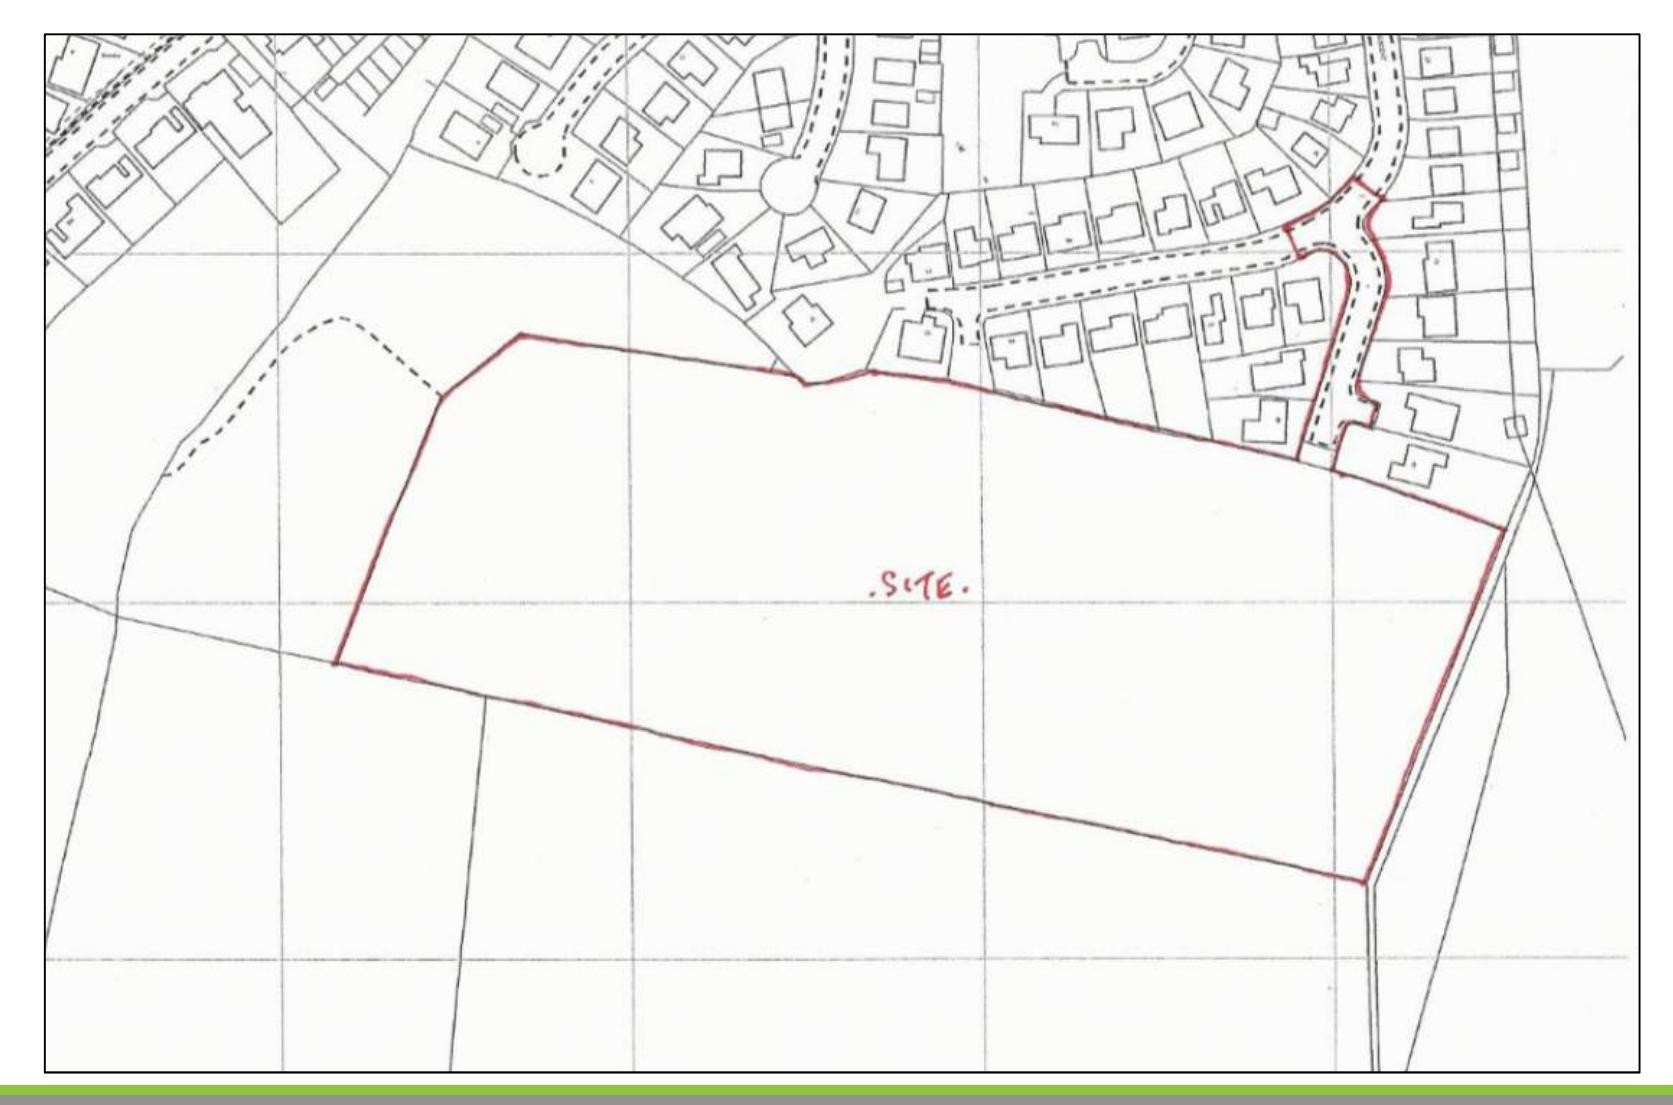
GEO2017-2356: Existing Site Layout Plan (Not to Scale) – Supplied by Client

A Conceptual Site Model (CSM) has been designed using the information presented within this P1 DTS to provide a tabulated representation of the anticipated ground, groundwater and ground gas conditions below the development area (Existing Site CSM). The CSM is presented within Section 4.0 and aids the completion of the Preliminary Qualitative Risk Assessment (PQRA – Section 5.0).

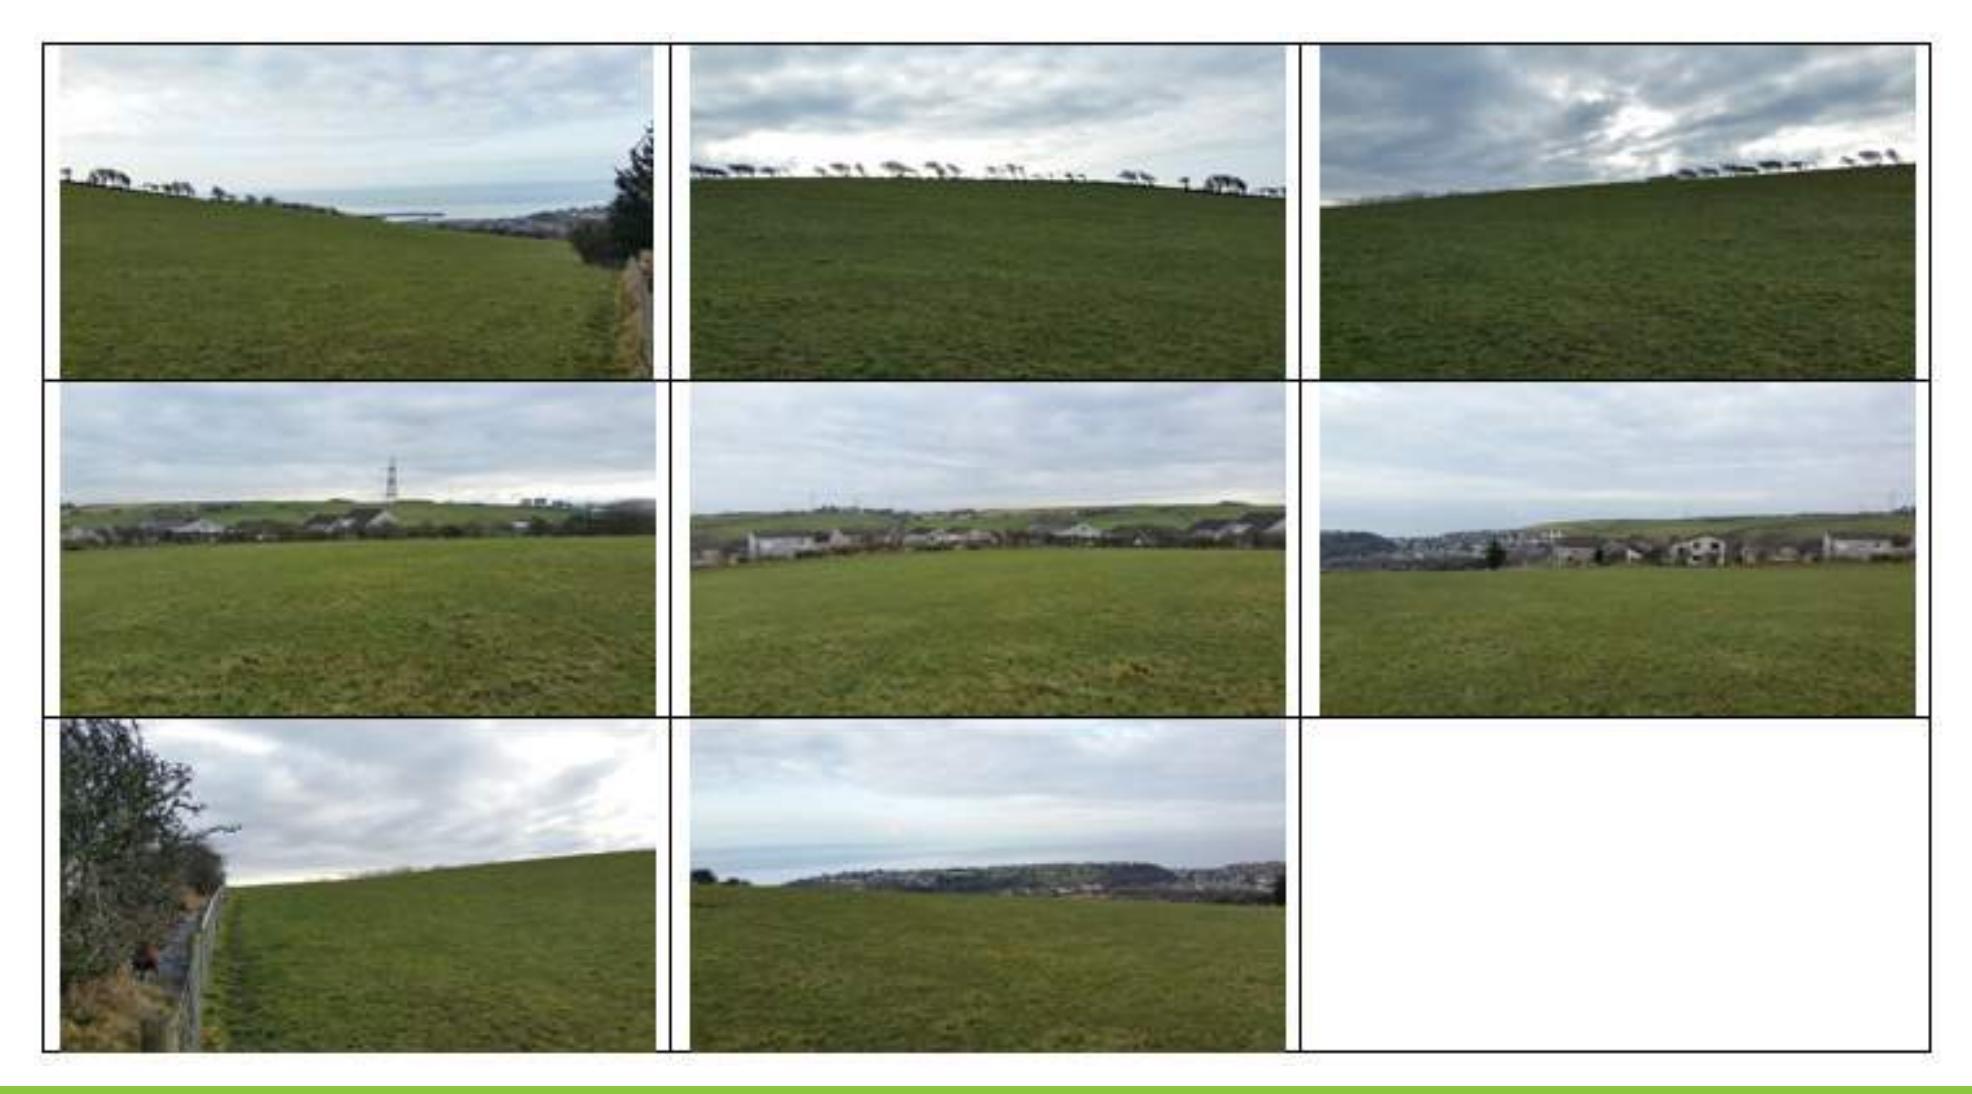
GEO2017-2356: Site Images (February 2017)

At the time of the site walkover the site was noted as being free of buildings. The site surfacing was noted as grass for agricultural grazing. Variations in levels have resulted in some areas of standing water and localised ponding of water. The site is surrounded by mature hedgerows and post-wire fences.

There was no visual evidence of fly-tipping or of surface staining (contamination). There was no evidence of recent bonfires. As the land is used for agricultural grazing there was no visual evidence of materials, chemical or fuel storage.

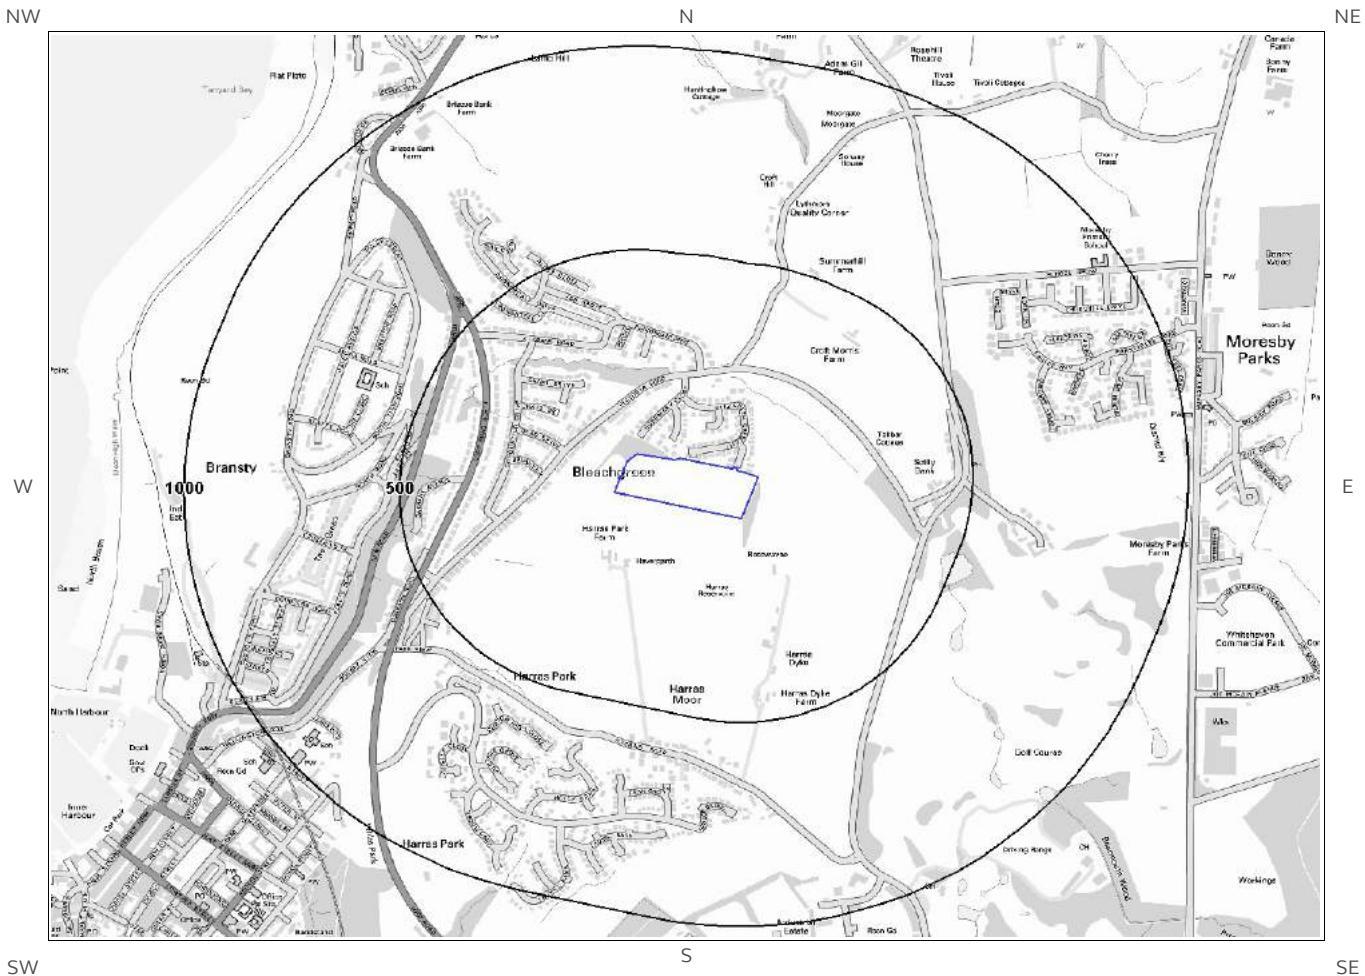
1.3 Bedrock and Faults Map (1:10,000 scale)

Solid geological deposits across the development site are indicated by the BGS as being Carboniferous Coal Measures, with the Whitehaven Sandstone Member (WS) underlain by alternations of mudstone, siltstone and sandstone. Subcropping coal seams are noted within close proximity to the site (nearest being c.27m north) that have the potential to pass beneath parts of the site.

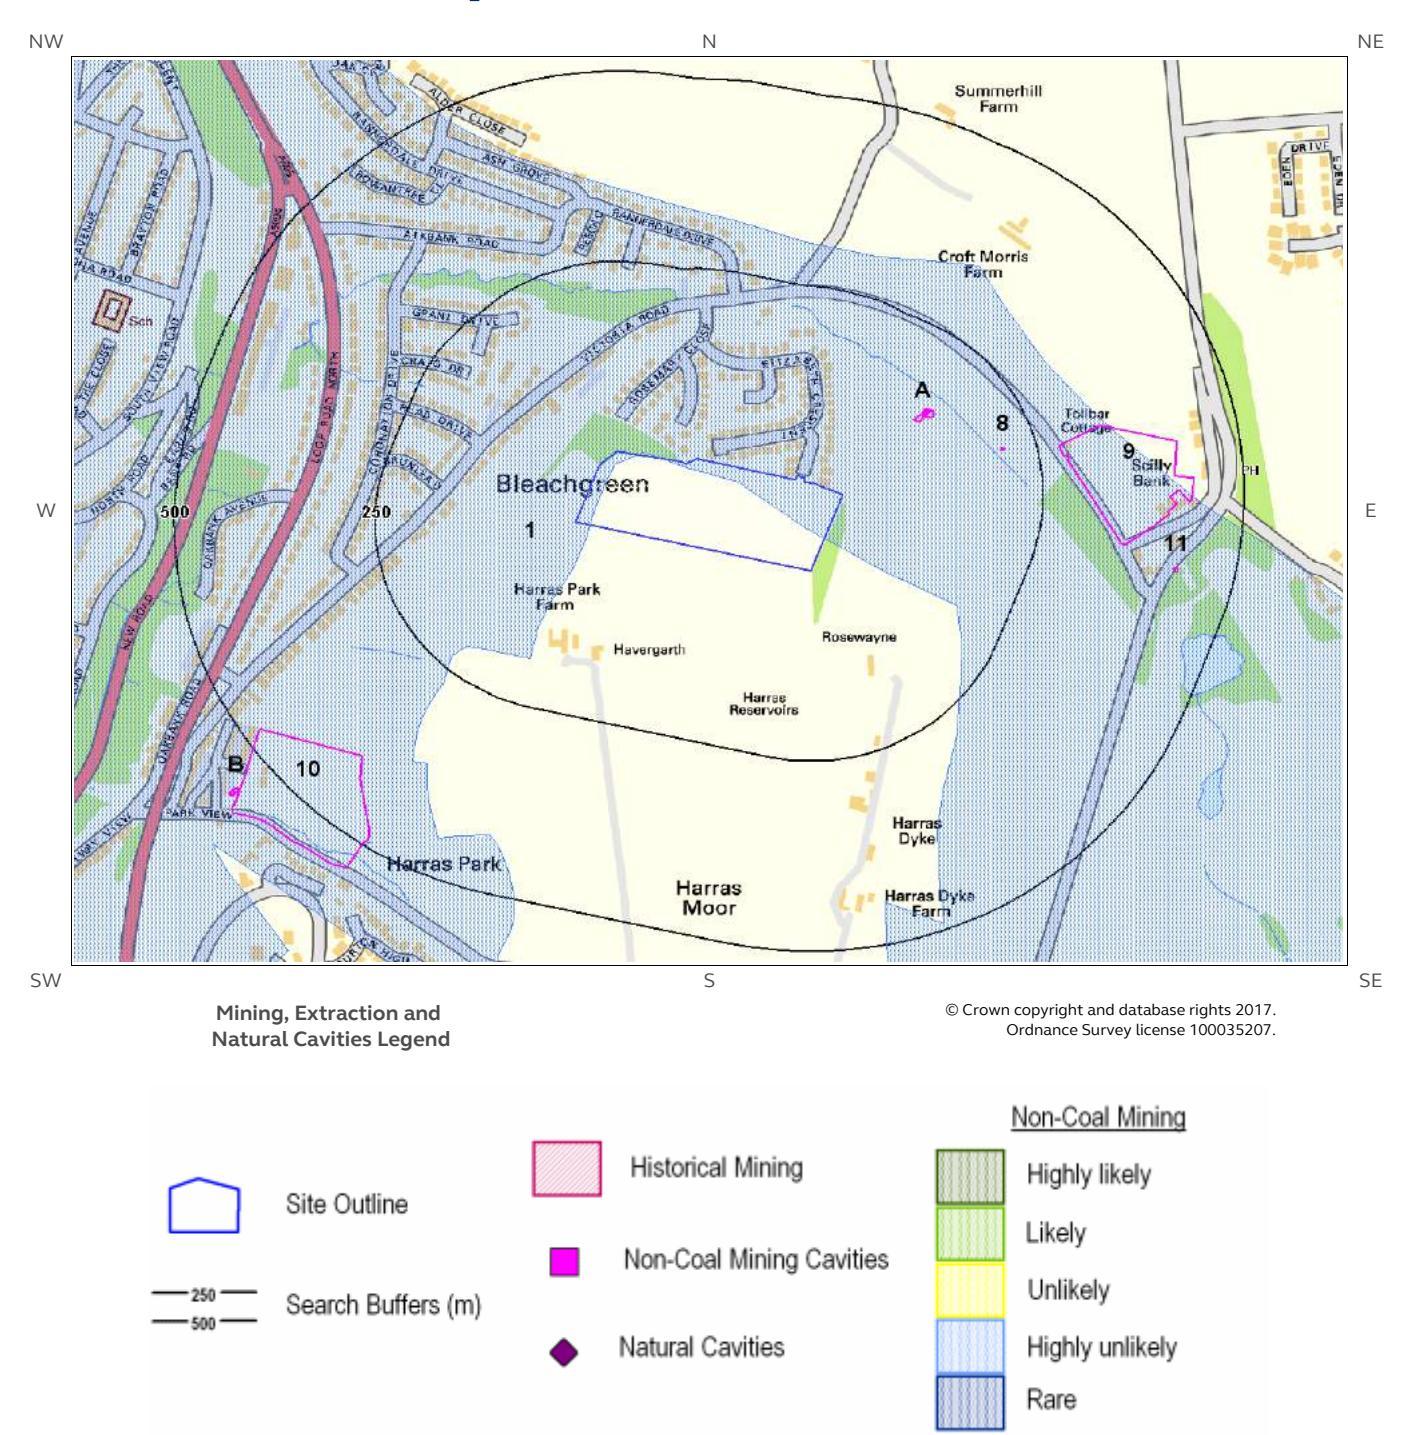
5 Mining, Extraction & Natural Cavities Map

ID	D	Distance (m)	Direction	Name	Commodity	Assessment of likelihood
	1	0.0	On Site	Not available	Iron Ore (Bedded)	Localised small scale underground mining may have occurred. Potential for difficult ground conditions are unlikely or localised and are at a level where they need not be considered
	Not shown	822.0	Ν	Not available	Iron Ore (Bedded)	Localised small scale underground mining may have occurred. Potential for difficult ground conditions are unlikely or localised and are at a level where they need not be considered

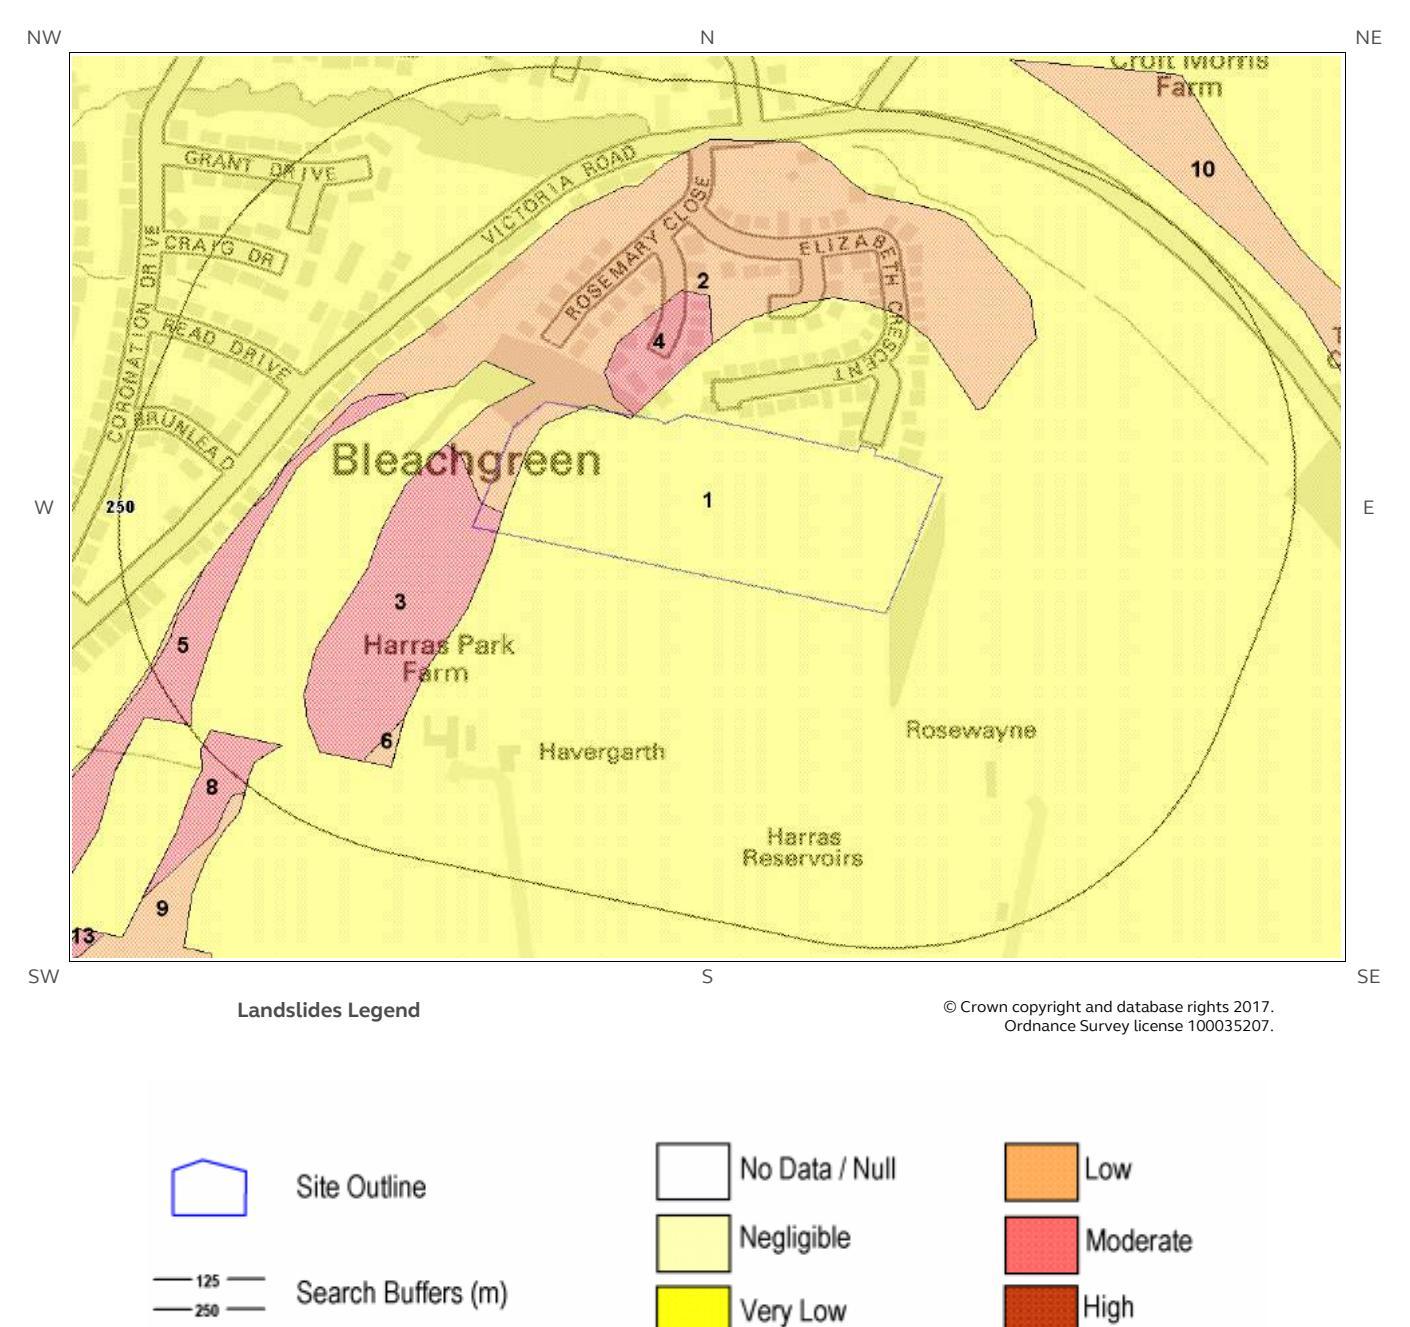
6.2 Landslides Map

- Shrink-swell clays very low level risk.
- Landslides very low to moderate risk. The GSR recommends consideration of ground movement and ground stability for new build.
- Compressible deposits Negligible level risk.
- Collapsible deposits very low level risk.
- Running sands negligible level risk.

It is recommended that reference be made to Section 6.0 of the Geoinsight GSR (Appendix II). Consequently, Phase 2: Ground Investigation works would be prudent to aid the design of foundations, any retaining structures and highways, as per any specific requirements of the Design Team.

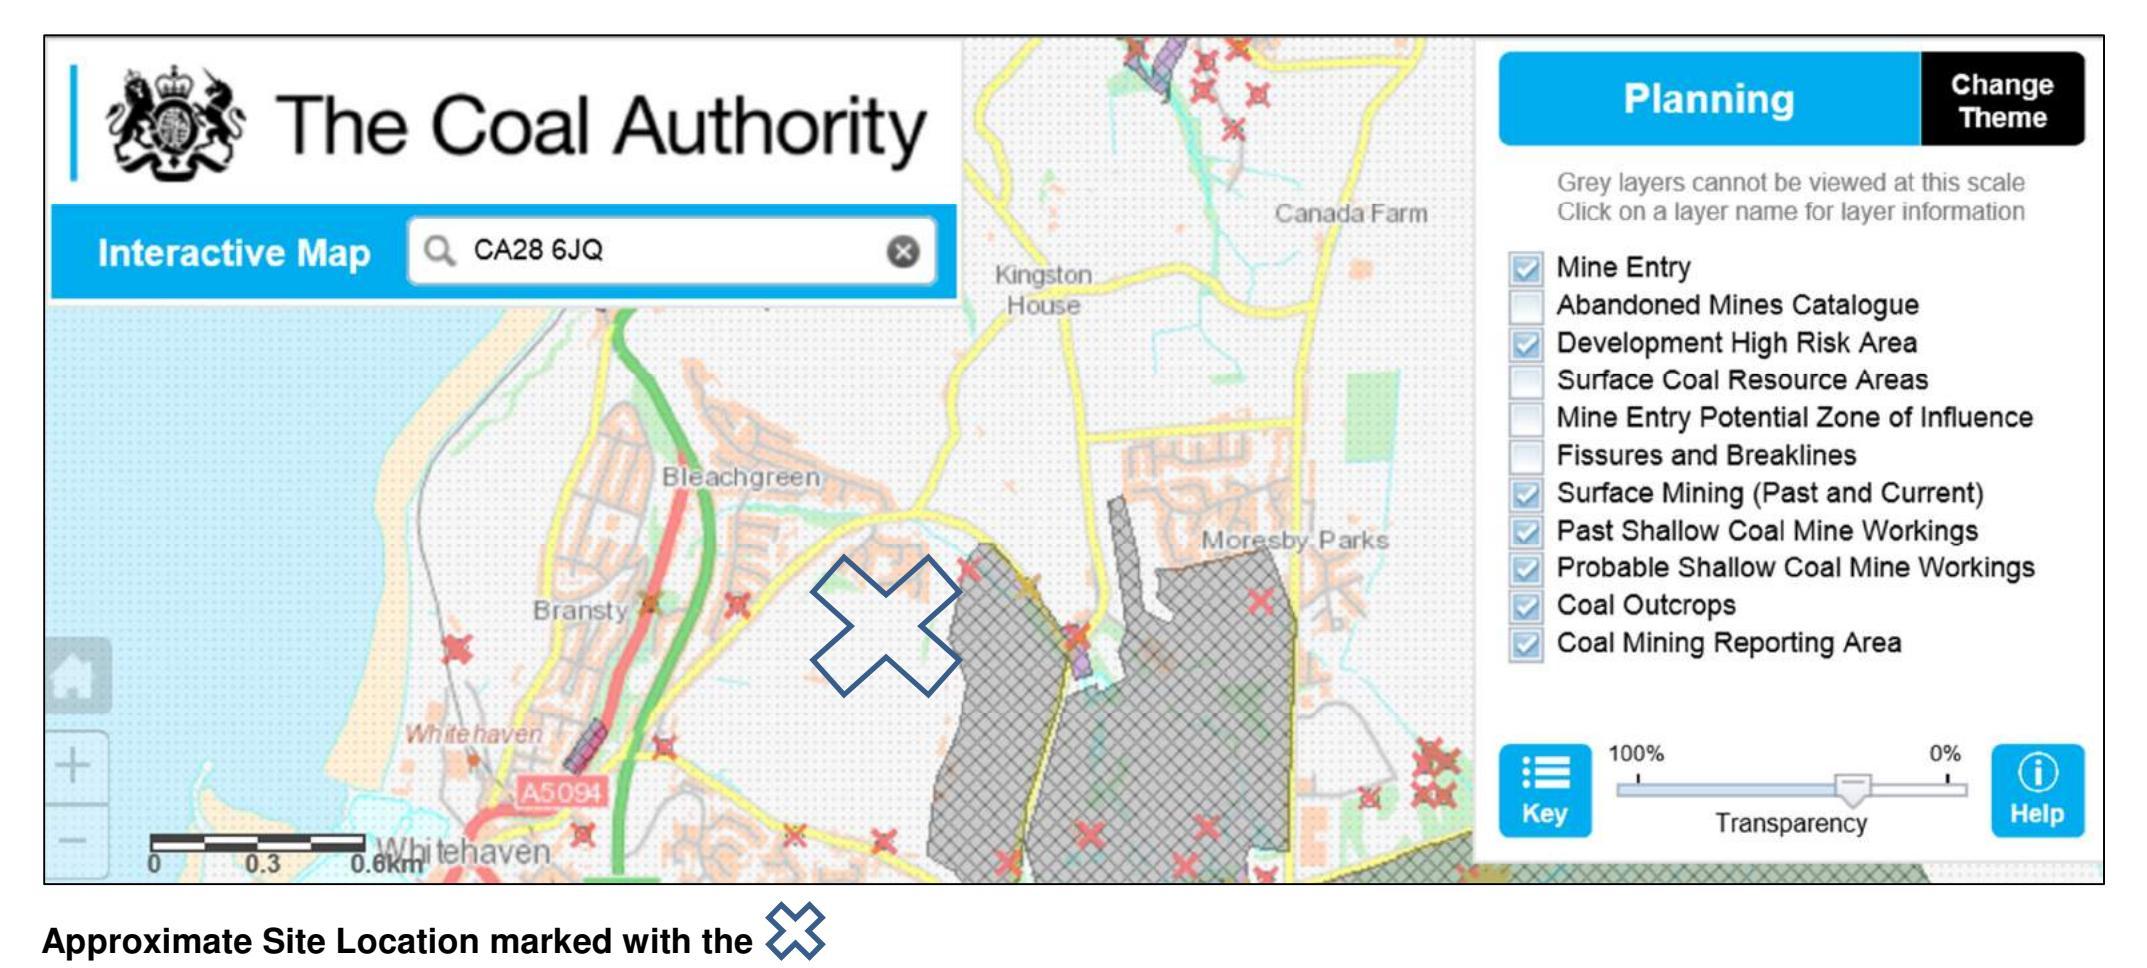
GEO2017-2356: Coal Authority Online Database

In summary, the CA records deep mining beneath the site area, with David Pit and Davy Pit noted to the east and George Pit to the west. Large areas of opencast coal mining (now reclaimed) are also recorded to the east, although geological plans suggest that they did not encroach on site.

Due to geological structural faulting, it may be the case that parts of the site (for example the north-east) are underlain by shallow coal and it is recommended that should planning permission be obtained then intrusive investigations include assessments pertaining to potential shallow coal mine workings.
