PHASE I DESK STUDY

Former Griffin Inn, Mill Street, Frizington CA26 3SQ

22/1242.1.1

Geo² Remediation Limited

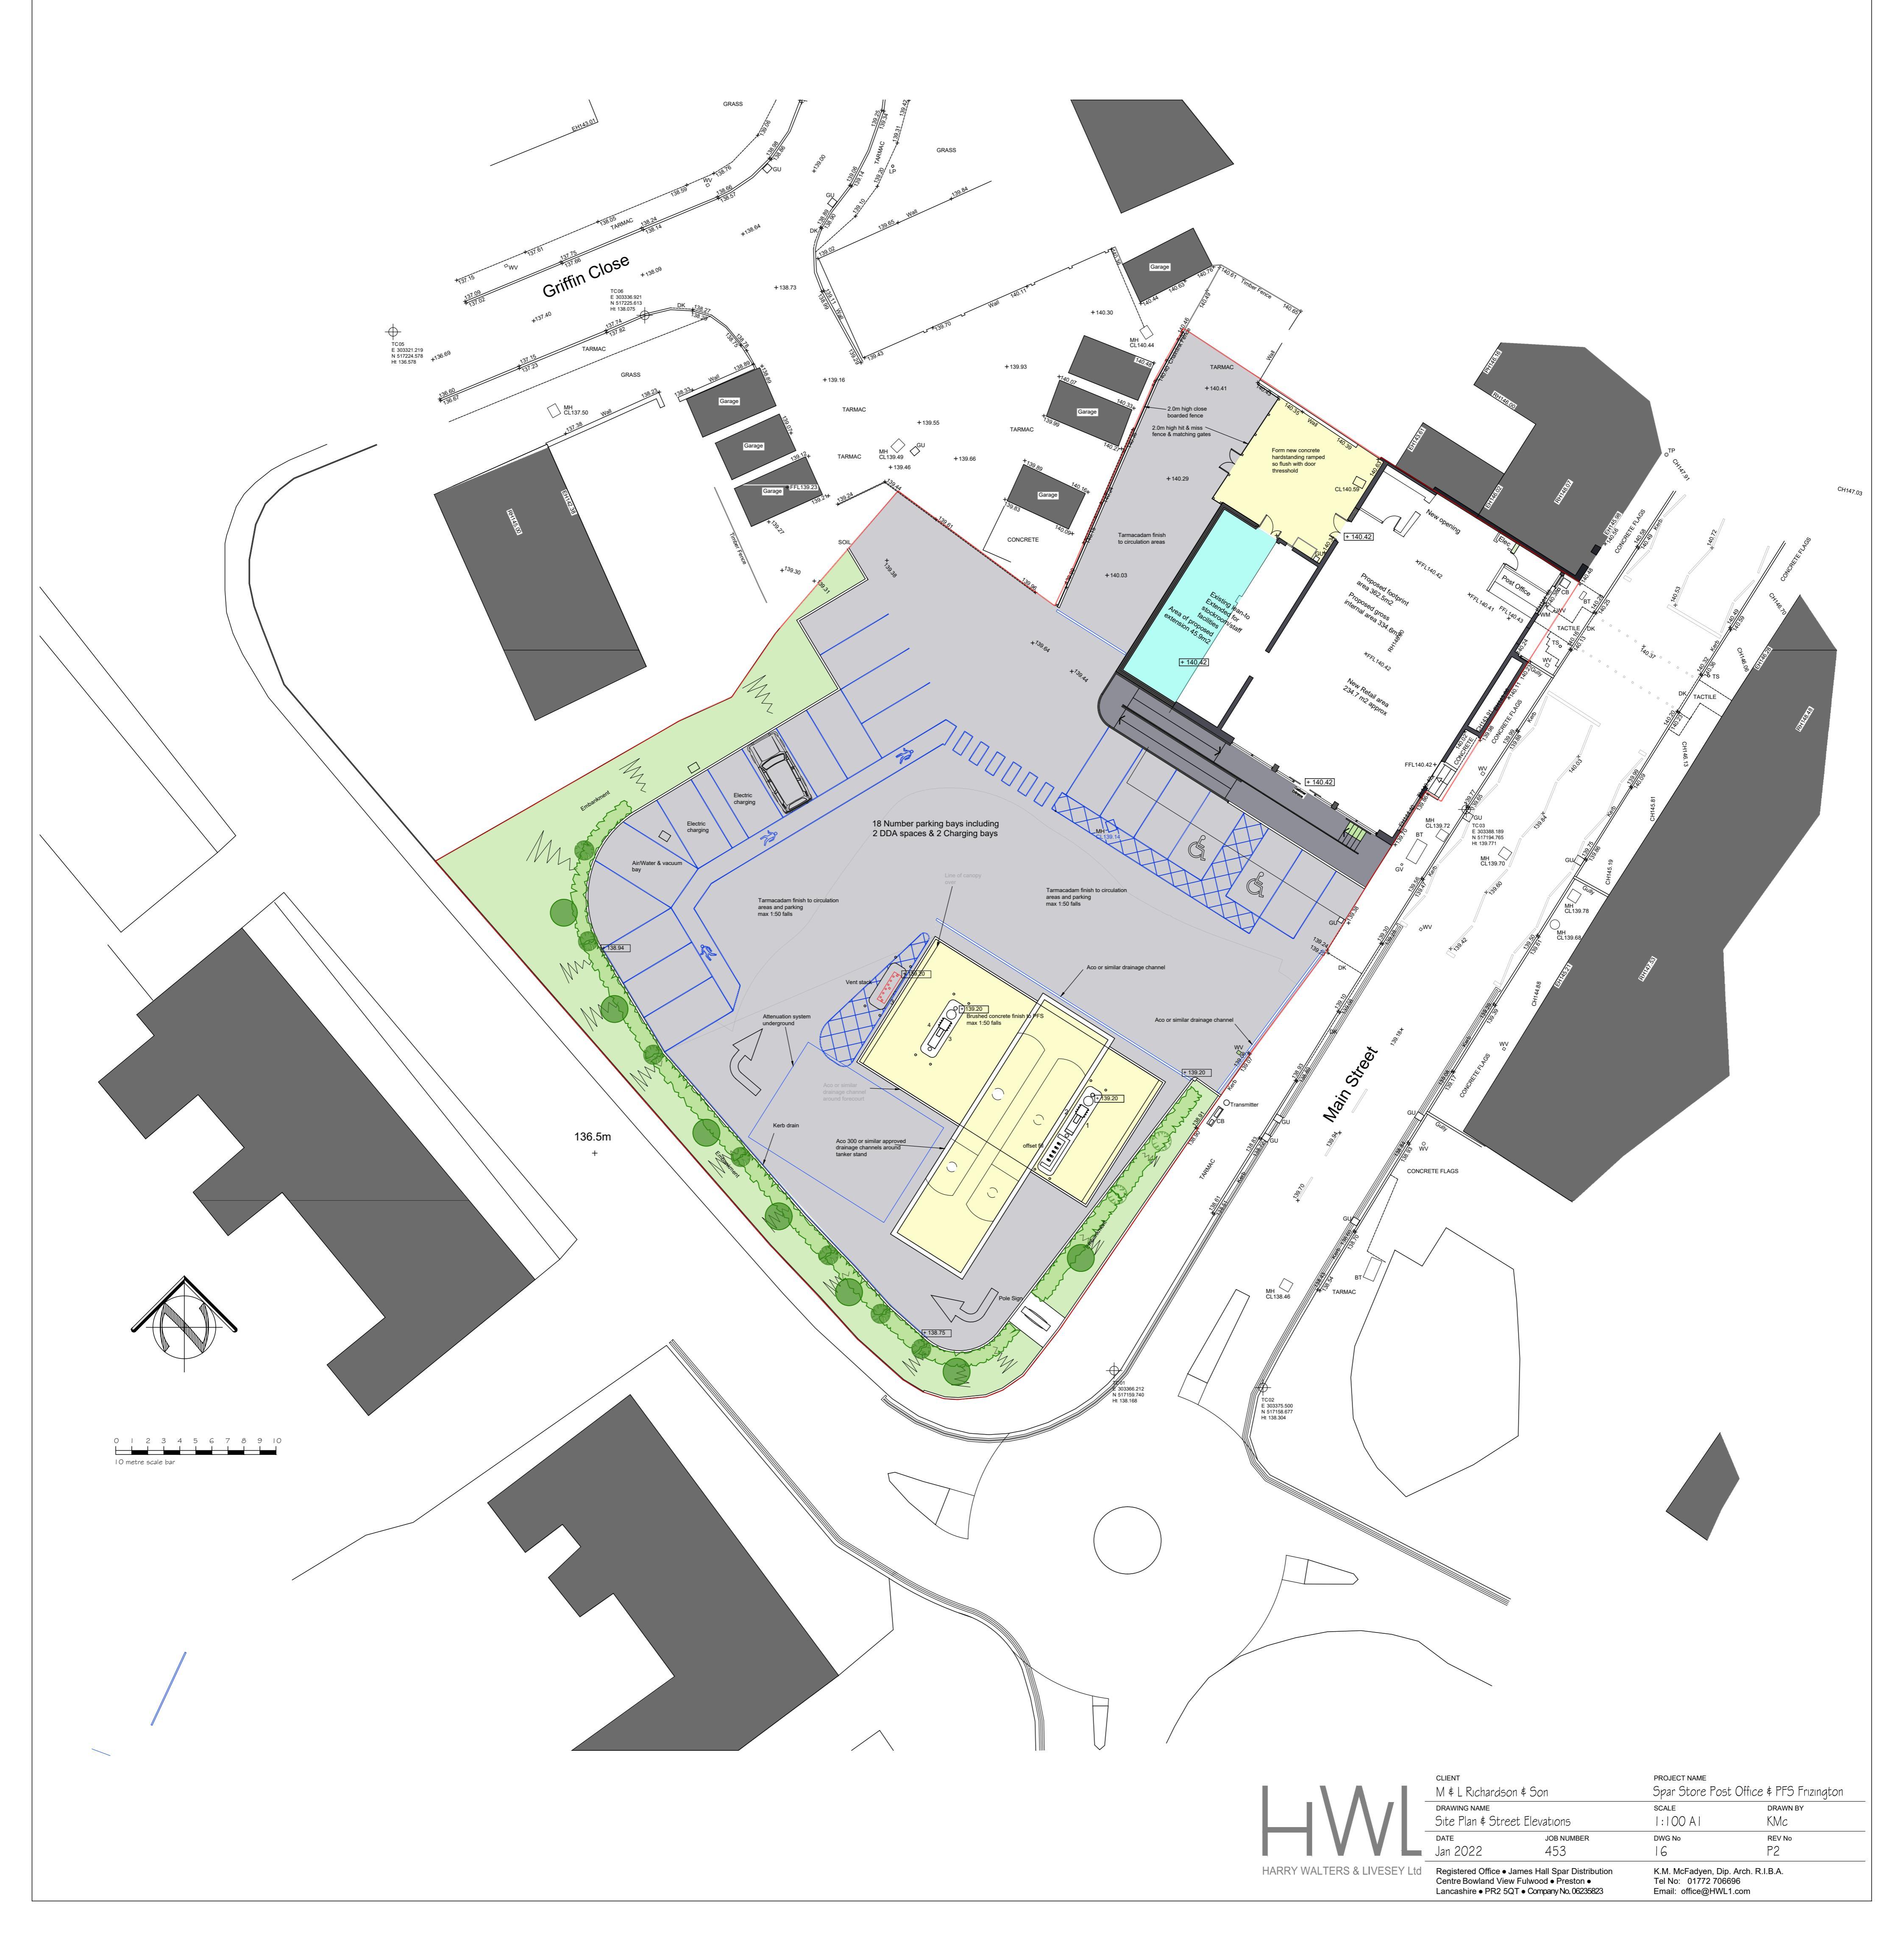
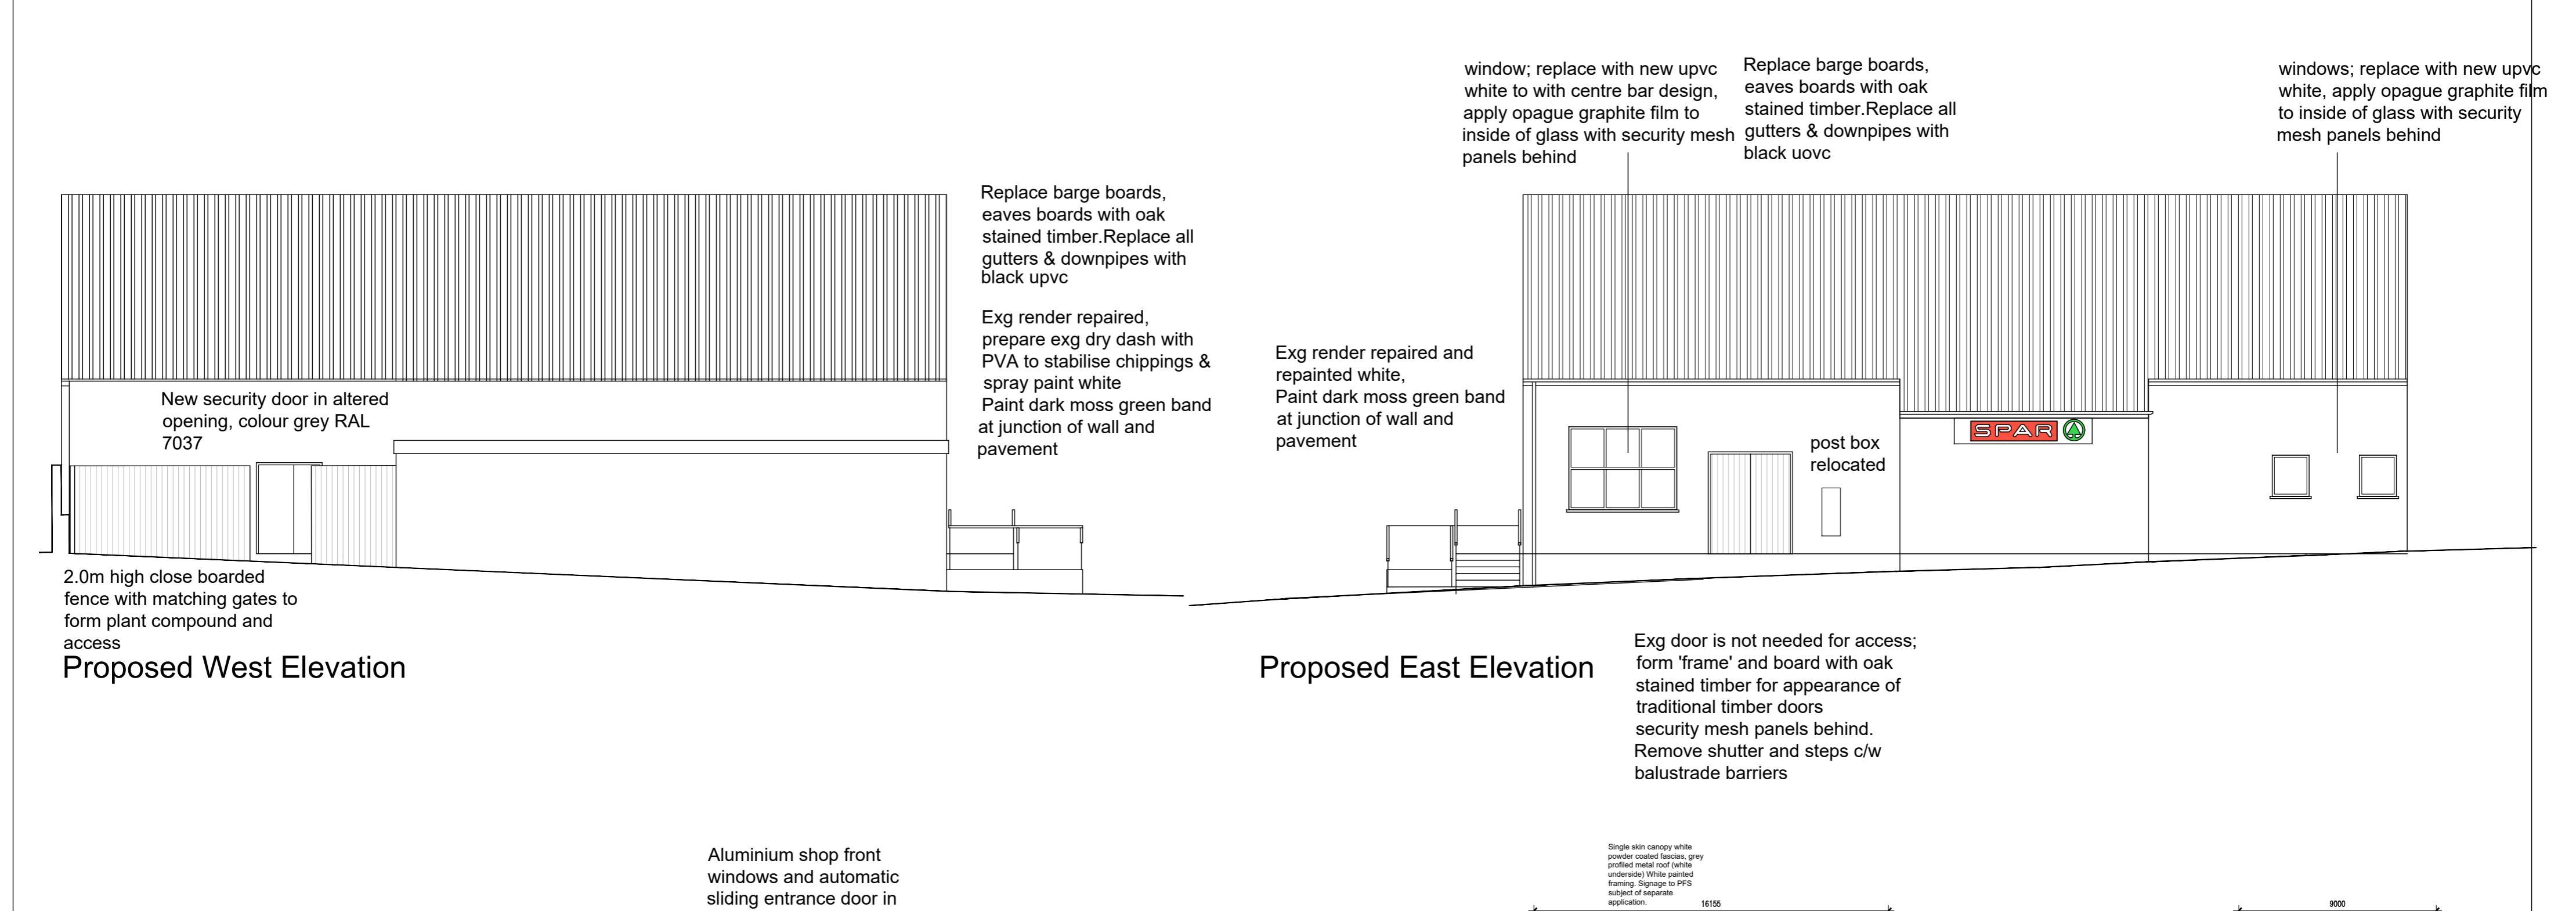
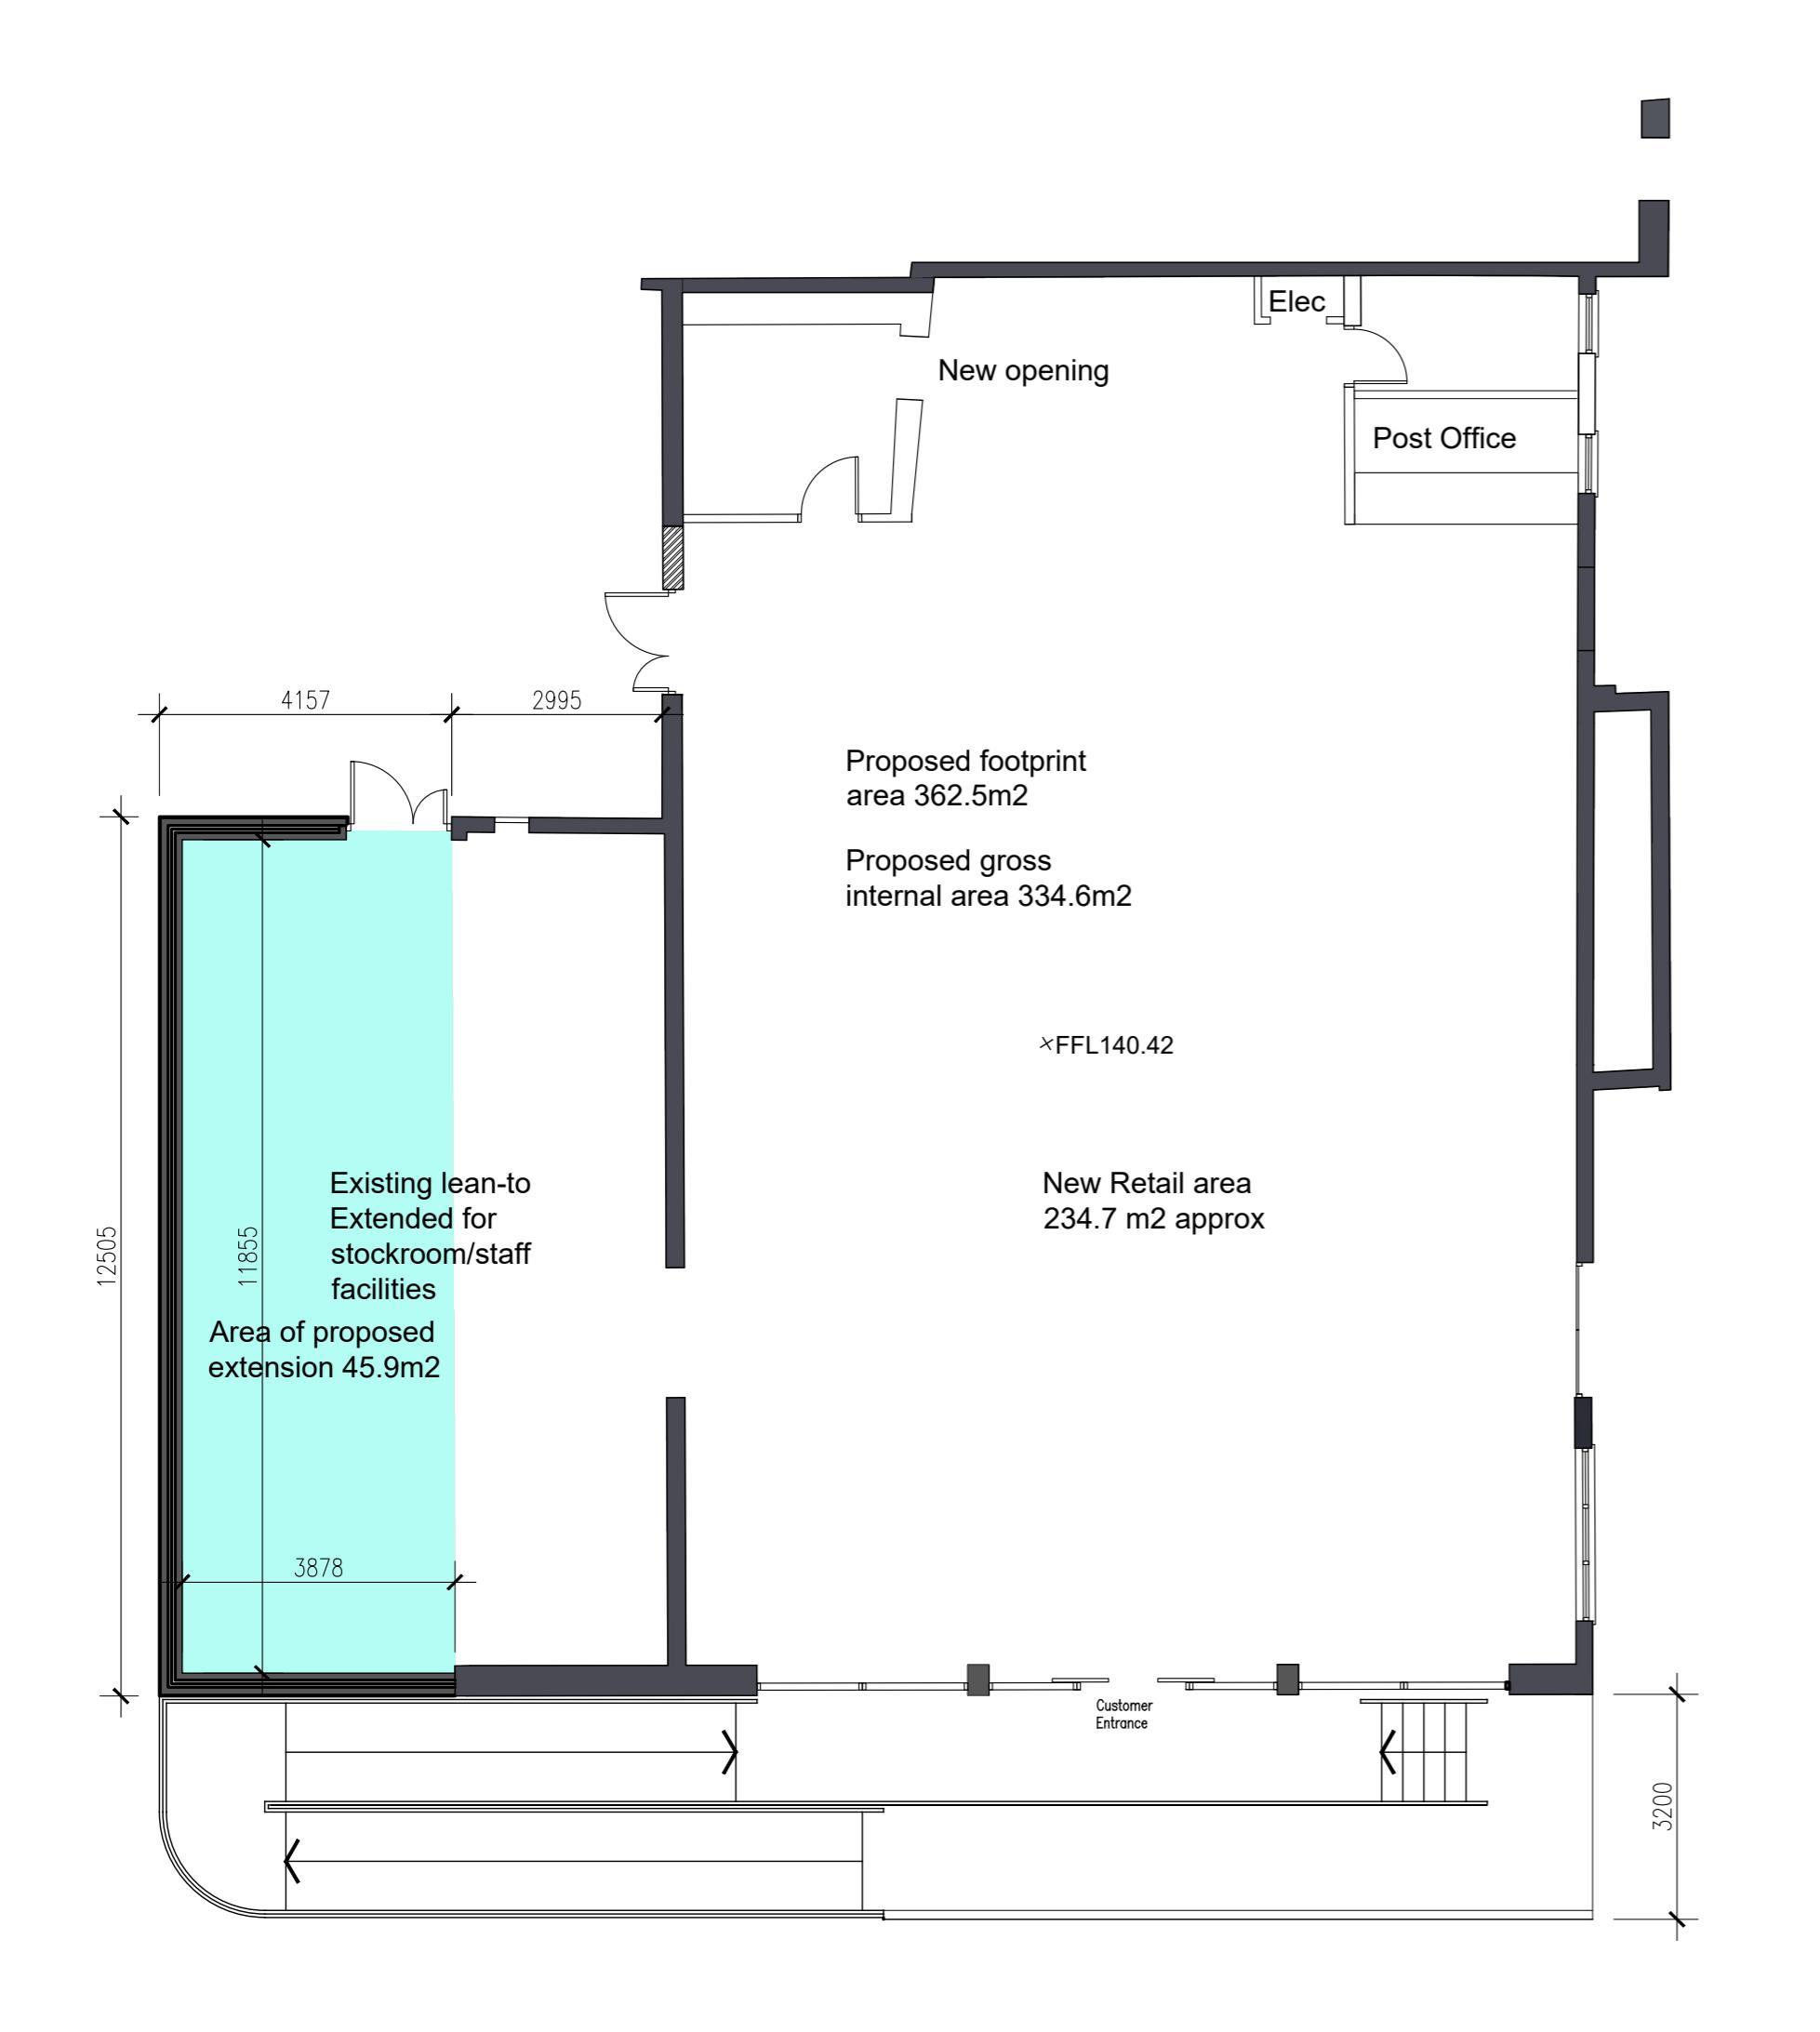
It is understood that the site is proposed to be redeveloped into a PFS. The Griffin Inn is to be demolished and an extension to the SPAR/Post Office building is proposed.

Plans of the proposed redevelopment is included as Figure 4, in Appendix A.
