REMEDIATION STRATEGY FOR LAND AT DALZELL STREET MOOR ROW

Nigel Kay Homes Ltd Hollowdyke Farm Frizington Cumbria CA26 3QZ

September 2024 Ref: GSI 2132 LD RS Report V1

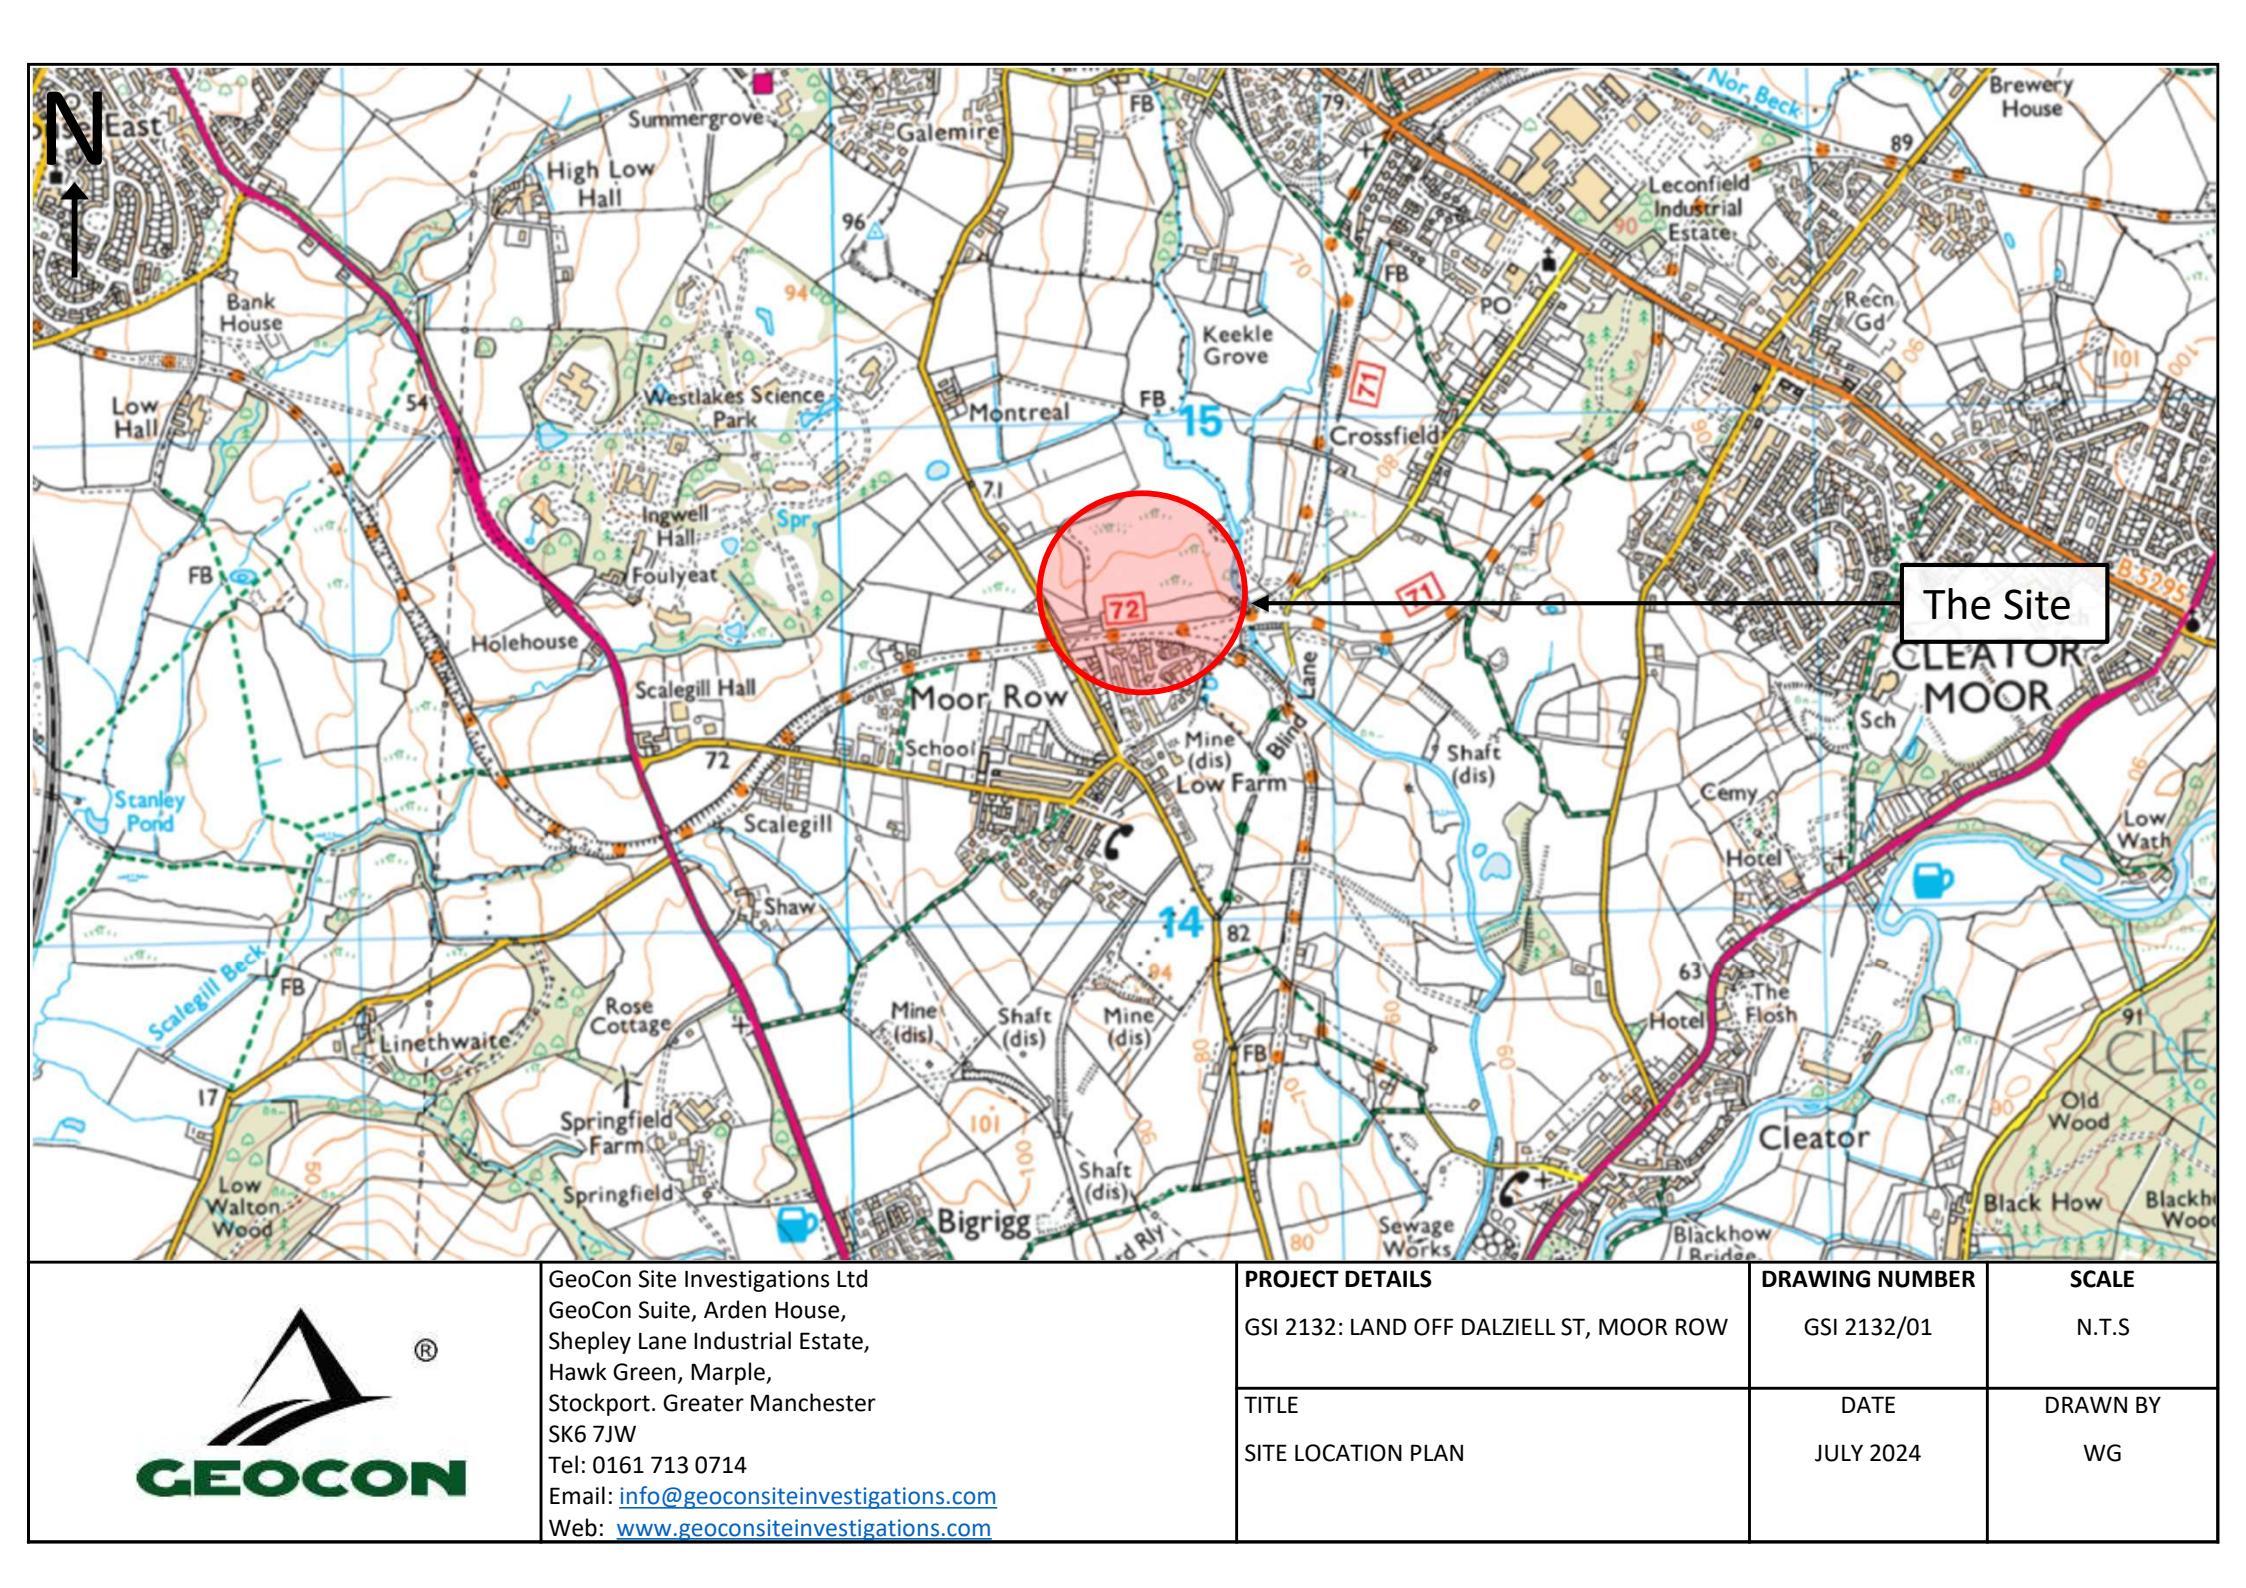
- 2.1.1 The site is located at Dalzell Street, Moor Row, Cumbria, at approximate National Grid Reference NGR: 300662, 514638.
- 2.1.2 A site location plan is presented as Drawing No. GSI 2132/01 in Appendix A.

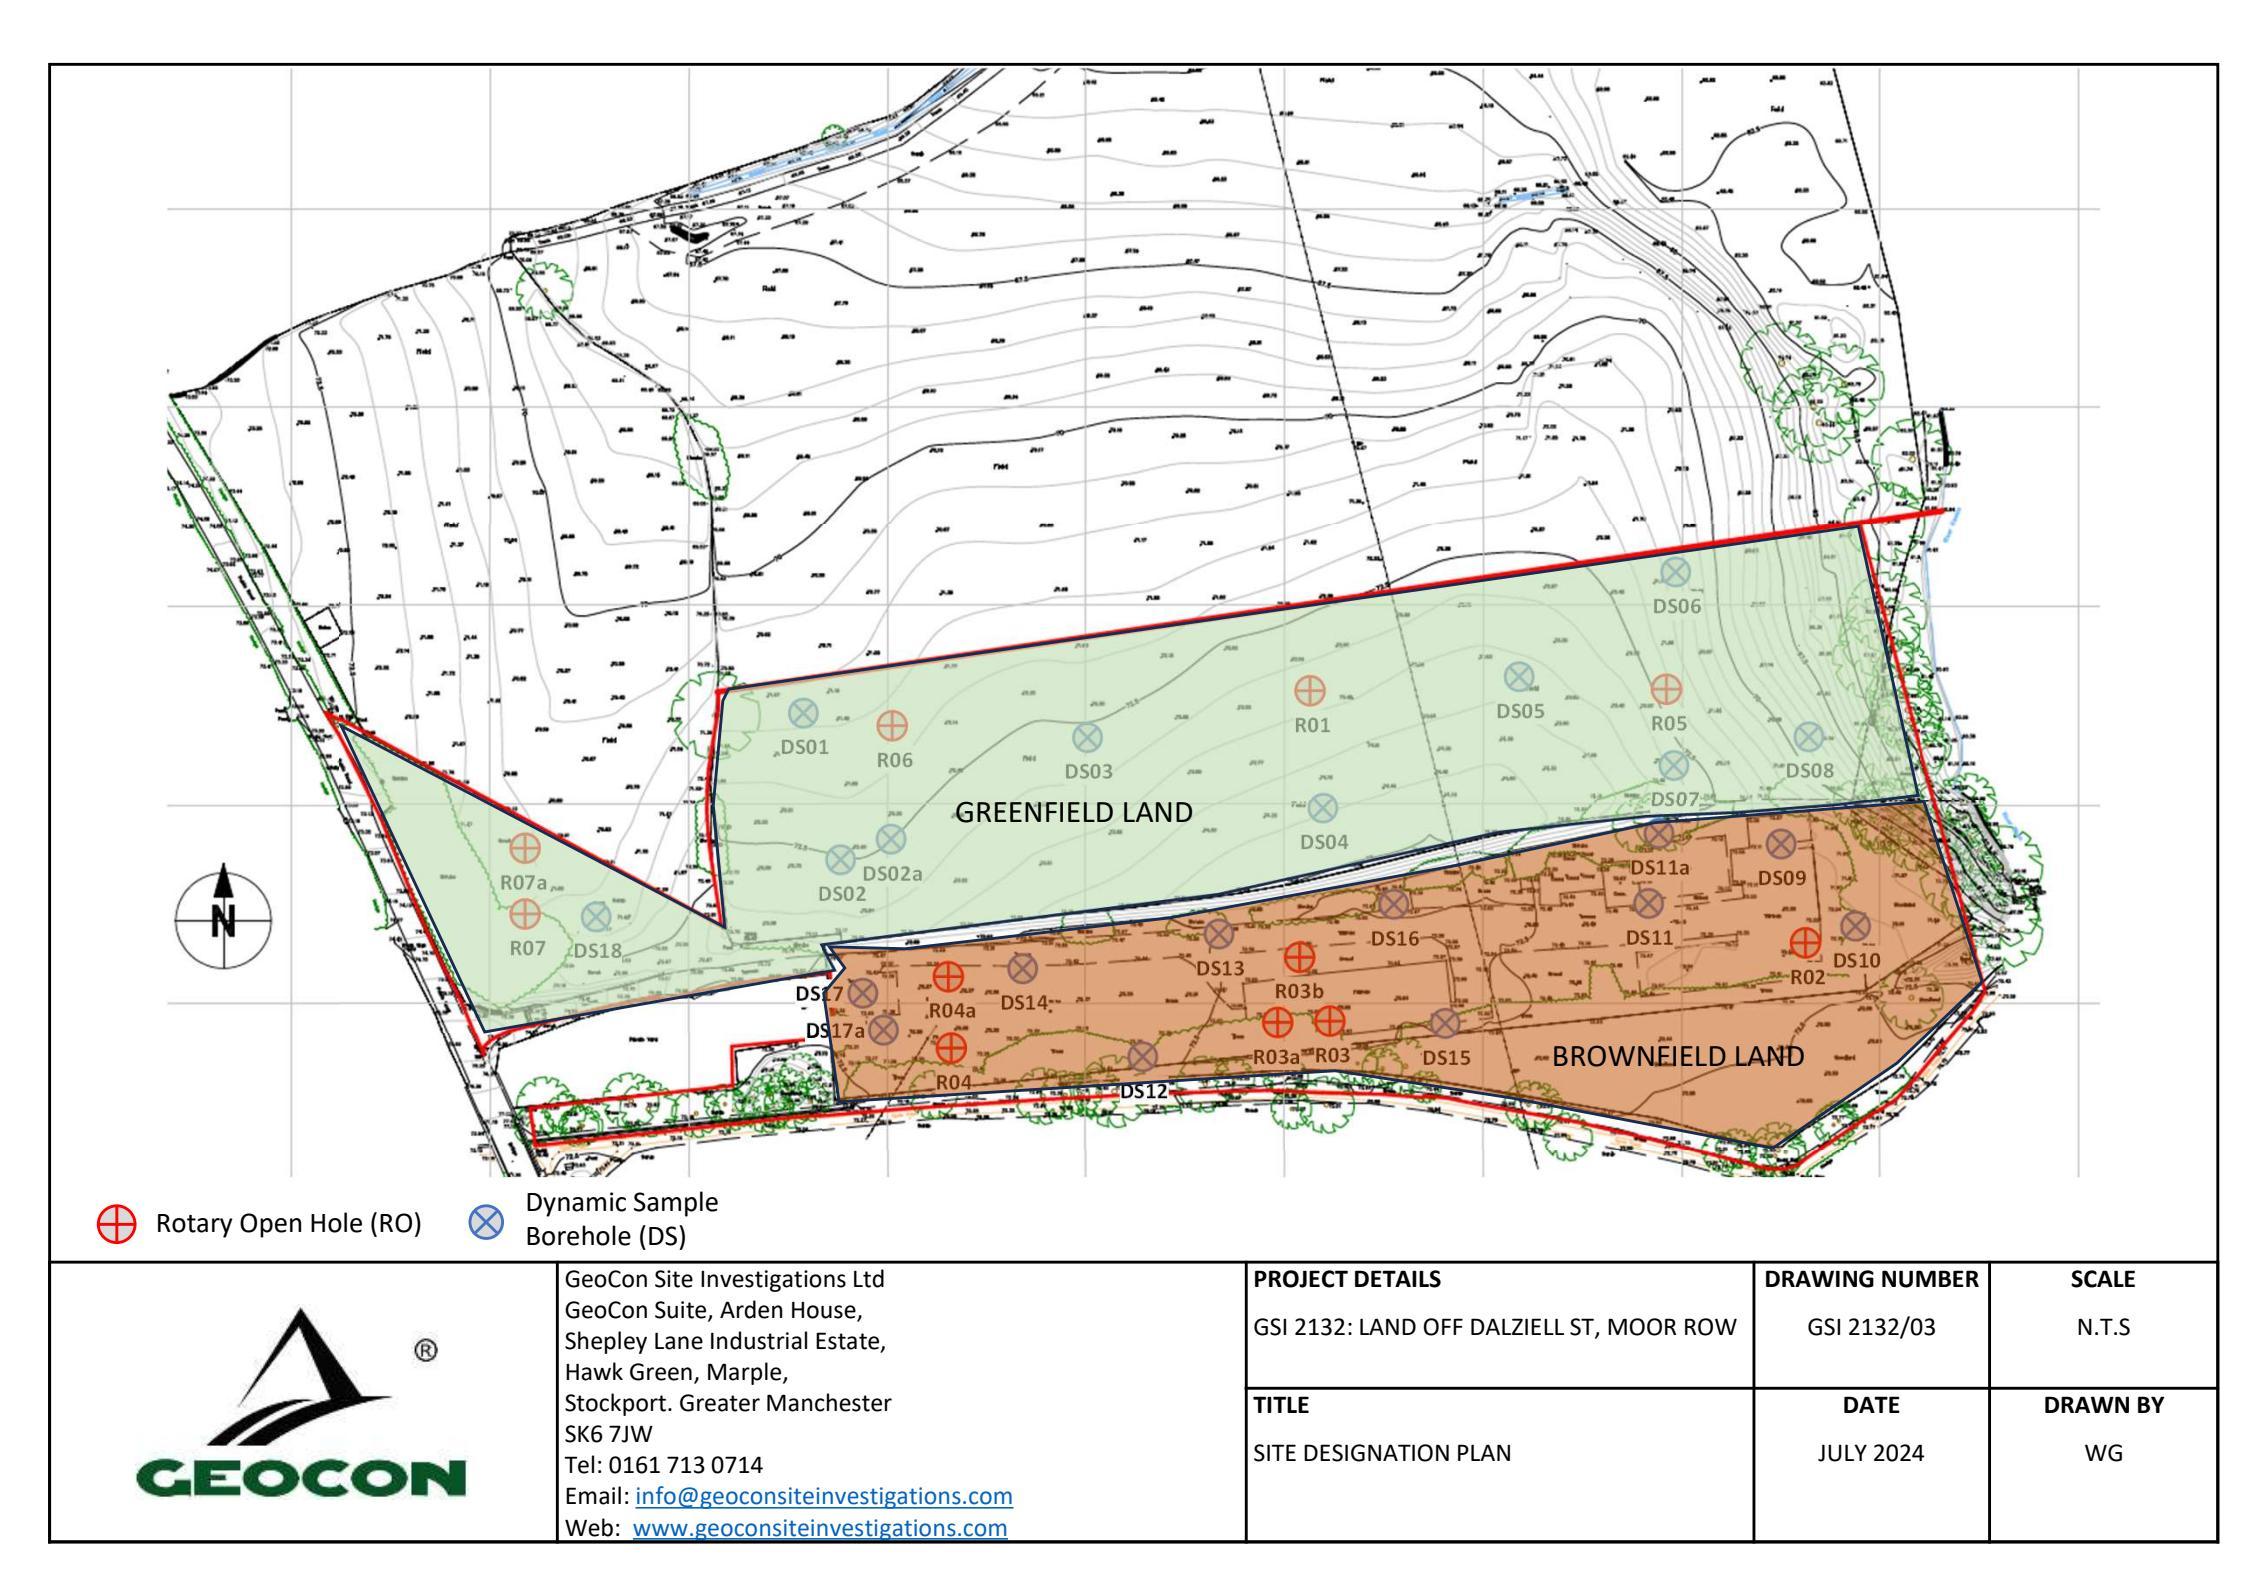
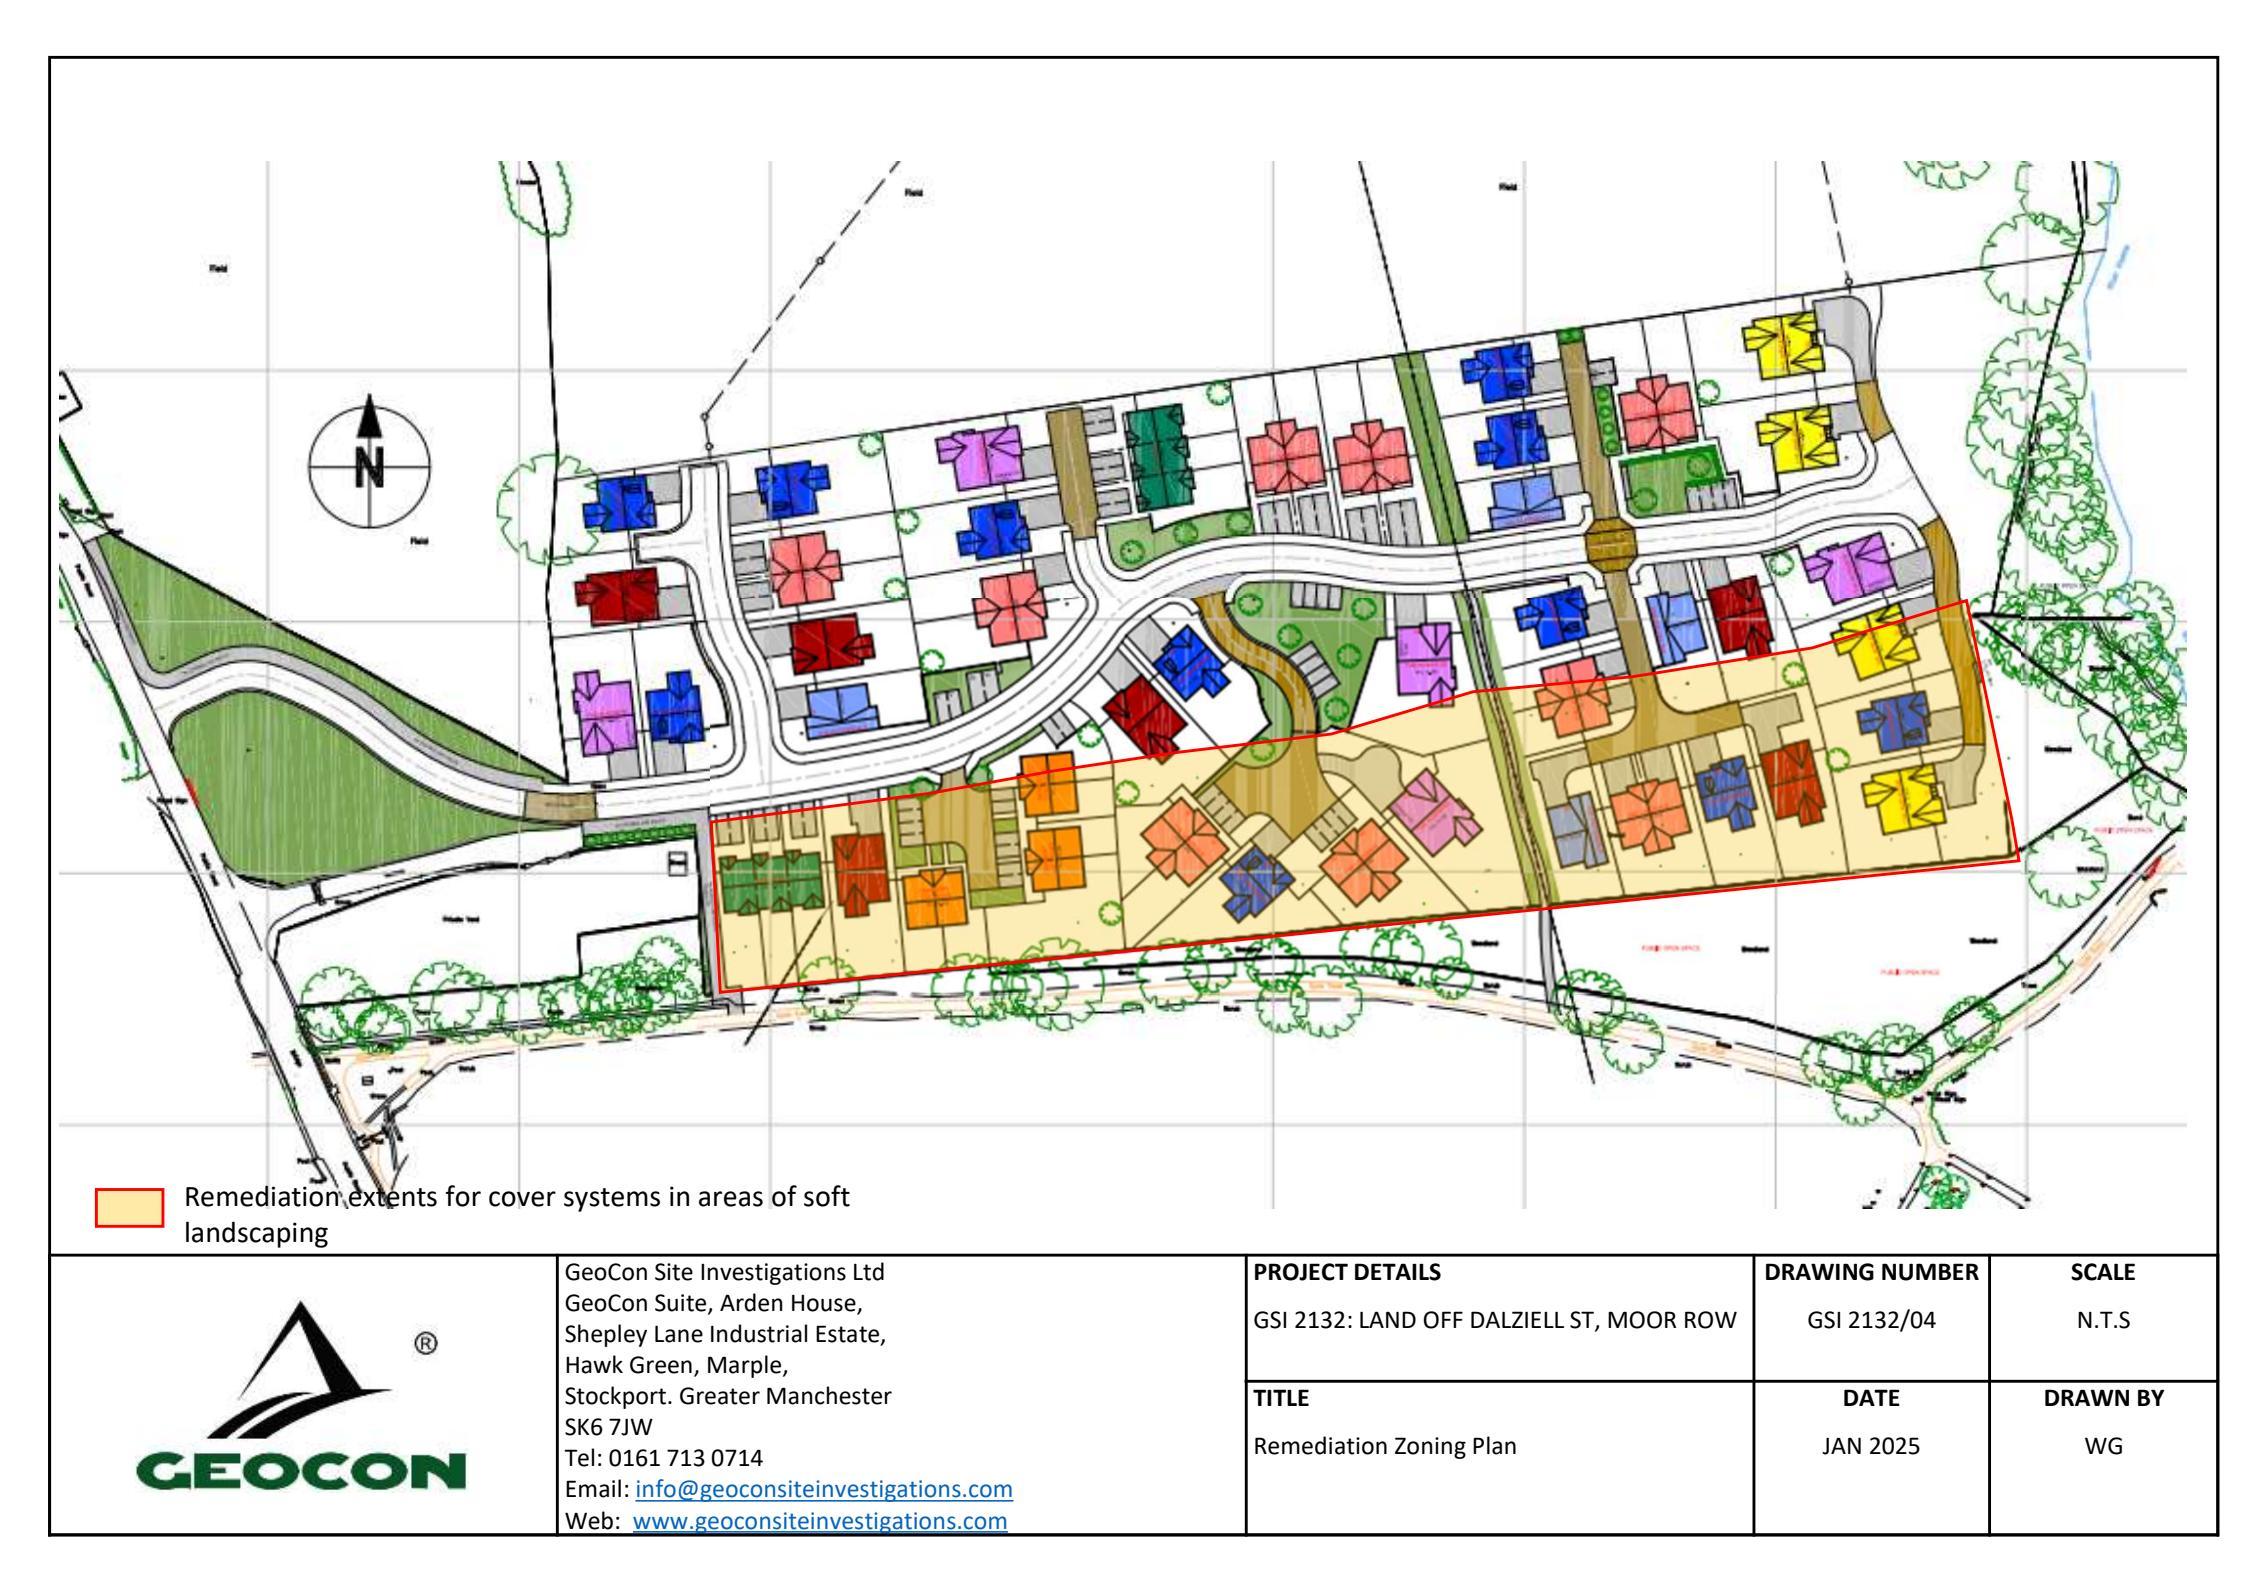
Concentrations above guideline values of Arsenic, Lead, Benzo(a)anthracene, Benzo(a)pyrene, benzo(b)fluoranthene, dibenzo(ah)anthracene were recorded with in the granular made ground, alongside quantified asbestos within the Brownfield portion of site only, as defined on drawing GSI2132/03 and GSI2132/04 (Appendix A).

- 5.4.1 Remedial measures are required with respect the new development and construction in the area defined as Brownfield portion of site.
- 5.4.2 Following discussions with the Environment Agency, and in absence of groundwater quality information, the areas of RO4, DS11, and DS17 require Made Ground soils be removed from these localised areas of the site, to remove the potential source of contamination within the shallow made ground materials which have the potential to impact Controlled Water receptors. Specifically, this contamination is correlates to Made Ground at the specified locations and described as dark grey or black gravels
