St Johns Church  
Cleator Moor  
Cumbria  
CA25 5BY

Proposed South West Elevation

PROJECT NO:  
0821-003

DRAWING NO:  
011

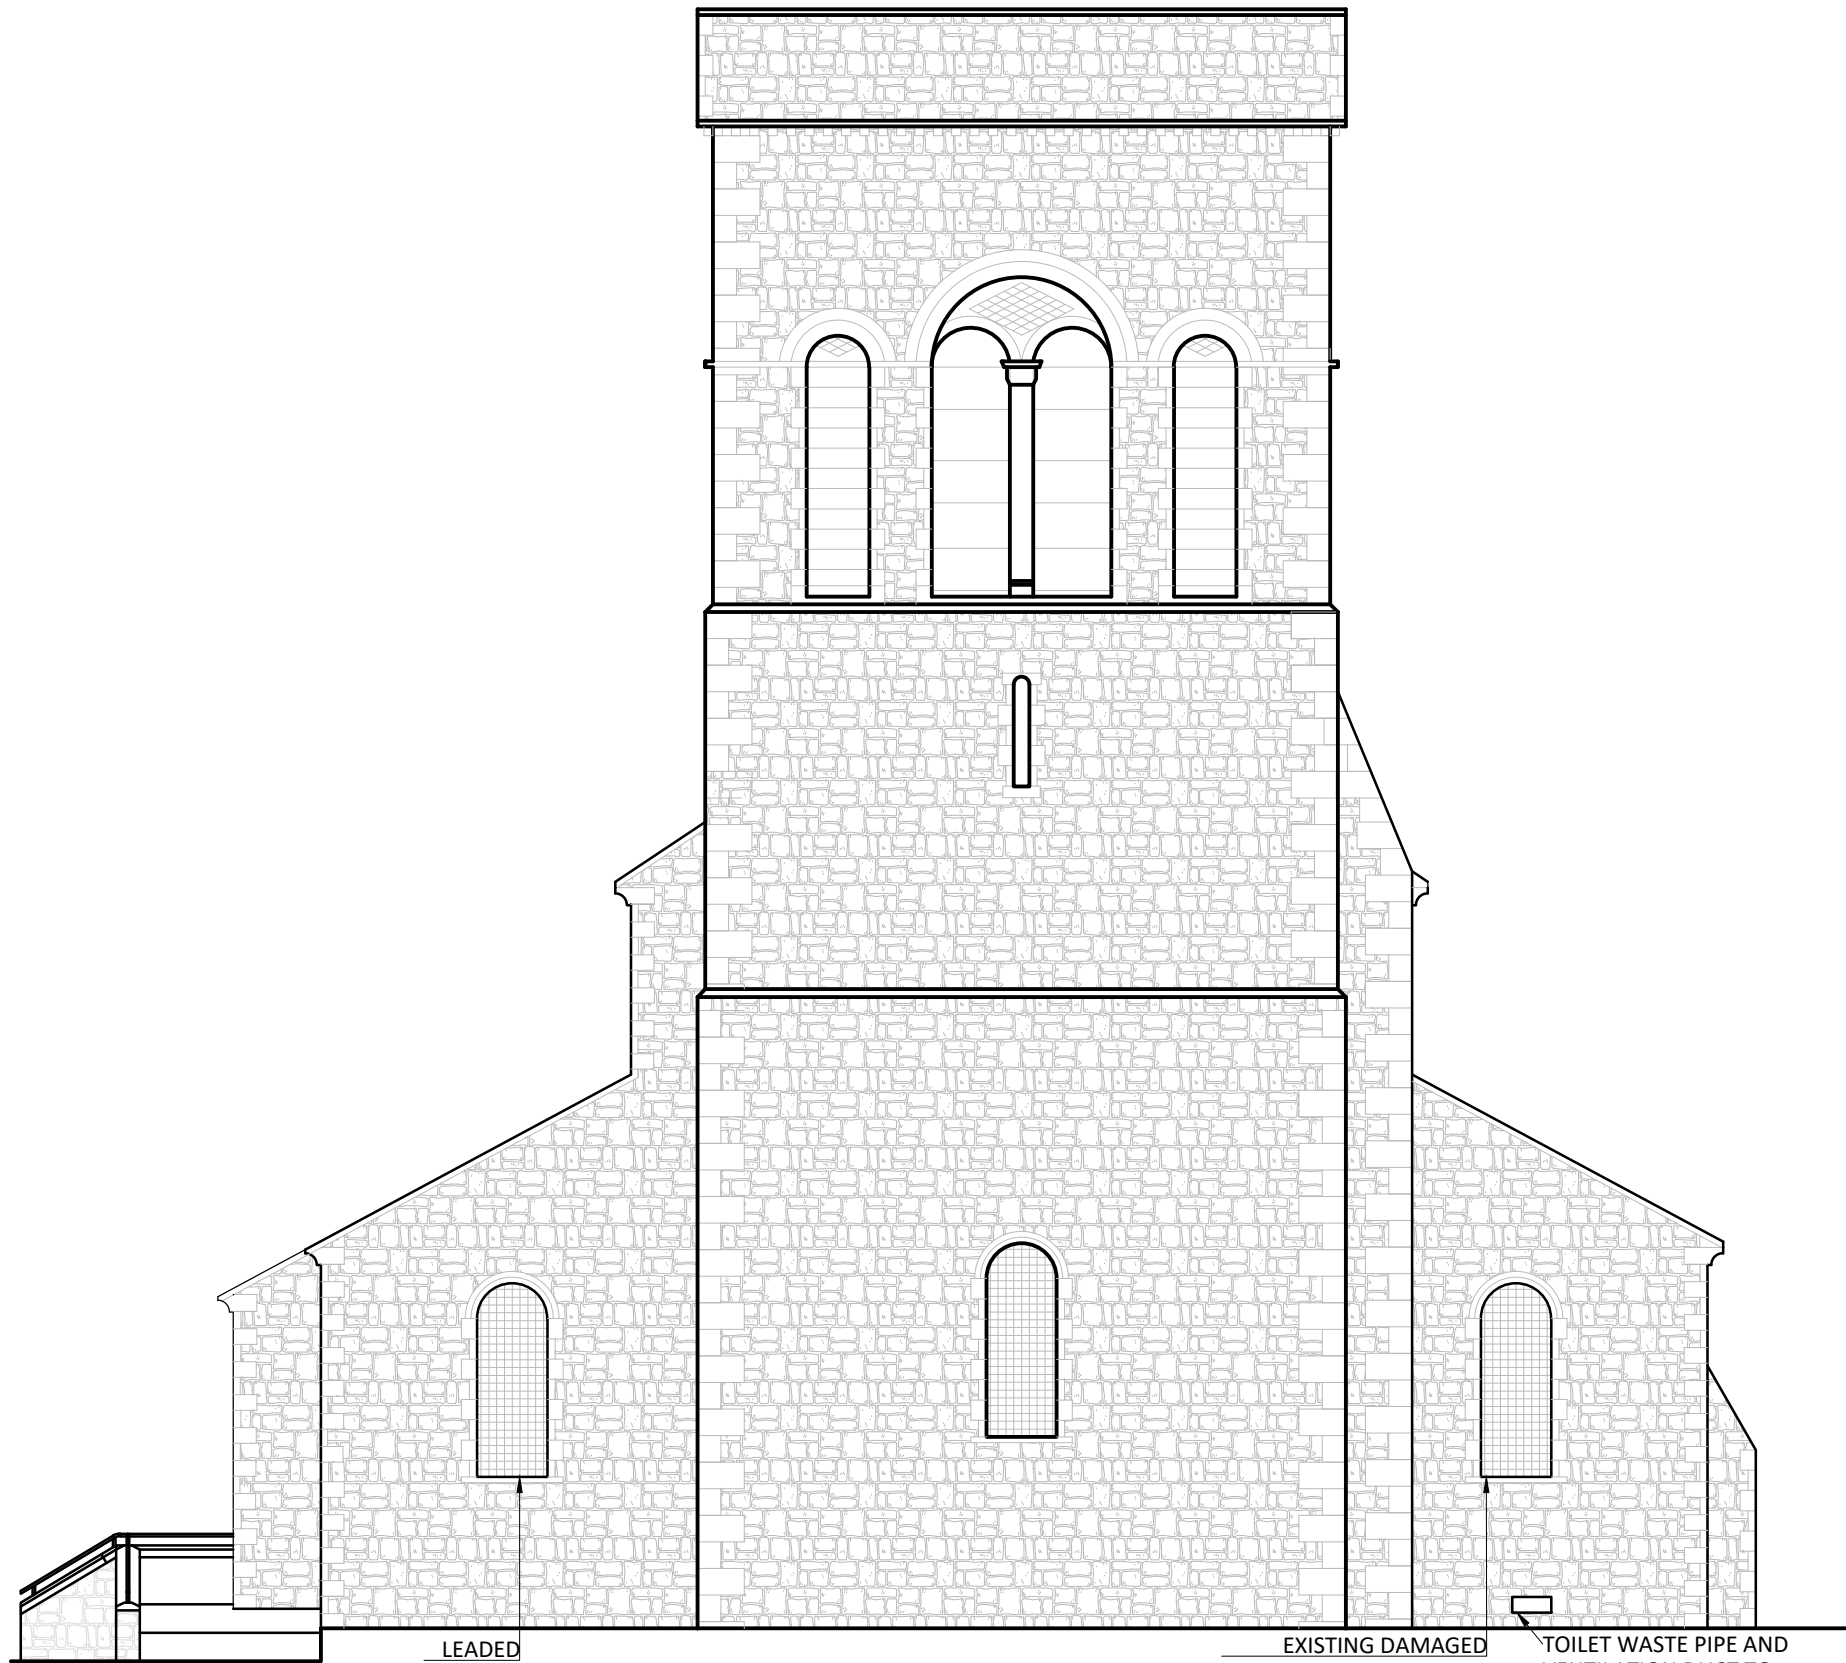
Proposed South West Elevation  
Scale 1:100

EXISTING DAMAGED  
WINDOW TO BE REPAIRED  
TO MATCH EXISTING.

TOILET WASTE PIPE AND  
VENTILATION DUCT TO  
EXIT THROUGH EXISTING  
VENT.
