PLANNING

Alterations to The Central, Egremont

Drawing Title - As Proposed Site Entrance

Job No - 1428	Dwg No - 15	Rev : A
DATE:	SCALE:	Paper
3 August 2025	1:100	A2

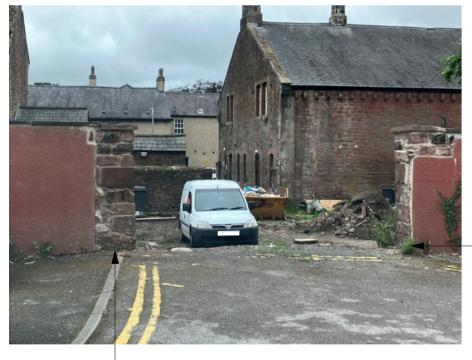
existing sandstone wall made good and returned

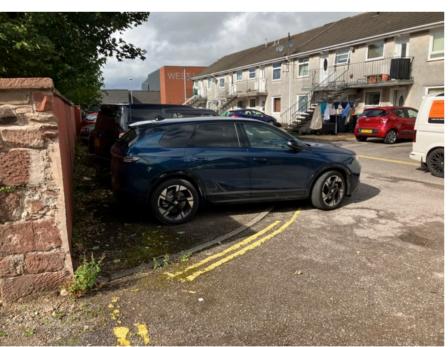
view looking West exiting site - cars parked on double yellow lines illegally blocking visibility at time of site visit

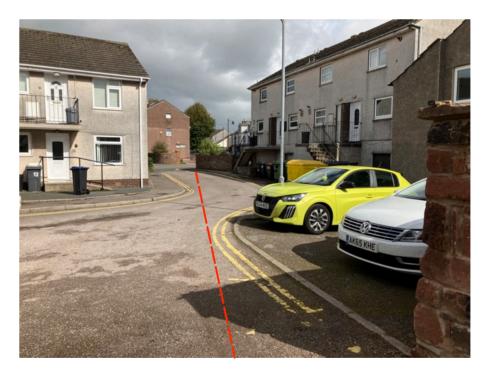
view looking North exiting site - forward visibility to main highway
