**Ref. 2102: Moorleys, Egremont, CA22 2UA, proposed reinstatement of the existing farmhouse and extension into adjacent barn to form a new dwelling.
New lime render specification to accompany revised Planning and Listed Building Consent applications.**

1.0 Proposed new lime render details.

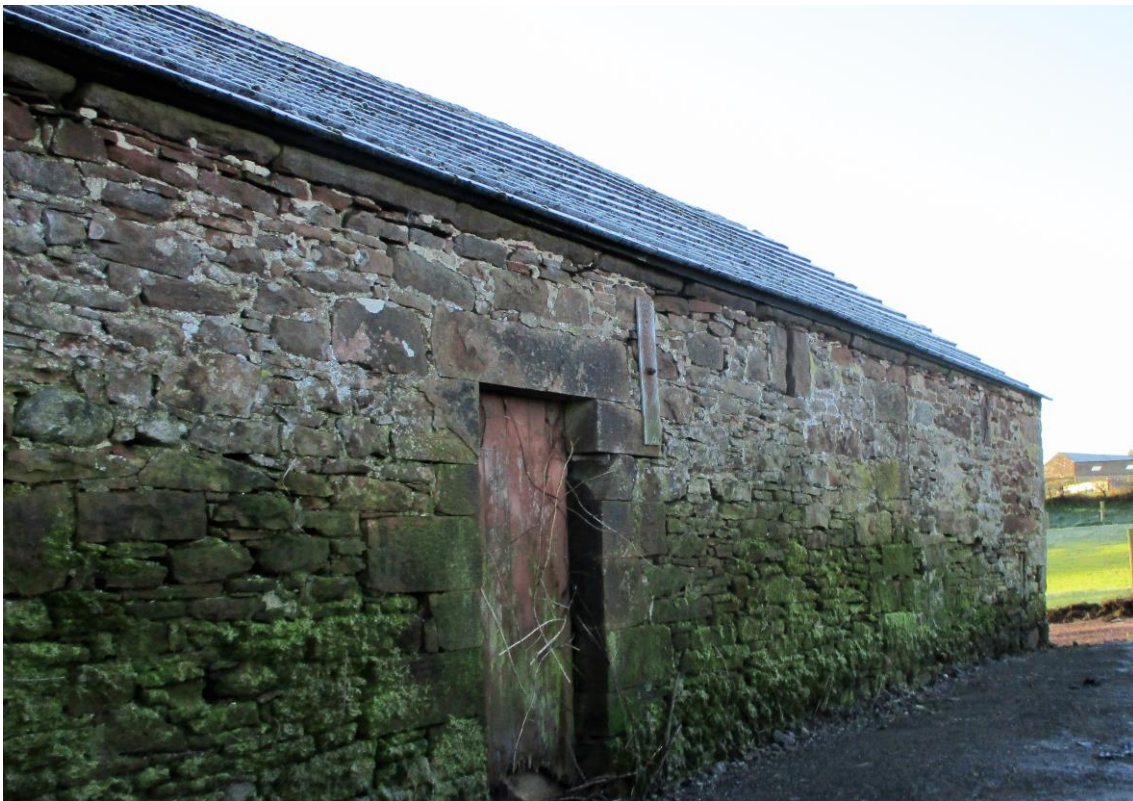
Photograph of the existing rear barn wall showing the effect of the weathering, the structural support plate will be removed when the front wall is re-constructed.

Externally it is proposed to apply a render finish to the rear wall of the barn which is intended as a measure to overcome the poor quality sandstone facing of the external wall in this location. This wall has a north westerly orientation and as such is subject to direct exposure from the prevailing weather conditions which over the years have caused the surface to deteriorate, additionally the original stones used to construct the wall were composed of many small pieces in uneven coursing, both of these points are indicated on the photographs below. The application of a render finish will provide a more durable finish and also help to avoid water penetration through the solid walls of the barn which is to be converted to living accommodation with an insulated independent internal lining, limiting the finish to the rear wall will avoid any significant impact to the properties general appearance.

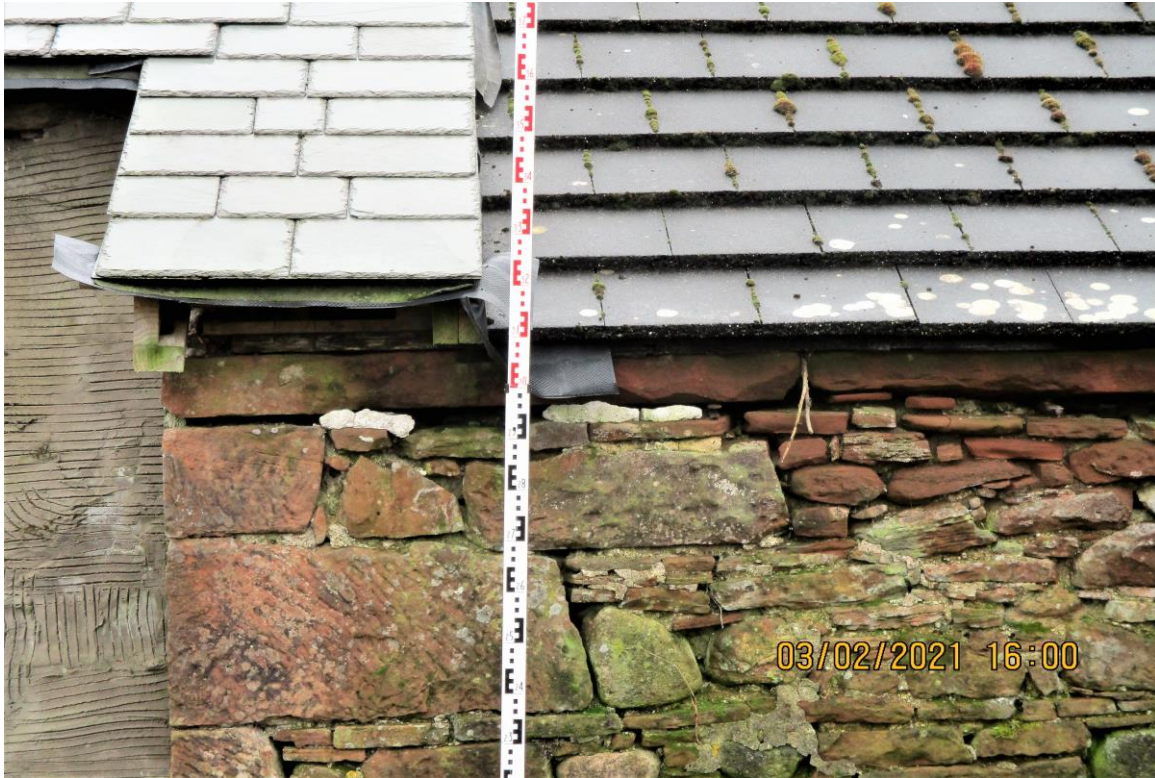
Detail of the rear barn wall showing the poor quality small weathered stone pieces.

The existing wall appears to be slightly hollow and I would suggest it also needs a lime grout to fill the centre of the wall back up. Before this is done the wall would have to be repointed up to one metre high barring a hole approx. 50mm high and 1.5m between each hole, then grout the wall and plug the hole once the grout gets to that point. Leave the grout to set for approx. two weeks then keep working up the wall with the same procedure.
