### **DESIGN AND ACCESS STATEMENT**

May 2024, rev Oct 2024

This Design and Access Statement has been prepared to accompany a Full Planning Application for the development of Griffin Close, Frizington.

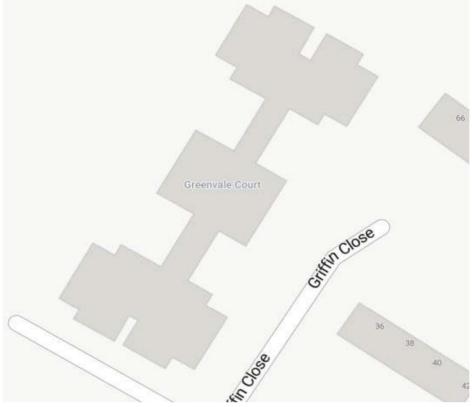
Footprint of the former building (Google maps)

The site formally contained Greenvale Court, sheltered housing scheme which was demolished in 2011 (planning reference: 4/10/2593/01F).

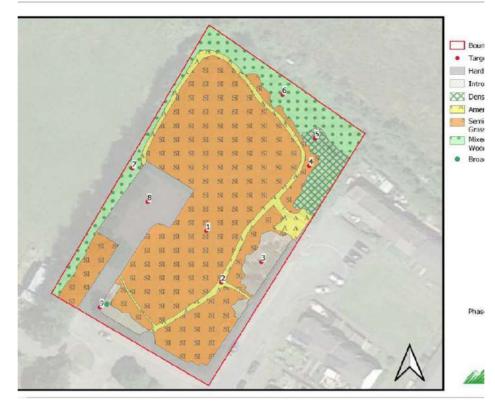
Plan from the Preliminary Ecology Survey

- 1.5 A diverse mix of mostly deciduous trees comprise the treelines north and west of the
- 1.6 Three trees (T1, T3 and potentially T2) will be removed from the site to facilitate the development proposal, in addition to some of the Willow scrub in the north-east of the site. Recommendations have been made regarding the best use of compensatory planting.

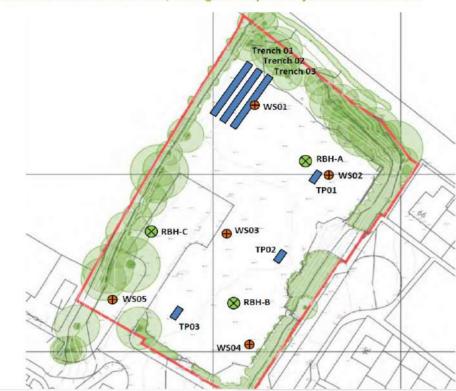
#### GEO2022-5496: Griffin Close, Frizington - Exploratory Hole Location Plan

Trial pit locations

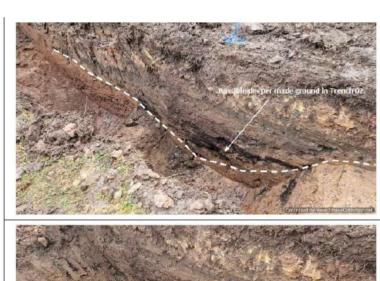
Excerpt from GI report

Depth From (m)	Depth To (m)	Strata Description	Legend	Testing / Samples
0.00	0.20	TOPSOIL: Dark grey brown sandy gravelly LO	DAM.	
0.20	Veries 0.95 – 1.30	MADE GROUND: Firm reworked brown occasional brick and pottery. Occasional org		
Varies 0.95 – 1.30	Varies 1.00 – 1.50	Stiff brown gravelly CLAY.		
		Base of trench varies 1.00m to 1.50m bgl in n Trench remained open and dry on completic Trench backfilled with arisings on completio	on.	
Engineer: J.B	rock	Log	Notes:

Dimensions: 1.60m wide x 11.7m long	B - Bulk Bag, J - Amber Glass Jar, T - Plastic Tub
Plant: Tracked 360 Excavator	LP - Limited Penetration (HSV/CBR)
Site Works Date: 20.10.2022	HSV = Hand Shear Varie (kN/m²)

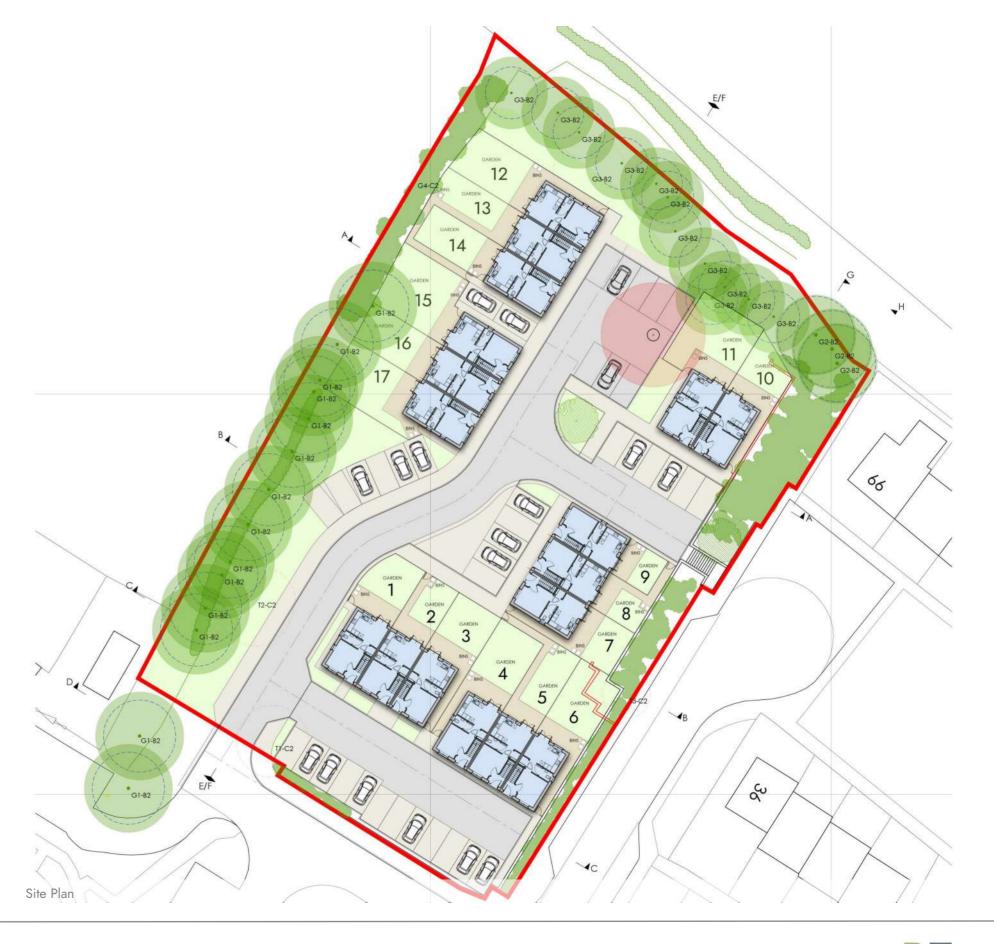
#### 3.2 SITE LAYOUT

The site layout is dictated by the site entrance; and existing boundaries, mine shaft and topography. Due to the existing level changes it was not possible to have properties accessed directly from Griffin Close and Greenvale Court but it was felt important for at least some of the properties face out of the site. Therefore a new access behind Greenvale Court was included so properties 1-6 could face out and towards the site access. A pedestrian access was also added to link Griffin Close with the new site. While plots 10-11 follow the pattern of the neighbouring dwellings with gables facing the edges of the site and can be seen as a continuation from No. 66 Griffin Close, albeit at different heights.

Plots 12-17 have been rotated to an east-west axis for two reasons, to allow some southern sunlight into the gardens without too much shading from the trees but also to face into the site and the Griffin Close dwellings beyond.

Initially the design allowed for 18 dwellings, however, this was reduced to 17 as shown following site investigations that showed the location of a mineshaft.

Parking has been divided into smaller parking courts where possible but also located outside properties so vehicles can be overlooked and have EV charging point linked to individual dwellings. While the arrangement of dwellings allow for natural surveillance on all areas of the site reducing the opportunity for anti-social behaviour.

The scheme includes 40 parking spaces which equates to 2 no. parking spaces per 2 bed dwelling plus 20% visitor parking spaces.

Footpaths have been used to ensure separation of pedestrians and vehicular traffic around the site. All properties have a level approach from parking areas and public footpaths. All properties have level access to the principal entrance door.

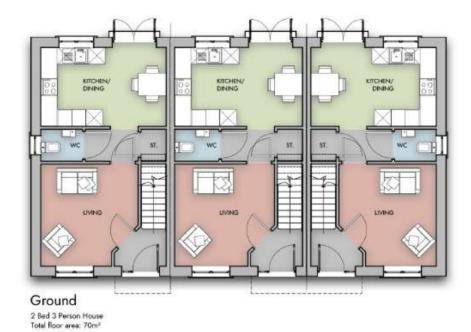
Ground Floor Plan

The proposed house type is an affordable two-bed two-storey house which has been used on several sites recently and has proved very popular.

70sqm
