AS BUILT SITE PLAN.

PROPOSED ALTERATIONS (AS BUILT)

Project and Client	
Kirkland Chapel, Kirkland, Cumbria. Conversion & Extension. Mr. R. Gould.	
Date	Scale
May 2012.	1 : 50 : 100. Print A1 @ 1:50.
Drawn	Drawing No.
AW.	G1024 / 012.

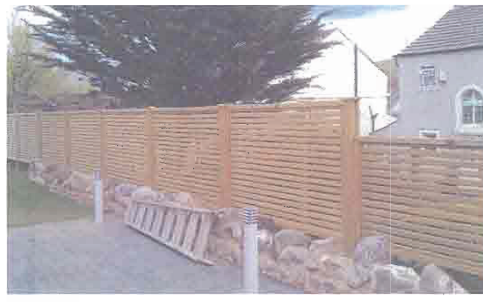
New timber screening to boundary

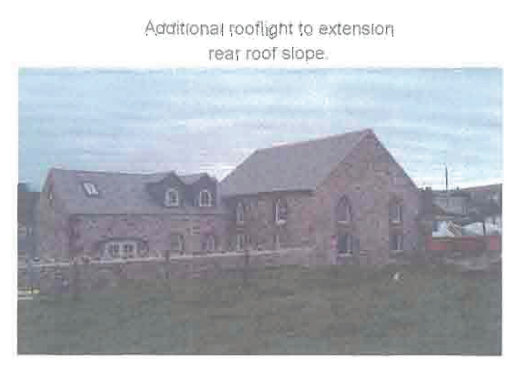
Additional rooflight to extension rear roof slope.

Additional rooflight to rear slope of new extension, providing additional natural daylight over secondary stairs.

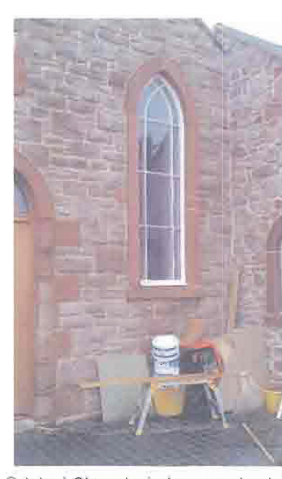
Original Chapel window opening left unaltered and new purpose made replacement window manufactured to suit opening

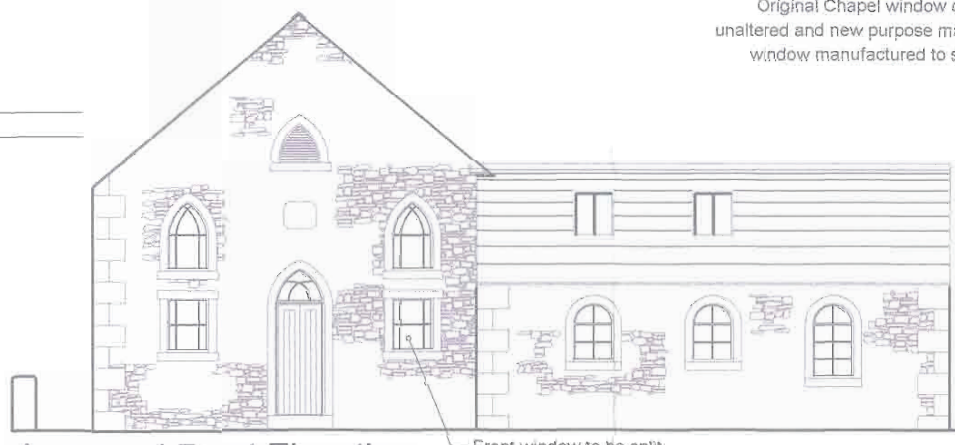
AS BUILT FRONT ELEVATION.

Front window to be split to match all other altered Chapel windows.

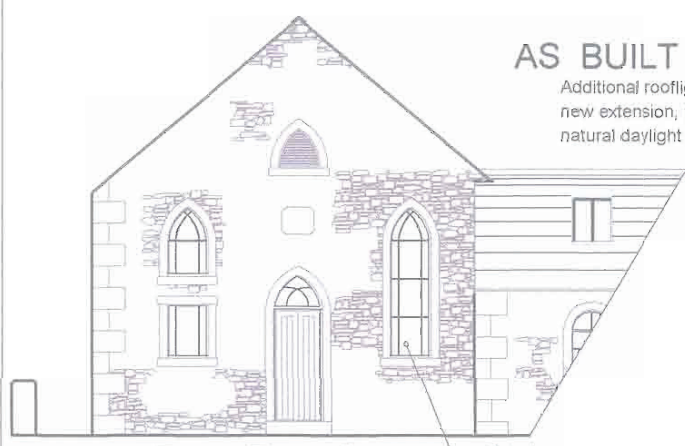
Front Elevation.

Right hand window left as an unaltered full height window to service hall and landing areas.
