## Front of the Property

## **Back of the Property**

## Side of the property.

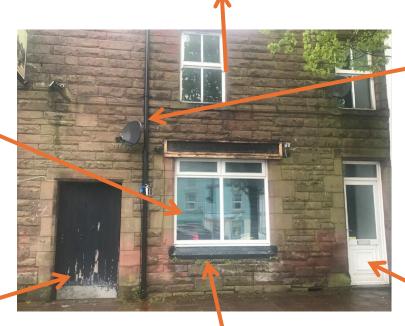
Picture 1: Wooden 3 section Victorian style sliding sash window style to replace the large UPVC front window.

Door to be replaced same style as now and in wood. Colour to be from the grey pallet the same as windows.

Windows to be replaced in <u>wooden</u> sliding sash as shown in the original style, which are still in place at the side of the property. Colour to be from a dark grey pallet and to match with wooden passage door.

Paint to be removed and all stone to be steam cleaned and pointed, in the same style. Black cast iron guttering and downpipes.

Sign and 2 sky dishes to be removed.
