Buzz Station - Culvert Repairs

SKDS commenced work on the culvert repairs on the 19/10/2020 and was completed on the 20/10/2020. Entry was made into the culvert under a Confined Space Entry permit.

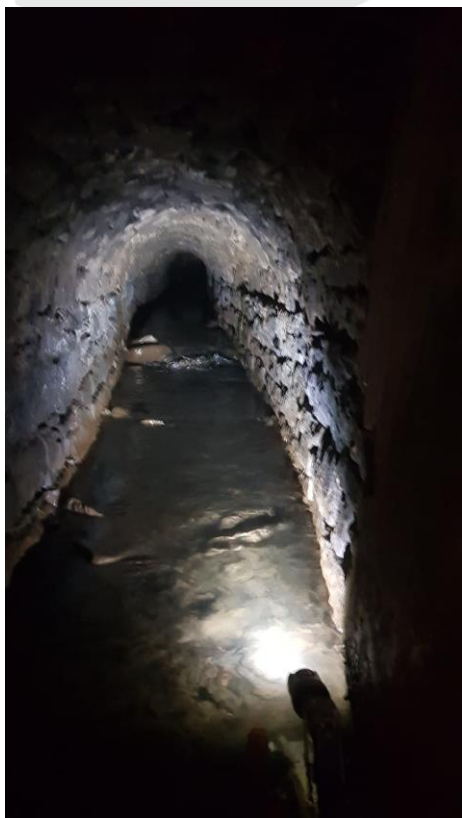
The culvert has a constant flow and is restrictive in size.

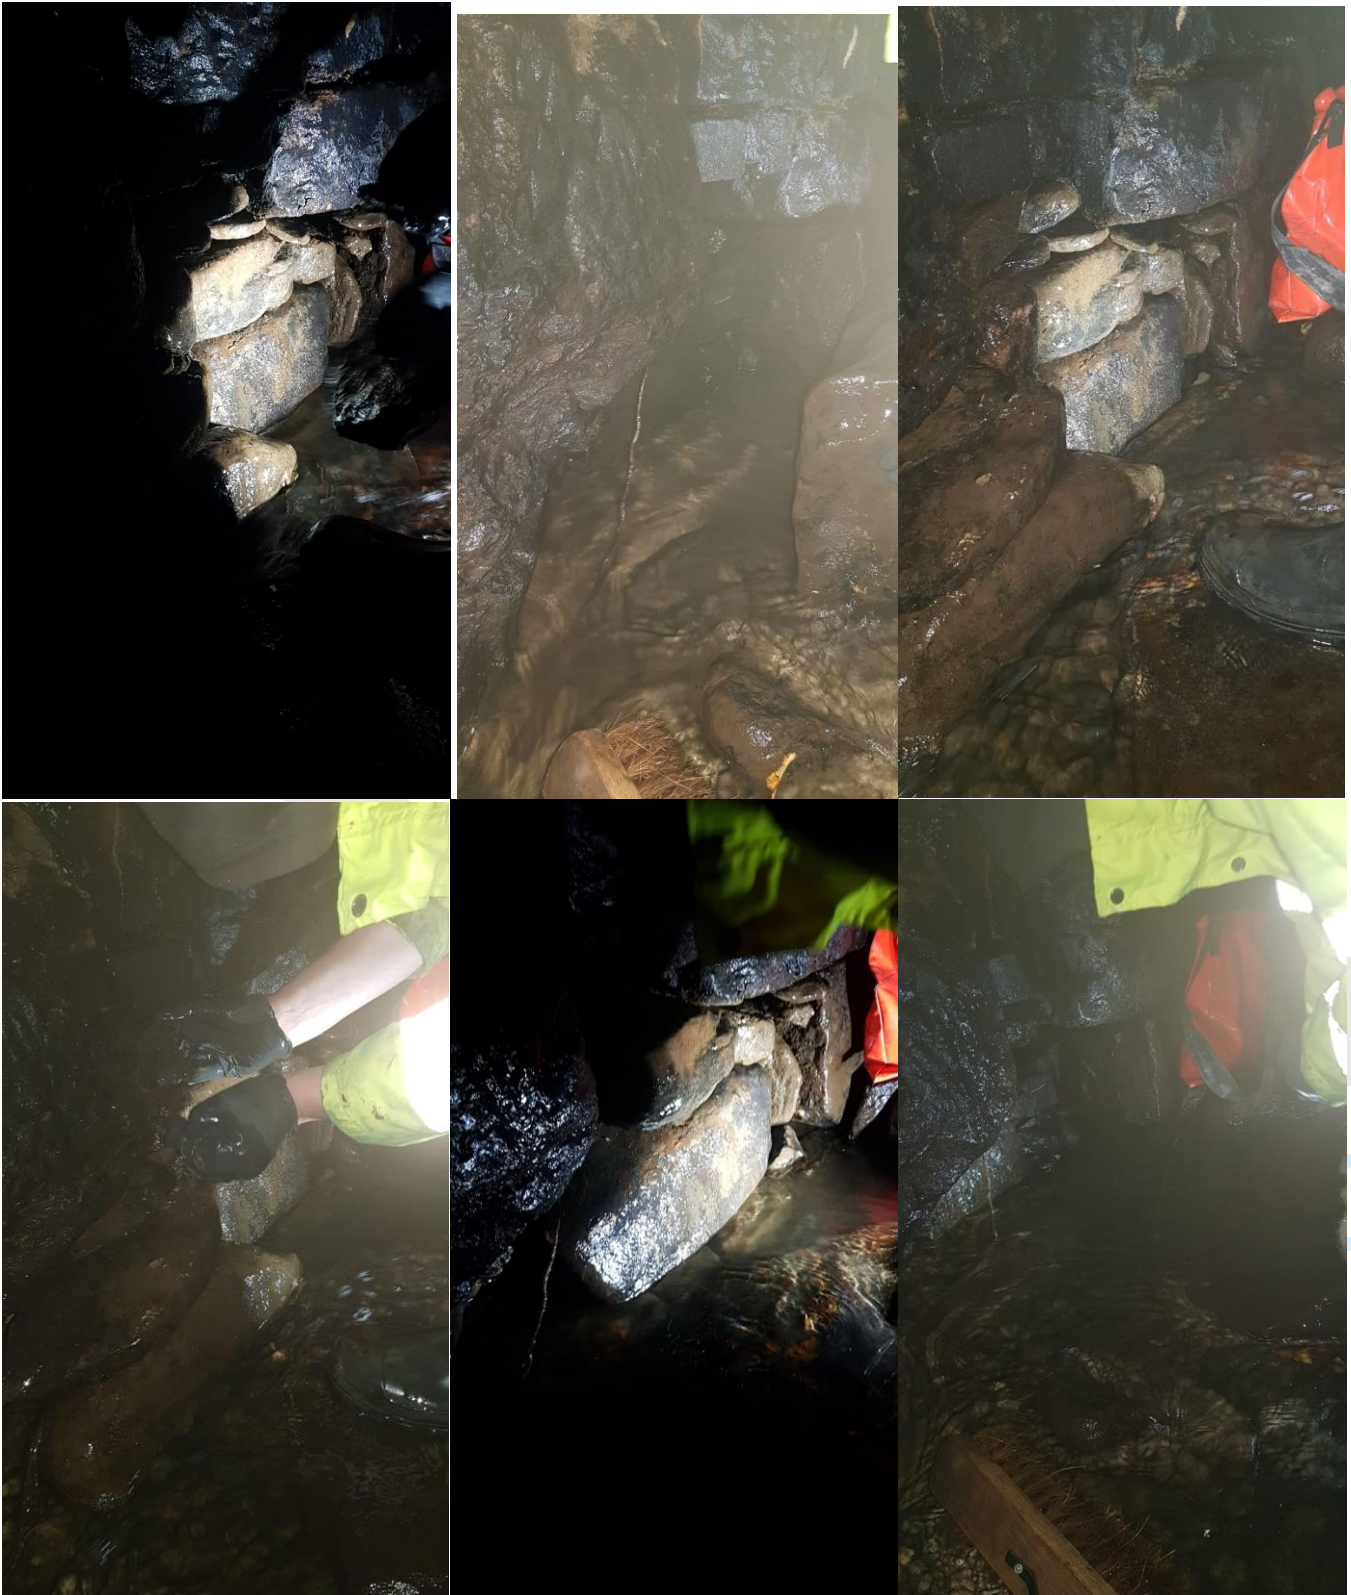
Stone retrieved from the culvert being used for repairing

All major defects were repaired by using stone retrieved from the culvert. These were held in place with a CT-6 compound.

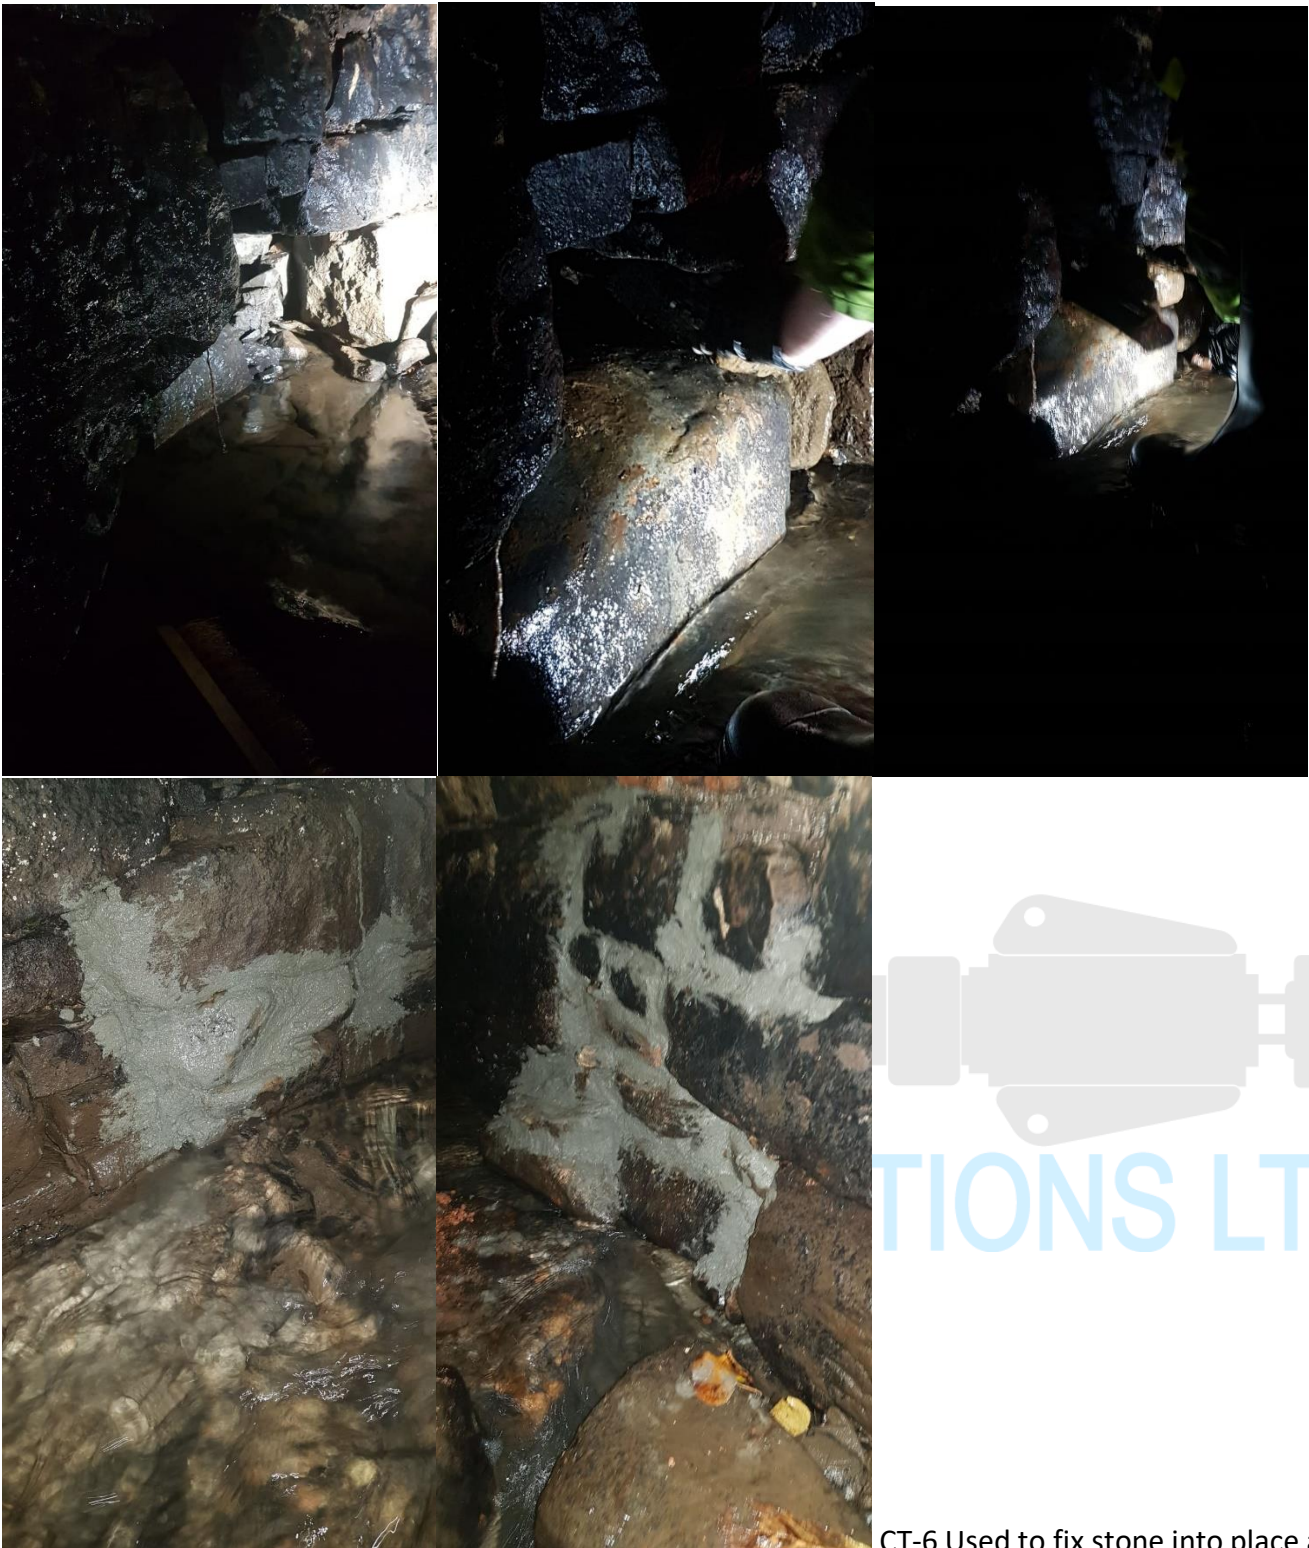
point up joints.

CT-6 Used to fix stone into place and

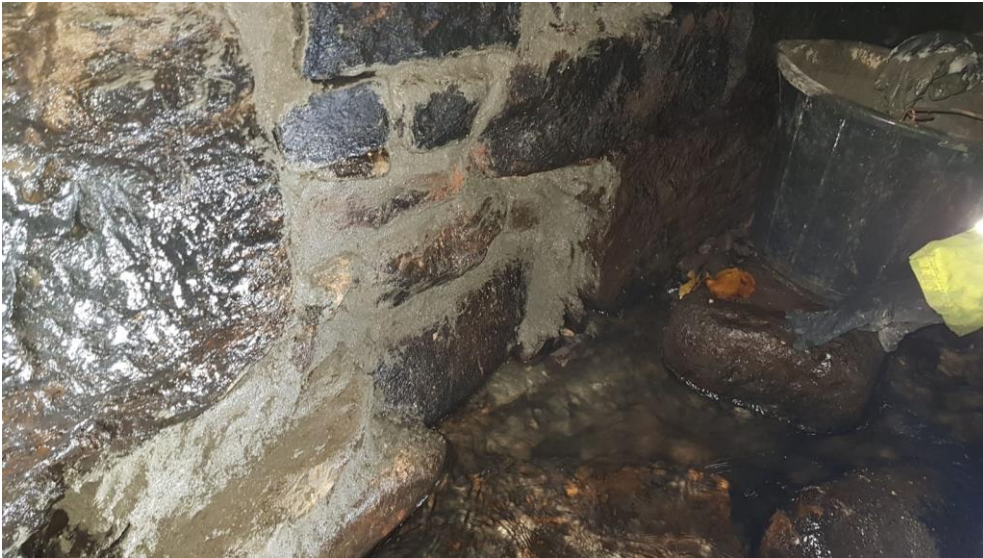
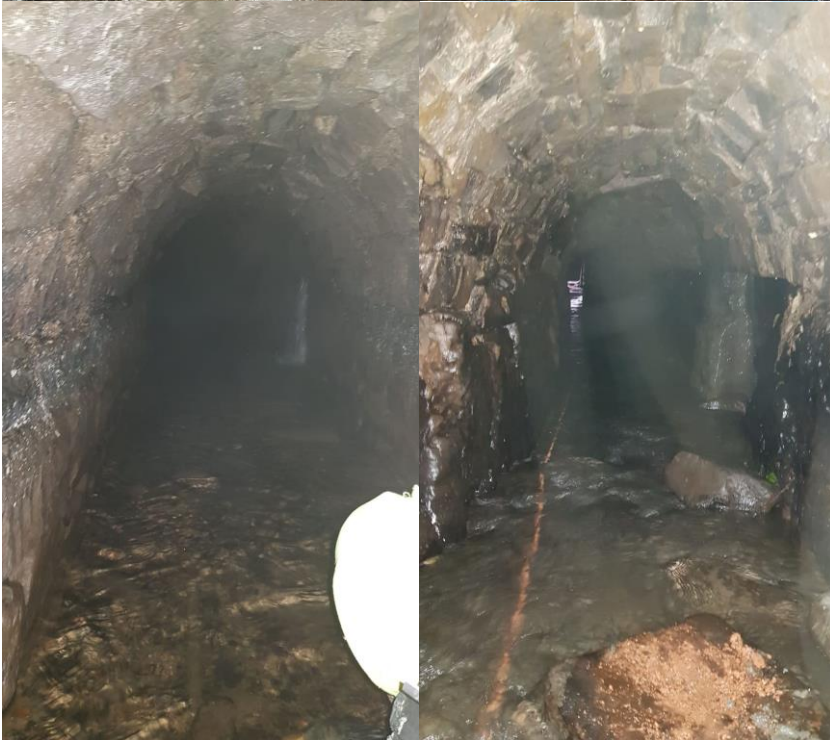
The walls and arch have been pointed.
