## **PHASE 2: GROUND INVESTIGATION REPORT**

**PROPOSED RESIDENTIAL DEVELOPMENT OF**

**LAND AT SCURGILL, EGREMONT**

**Report Ref:** 2021-4817

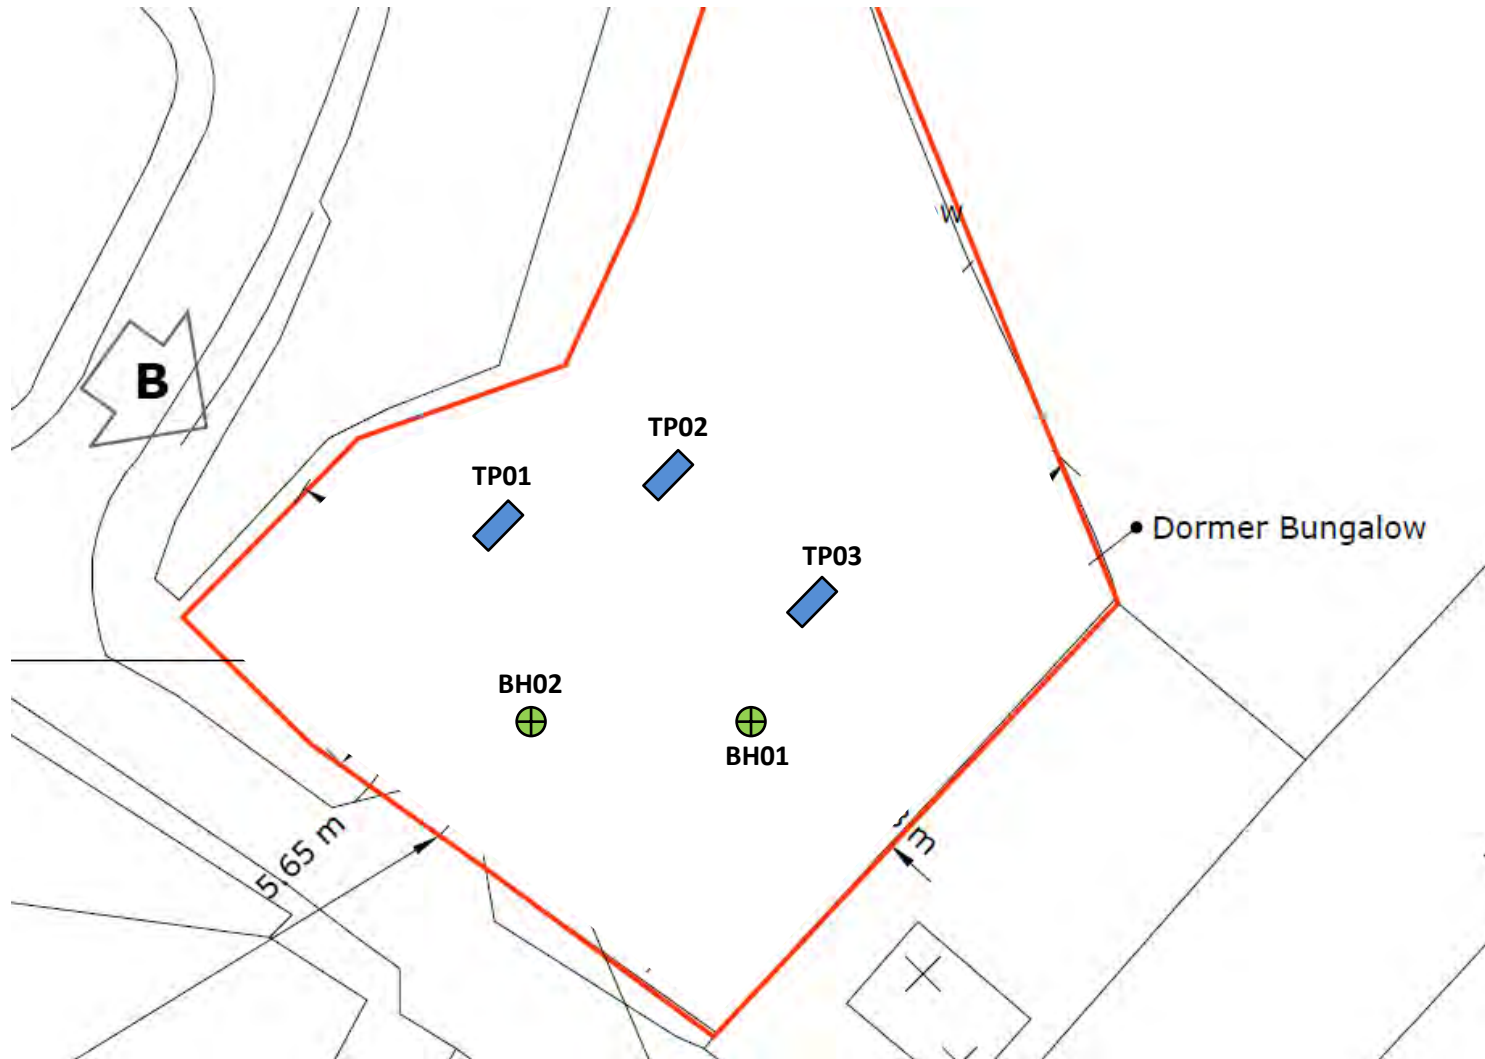
**GEO2021-4817: Scurgill, Egremont, Cumbria – Exploratory Hole Location Plan**

- 2 No. Percussive Boreholes (BH01 and BH02) to depths of between c.2.60m and c.4.00m bgl.
- 3 No. trial pits (TP01 to TP03) excavated to depths of between c.0.50m and c.1.60m bgl using a mechanical excavator and hand digging tools.
- In-situ geotechnical testing - Standard Penetration Tests (SPT).
- Site supervision by a suitably qualified and experienced Geo-Environmental Engineer.
- Gas and groundwater monitoring (6 visits completed).
- Laboratory based chemical screening.

The ground investigation fieldworks were completed during June 2021. The exploratory holes were located within close proximity to the proposed development. The Exploratory Hole Location Plan is provided in Appendix II.

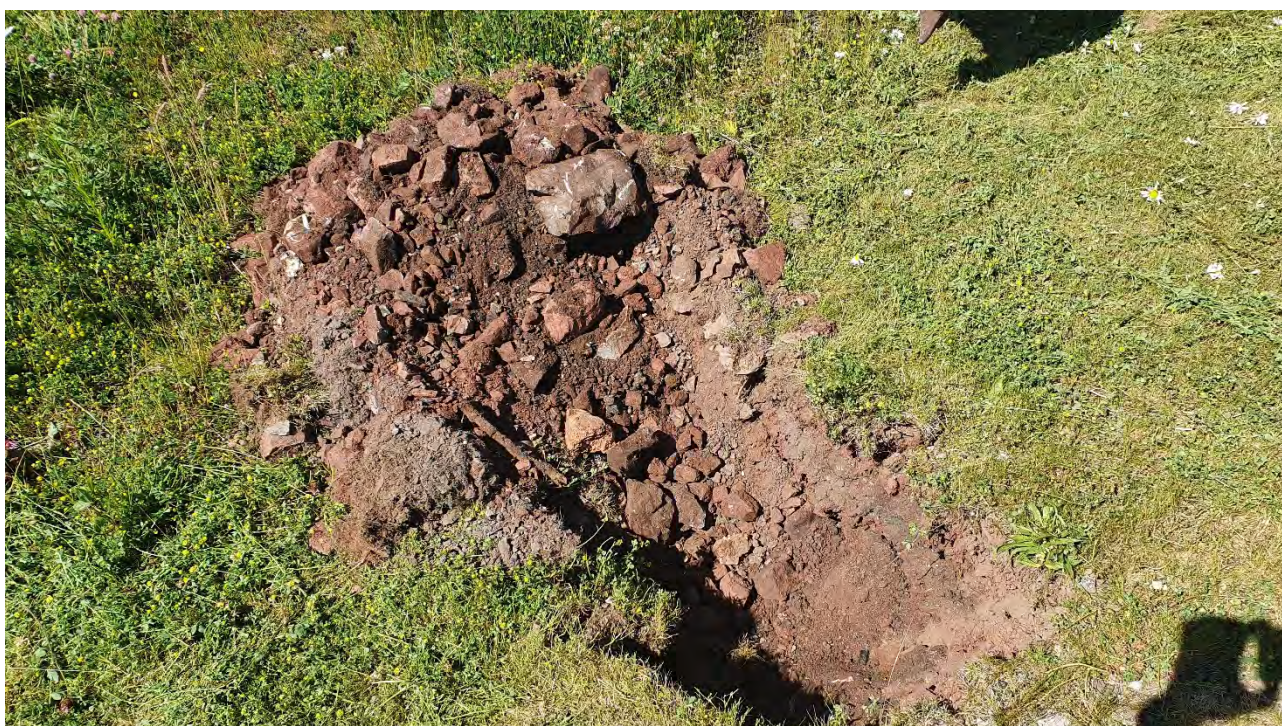
## GEO2021-4817: Scurgill, Egremont, Cumbria – TP02

| Depth From (m) | Depth To (m) | Strata Description | Legend | Testing / Samples |
|---|---|---|---|---|
| | | End of trial pit at 1.60m.<br>Trial pit is dry on completion.<br>Trial pit backfilled with arisings. | | |
