## **Heritage Statement**

**Property:** 3 Marine Terrace, Whitehaven, CA28 6HX

**Proposal:** Reduction and capping of the rear chimney stack

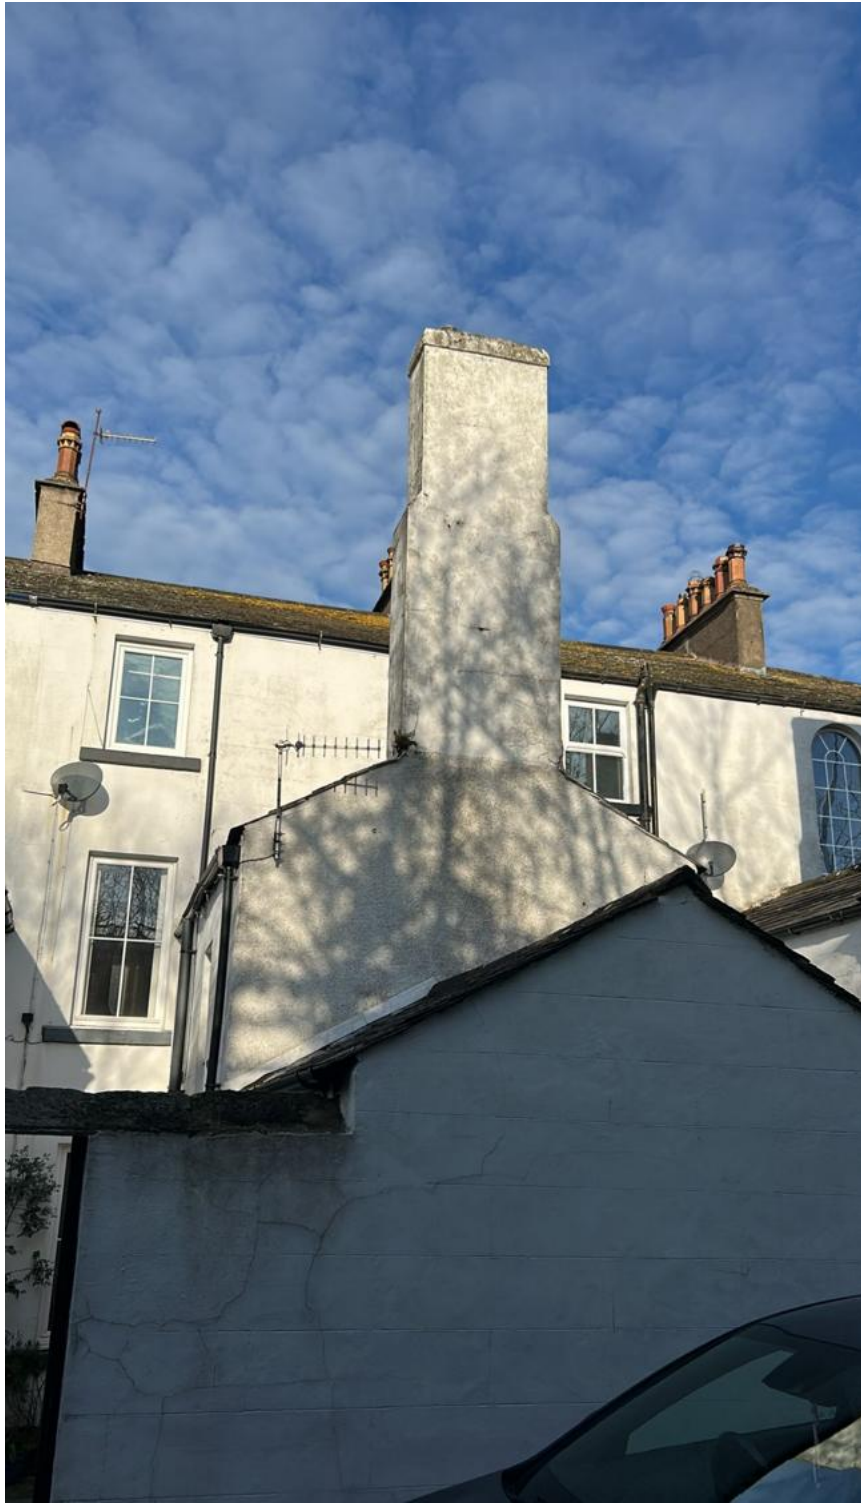
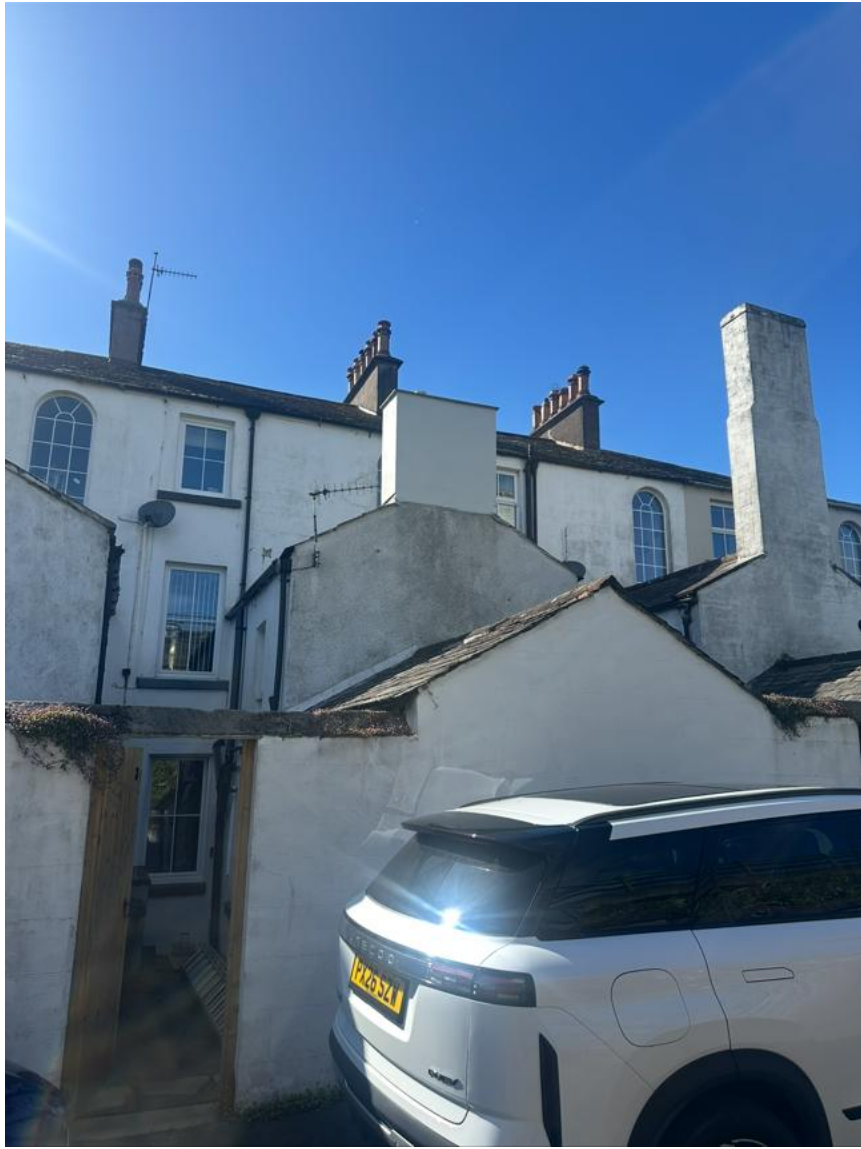
During scheduled render repair works to the rear chimney stack, the contractor discovered severe structural failure upon removing the external render. The chimney was found to be structurally unsafe, suffering from substantial internal deterioration, large voids, and loose brickwork falling into the flue. The stack was effectively being held upright solely by the failing render, posing an immediate safety hazard.

To mitigate the immediate danger of collapse, the chimney has been carefully taken down to a lower, structurally stable height. The chosen long-term solution is to cap the chimney at this reduced level rather than rebuild it to its original height. This approach permanently resolves the structural safety risk, mirrors the existing roofline alterations of neighbouring properties, and ensures the building remains weather-tight without altering the primary historic character of the front elevation.
