METHODOLOGY STATEMENT

71 Lowther St, Whitehaven CA28 7AH

Removal of ATM and Signage from external Facade.

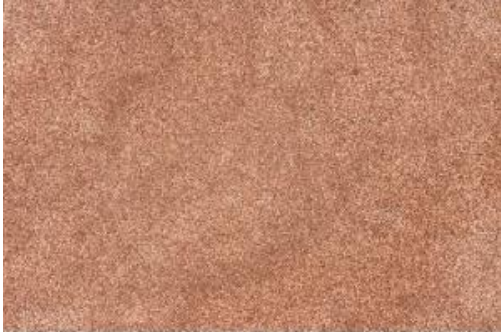
Stone Sample: St Bees, Sandstone

- 1.1 This methodology statement itemises the sequence of work associated with removal of the external ATM and the making good to the fabric of the exterior and Interior walls of the bank once the ATM has been removed. Making good of existing fixings where external signage removed.
- 1.2 The redundant aperture through the wall will be infilled internally with brickwork.
- 1.3 Externally, parts of the existing stone surrounding the ATM aperture will be removed and new sections of Matching stone fitted to match the existing finish.
- 1.4 Stone to be used is (See photos) – St Bees, Sandstone

- 2.8 Dress the stone section surrounding the ATM aperture as required ready to accept the new Stone.
- 2.9 Fit new Stone sections to match existing using sample as photo – St Bees, Sandstone & Mortar to match. See Analysis report.
