## **PHASE 1: DESK TOP STUDY REPORT**

**PROPOSED RESIDENTIAL DEVELOPMENT OF LAND AT:**

**SUMMERGROVE, WHITEHAVEN, CUMBRIA**

**Report Ref:** 2018-3441

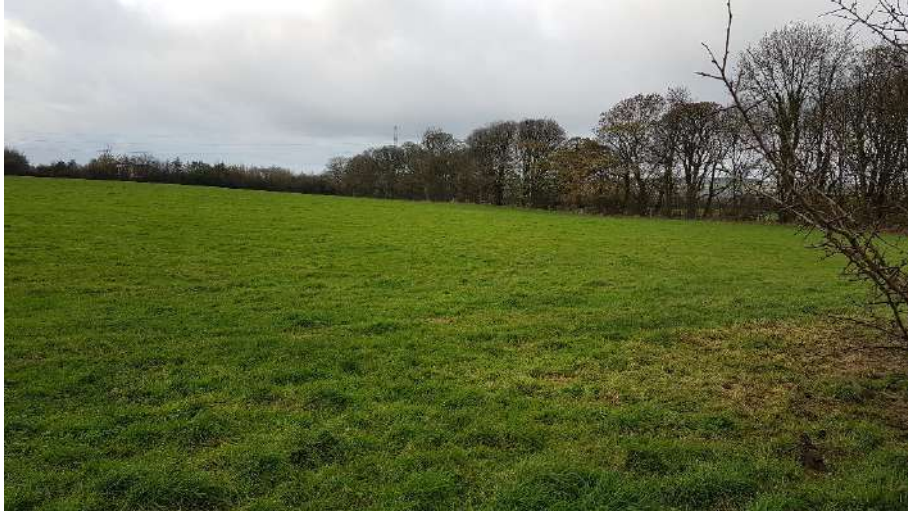
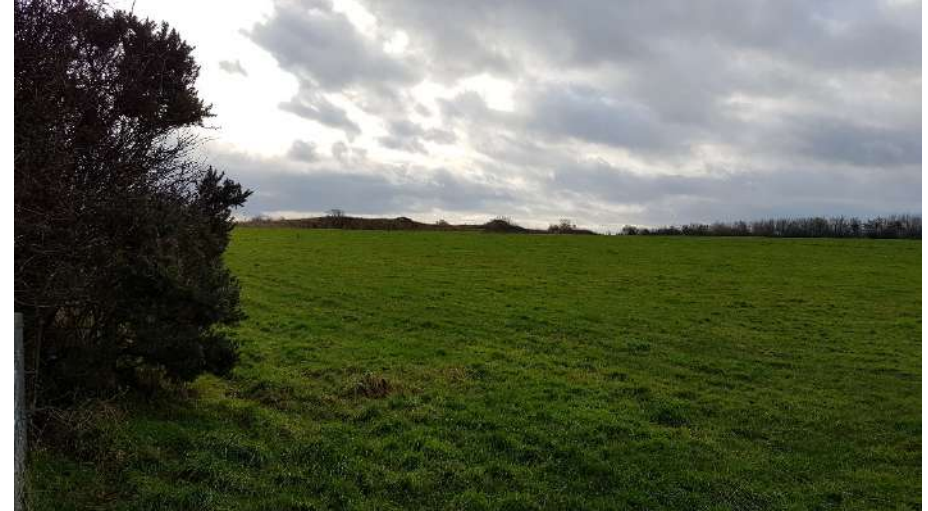
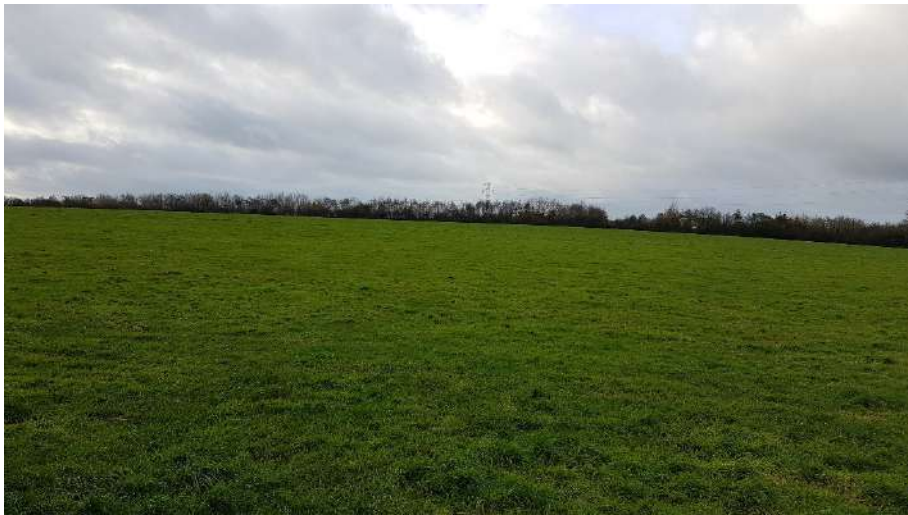
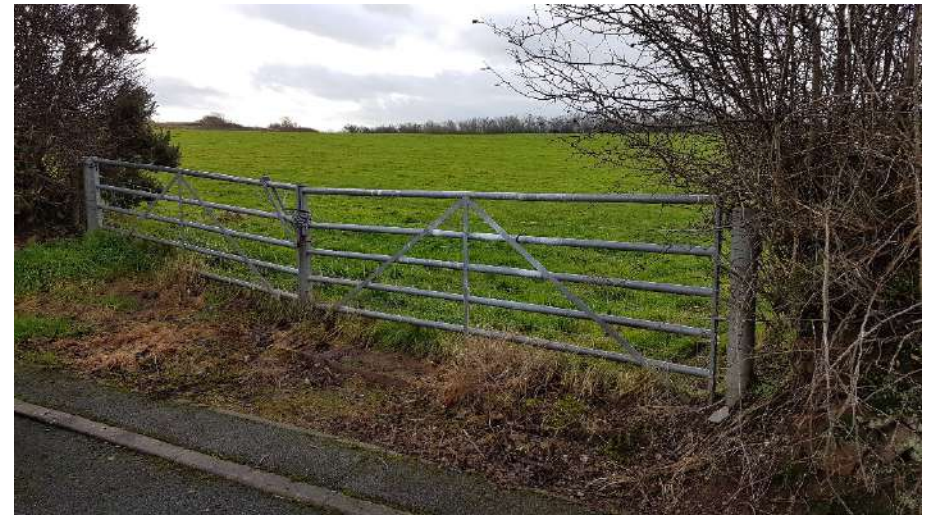
**GEO2018-3441: Summergrove, Whitehaven – Site Photographs (November 2018)**

However, an inspection of the utility plans obtained in preparation for the ground investigation works indicates that there are no mains utilities on site. No evidence of buried utilities was noted during the site walkover.
