Former Station Yard, Moor Row Proposed Residential Development Access Arrangements

Stage 1 Road Safety Audit

| REPORT CONTROL | | | | |
|---|--|---|--|--|
| Report Number | NS22/788/RSA1 | | | |

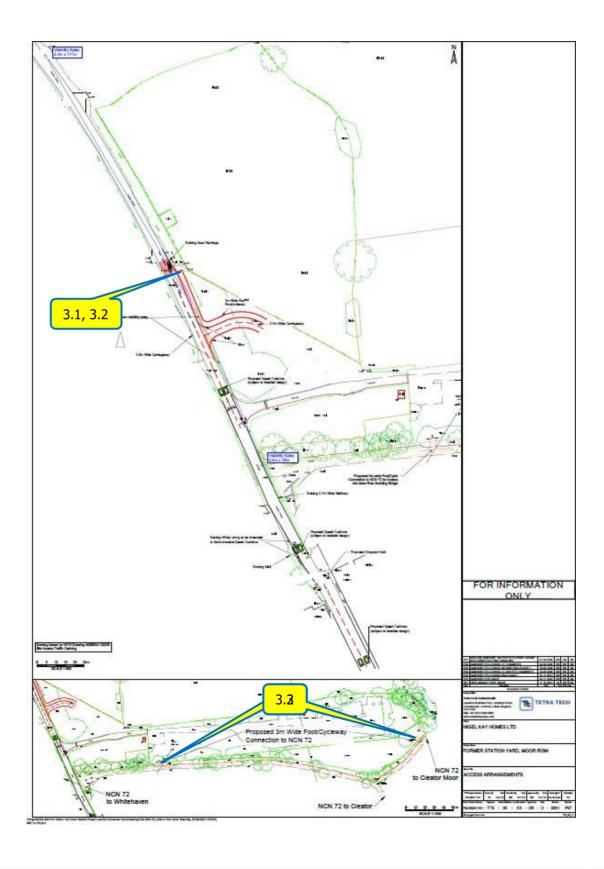
### 6. LOCATION PLAN OF ITEMS RAISED BY THIS AUDIT

Location: The northern end of the proposed footway/cycleway between the development and the speed limit boundary.

Summary: The absence of dropped kerbs could lead to pedestrians tripping and falling.

At this stage, dropped kerbs are not present on the northern end of the footway/cycleway. Providing dropped kerbs could reduce the risks both of physically impaired pedestrians tripping and of wheelchair users being stranded or of overturning.

3.2 Location: The proposed footway/cycleway between the development and the speed limit boundary.

Summary: The absence of traffic signs could result in conflicts between cyclists and pedestrians.

Appropriate shared facility signing will help to inform pedestrians of the likelihood of encountering cyclists and reduce the risk of collisions. Direction signs could also be provided to help to guide pedestrians and cyclists through the development to access NCN 72 and reduce the risk of conflicts with vehicles on the bridge to the south.

Location: The accesses to NCN 72 from the development.

Summary: The absence of warning signs could increase the risk of collisions.

At this stage, there are no signs specified to inform users leaving the development of the presence of NCN 72 and of the likelihood of encountering cyclists. Providing signs could reduce the risk of collisions involving cyclists on NCN 72.

It is recommended that dropped kerbs are specified for the northern end of the footway/cycleway on Dalzell Street.

It is recommended that the entry point to the footway/cycleway is signed for to indicate its use by both pedestrians and cyclists (Diagram 956 if the facility is unsegregated). In addition, the opportunity could be taken to provide signs guiding users towards NCN 72.

It is recommended that appropriate signs are specified as the detailed design progresses.
