Road Safety Audit – Stage 1 & 2 combined

Proposed Housing Development, Crossings Close, Cleator Moor

Ref: K39555.RSAS2/001b

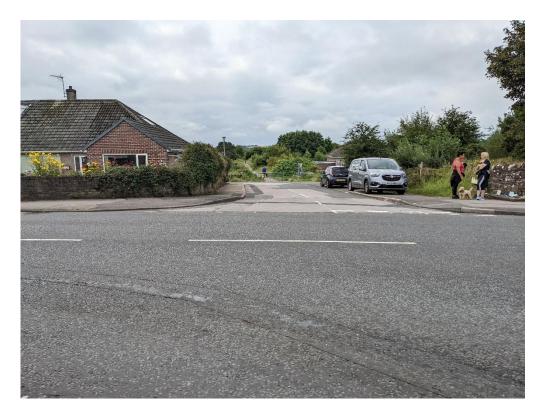
Photo 1 - View from Whitehaven Road into Crossings Close

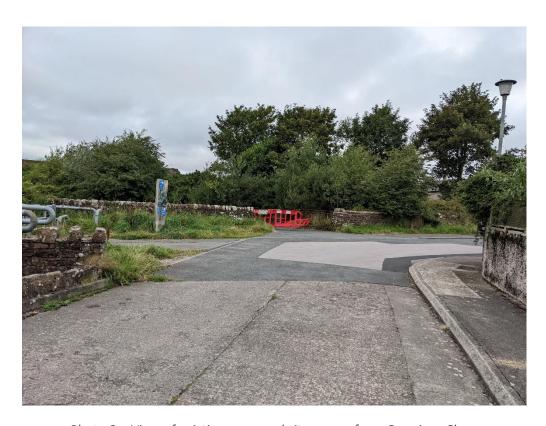
The access to the site is a 4.8m private lane, adjoining Crossings Close. There is a pedestrian route indicated from the lane onto an existing verge area on Crossings Close. This verge provides a link to the footways onto Whitehaven Road, however, as witnessed on site, this area is used for parking, and is often blocked, which could force pedestrians onto the carriageway.

Photo 2 – View of existing proposed site access from Crossings Close

It is recommended that consideration be given to blocking the verge off to motorised vehicles, or an additional crossing point considered to the footway opposite.

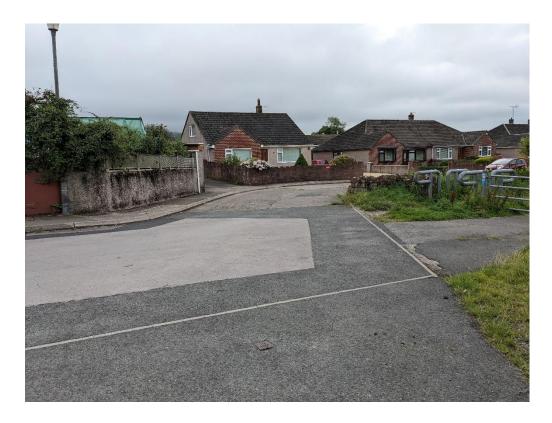
Photo 3 – Visibility east out of proposed development

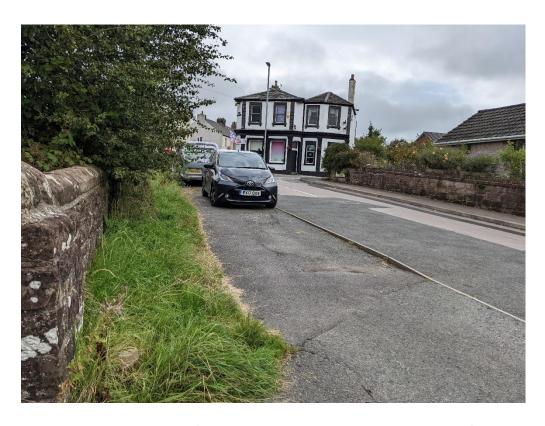
Immediately north of the proposed access from the site onto crossings close, there is an existing paved verge with dropped kerbs, within which vehicles currently park, as noted in Item 1. The current proposals have this area remaining as is, and as such the junction visibility will be impaired.

Photo 4 – Visibility north out of proposed access, showing paved verge used for parking

It is recommended that consideration be given to blocking the verge off to motorised vehicles.
