Summary Information Report

To Support the Demolition of the Calder Engineering Workshop (CEW) Complex

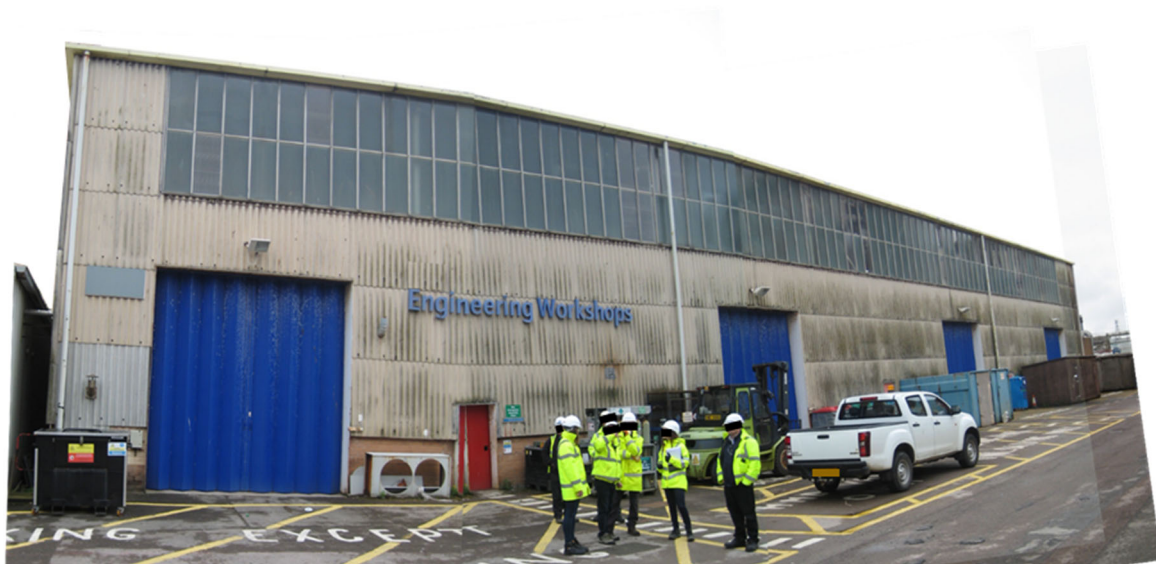
The building is located to the east of the River Calder, and adjacent to the northern end of the Calder Fabrication Workshop (CFW). The CEW building was built circa 1960 and consists of a Workshop and a two-storey Annexe along the West Side. In addition to this, a single storey structure to the North of the CEW known as the Armature Cleaning Building (ACB) was also constructed. In 1969, a single storey 'L' shaped extension was built at the North End of the CEW linking it directly to the ACB.

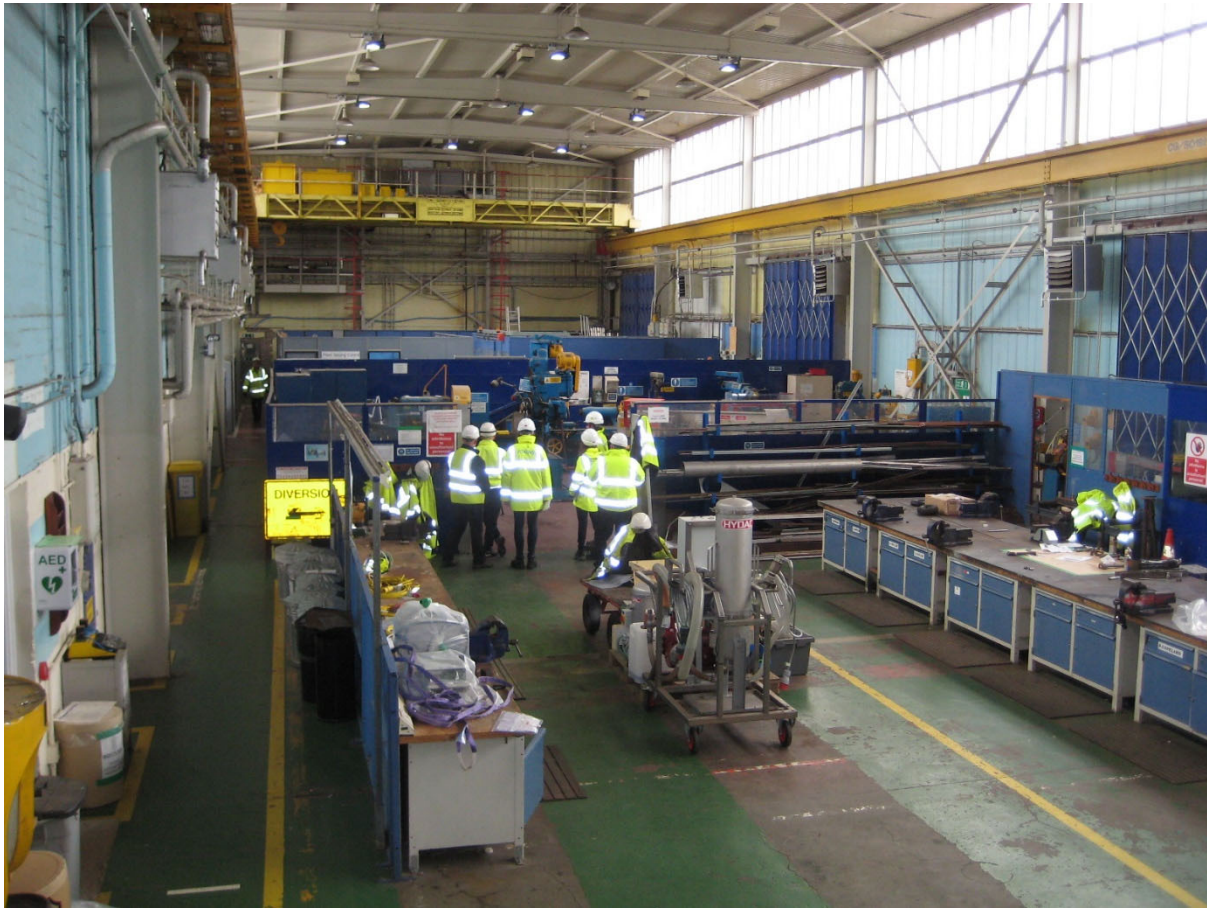
Calder Engineering Workshop internal view 2019

This is a steel framed single-storey structure. It has a duo pitched roof and is 54.5m long x 15.8m wide x 9.5m to the apex. The steel columns at 25'0" (7.62m) centres are supported on concrete pad foundations approximately 750mm below ground level.

The ground floor consists of a 225mm thick reinforced concrete ground bearing slab. There are cable and service trenches formed in the ground floor slab that are either covered with pre-cast concrete units or durbar plate. A 12 tonne overhead crane services the entire

workshop area, supported on rails attached to the main steel frame columns. There is patent glazing to the East and West elevations above EOT crane level up to Eaves level. There are 4no. sliding folding doors in the East Elevation 4.6m high x 4.25m wide.

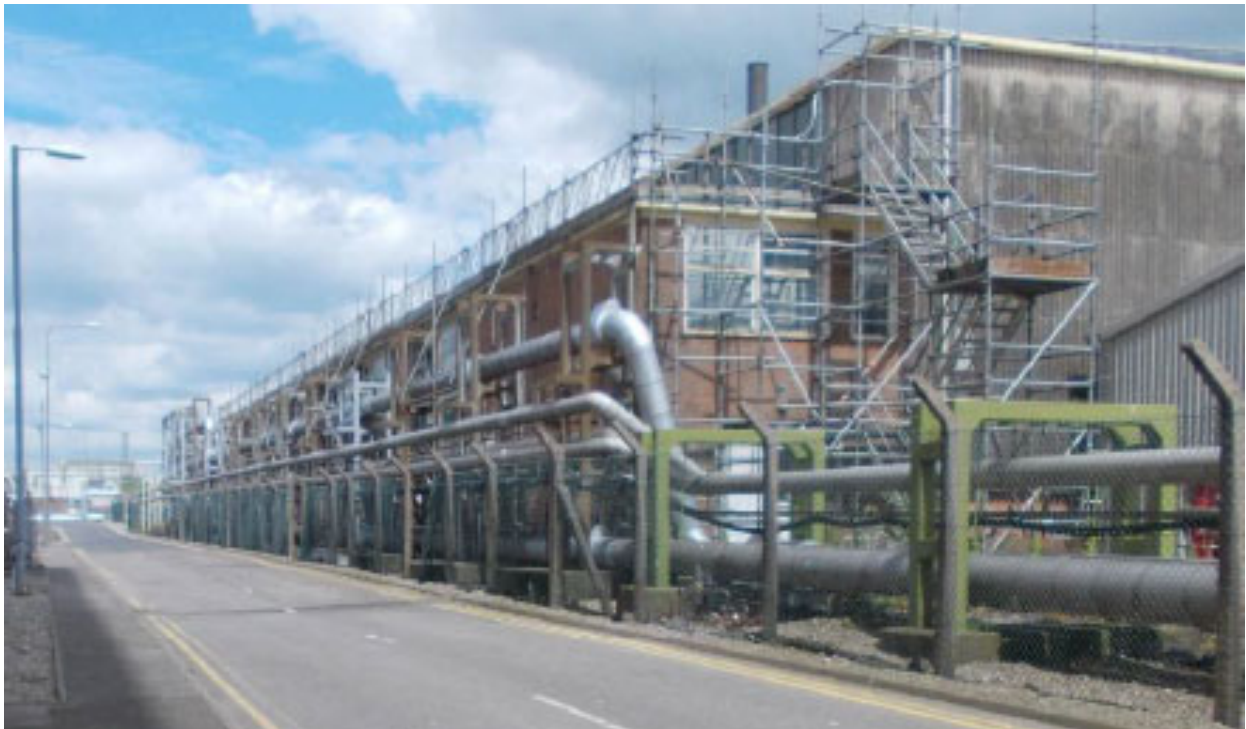
CEW Two Storey Annexe External View 2017

This is a two-storey building that runs the along the full West elevation of the workshop structure and houses offices, toilets and mess rooms. It is 54.5m long x 5.5m wide x 6m high over two floors. The flat roof and 1st floor level are formed from pre-cast concrete floor units supported on steel beams at approx. 5.6m centres spanning in the East/West direction. These steel beams are supported on the West Elevation by 16" x 12" (410mm x 300mm) load bearing masonry piers and of the other side on a 9" (225mm) load bearing internal party wall between the Workshop and the Annexe. The wall on this side extends full height of the Annexe and runs along the outside face of the Workshop columns.

On the West face there are full height masonry cavity walls to the Northern and Southern end bays acting as shear walls, the internal bays to the West elevation consist of dado masonry internal walls with colour glaze asbestos panels on the exterior. This wall construction is found at ground and first floor with patent glazing above to underside first floor and roof respectively. There are a series of single skin internal masonry shear walls

running East/West along the building at each level. Full height masonry cavity walls are found in the two external end bays.
