**Survey for Bats, Barn Owls & Breeding Birds,
Newtown Cottage, Sandwith, Whitehaven, Cumbria, CA28 9UP.
Supplementary Report following original report in December 2019**

**Report by
Steve Wake
Member of the Cumberland Bat Group
70 Scotby Road, Scotby, Carlisle, Cumbria, CA4 8BD
Natural England Licence No.2019-42366**

**Report commissioned by:
Mike Dawson of Day Cummins Architects on behalf of
Mrs J Taylor & Mrs L Telfer**

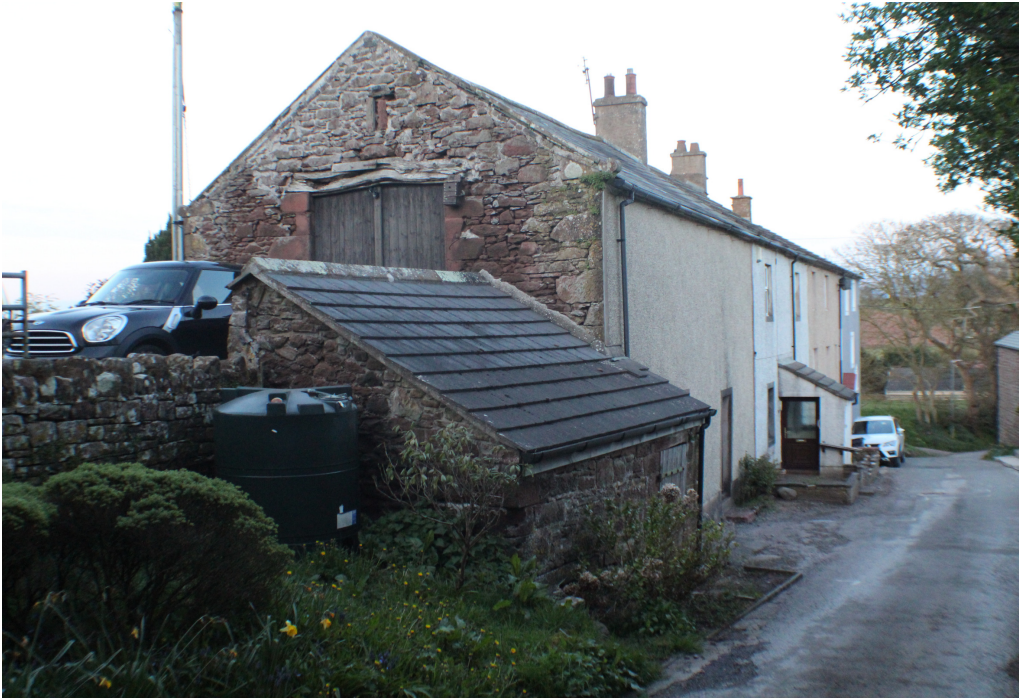
Property viewed from the west

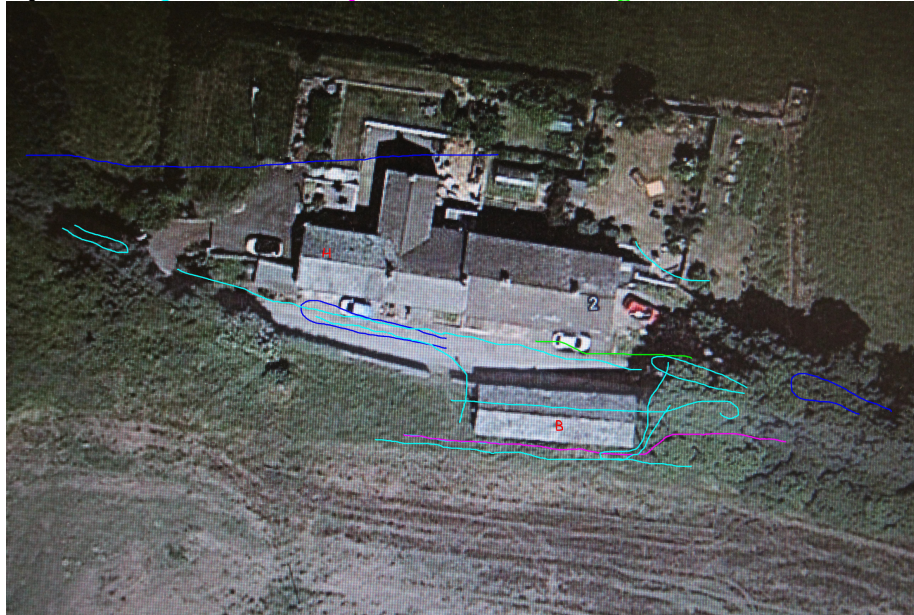
Bat Activity Survey H House. B Barn

On 25th April 2023. Pipistrelle---

On 9th May 2019. Pipistrelle---. Myotis---. Brown Long Eared---

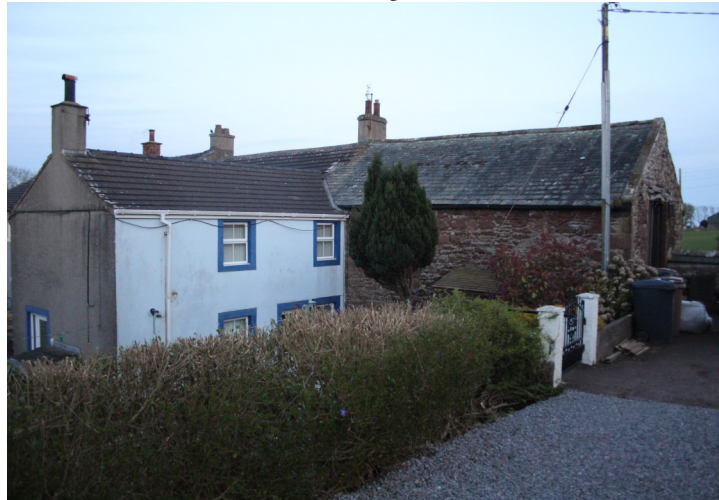
View of cottage from the north west

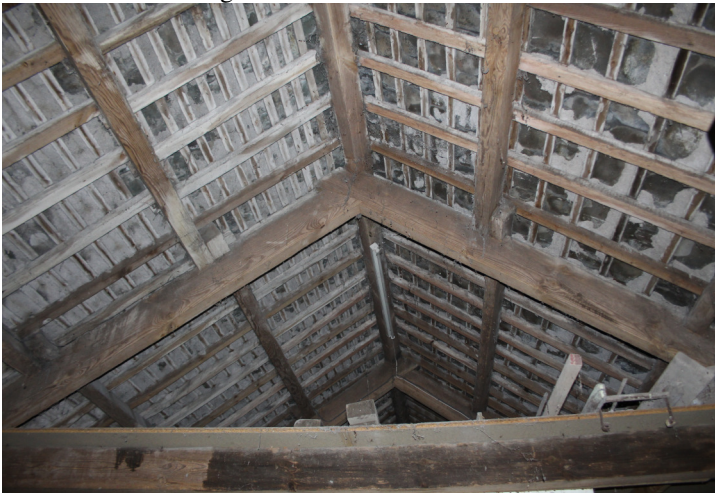
Interior roof of cottage

Existing bat access routes to the any cavities of walls and eaves top voids should be retained, with sloped pointed mortar tubes, they can provide roost access for crevice roosting bat species.

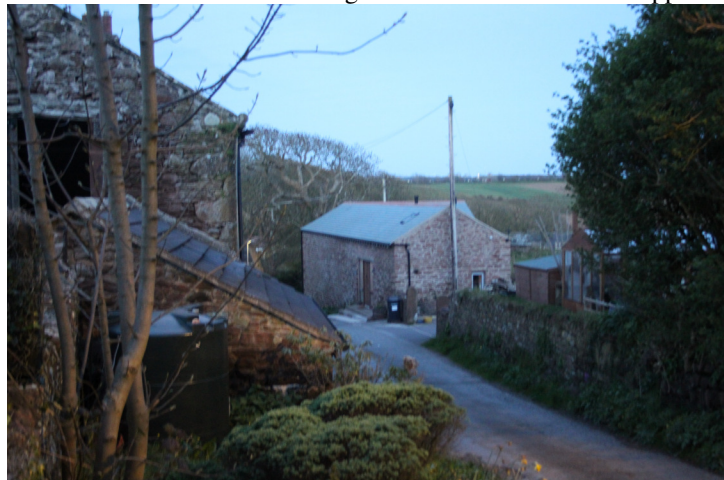
There is no evidence to suggest the habitat around the building has suffered any serious change since the building survey in 2019 although the barn opposite has now been converted.

View east along road with converted barn opposite
