GROUND INVESTIGATION REPORT

(GROUND GAS RISK ASSESSMENT)

**PROPOSED RESIDENTIAL DEVELOPMENT OF
LAND THE FORMER FISH FACTORY, HENSINGHAM**

Report Ref: 2018-3413

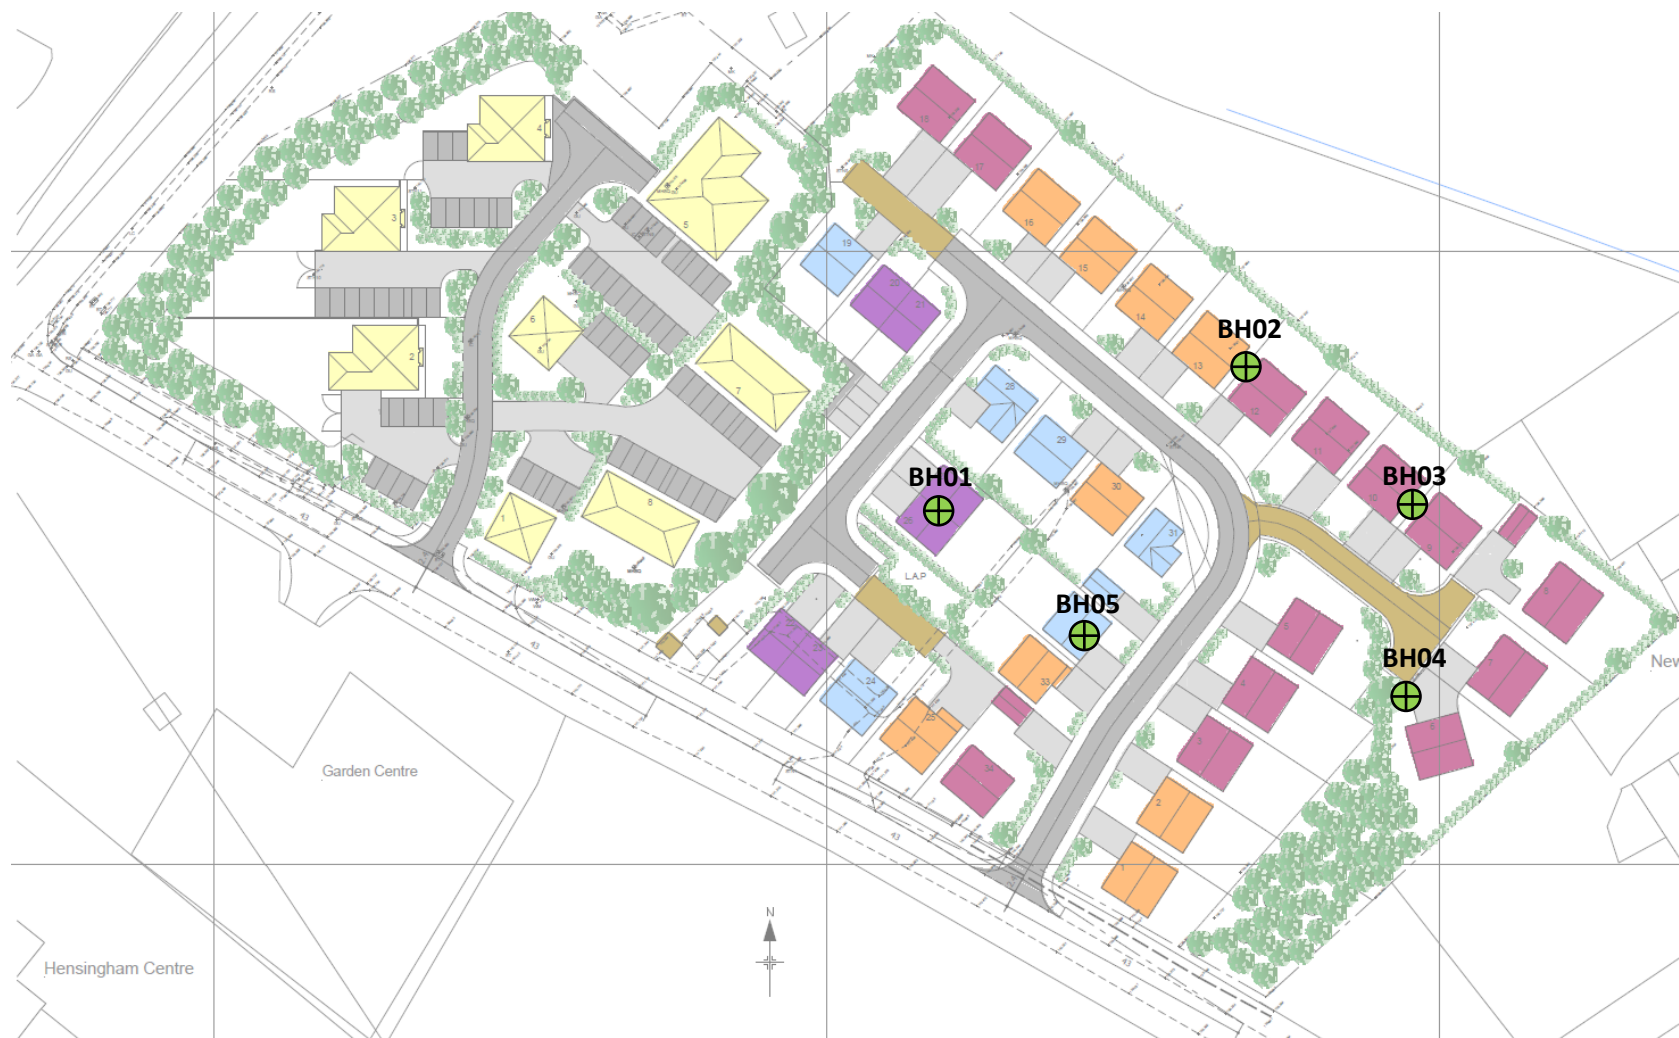
GEO2018-3413: Former Fish Factory, Whitehaven, Cumbria – Exploratory Hole Location Plan

The ground investigation works were completed on the 8th November 2018. The boreholes were located across the site to provide general site coverage taking cognisance of buried utilities, site topography, mounds of materials and locations of the proposed residential units. The exploratory hole location plan is provided in Appendix I.

- 5 No. Dynamic Sampling Boreholes (BH01 to BH05) to depths of between c.0.95m and c.2.70m bgl.
- Site supervision by a suitably qualified and experienced Geo-Environmental Engineer.
- Gas and groundwater monitoring (6 visits completed to date).
