Plot 9
Rheda Park
Frizington

Pre-development Arboricultural Report

Treescapes Consultancy Ltd.

Reference No. EJC/119-2022

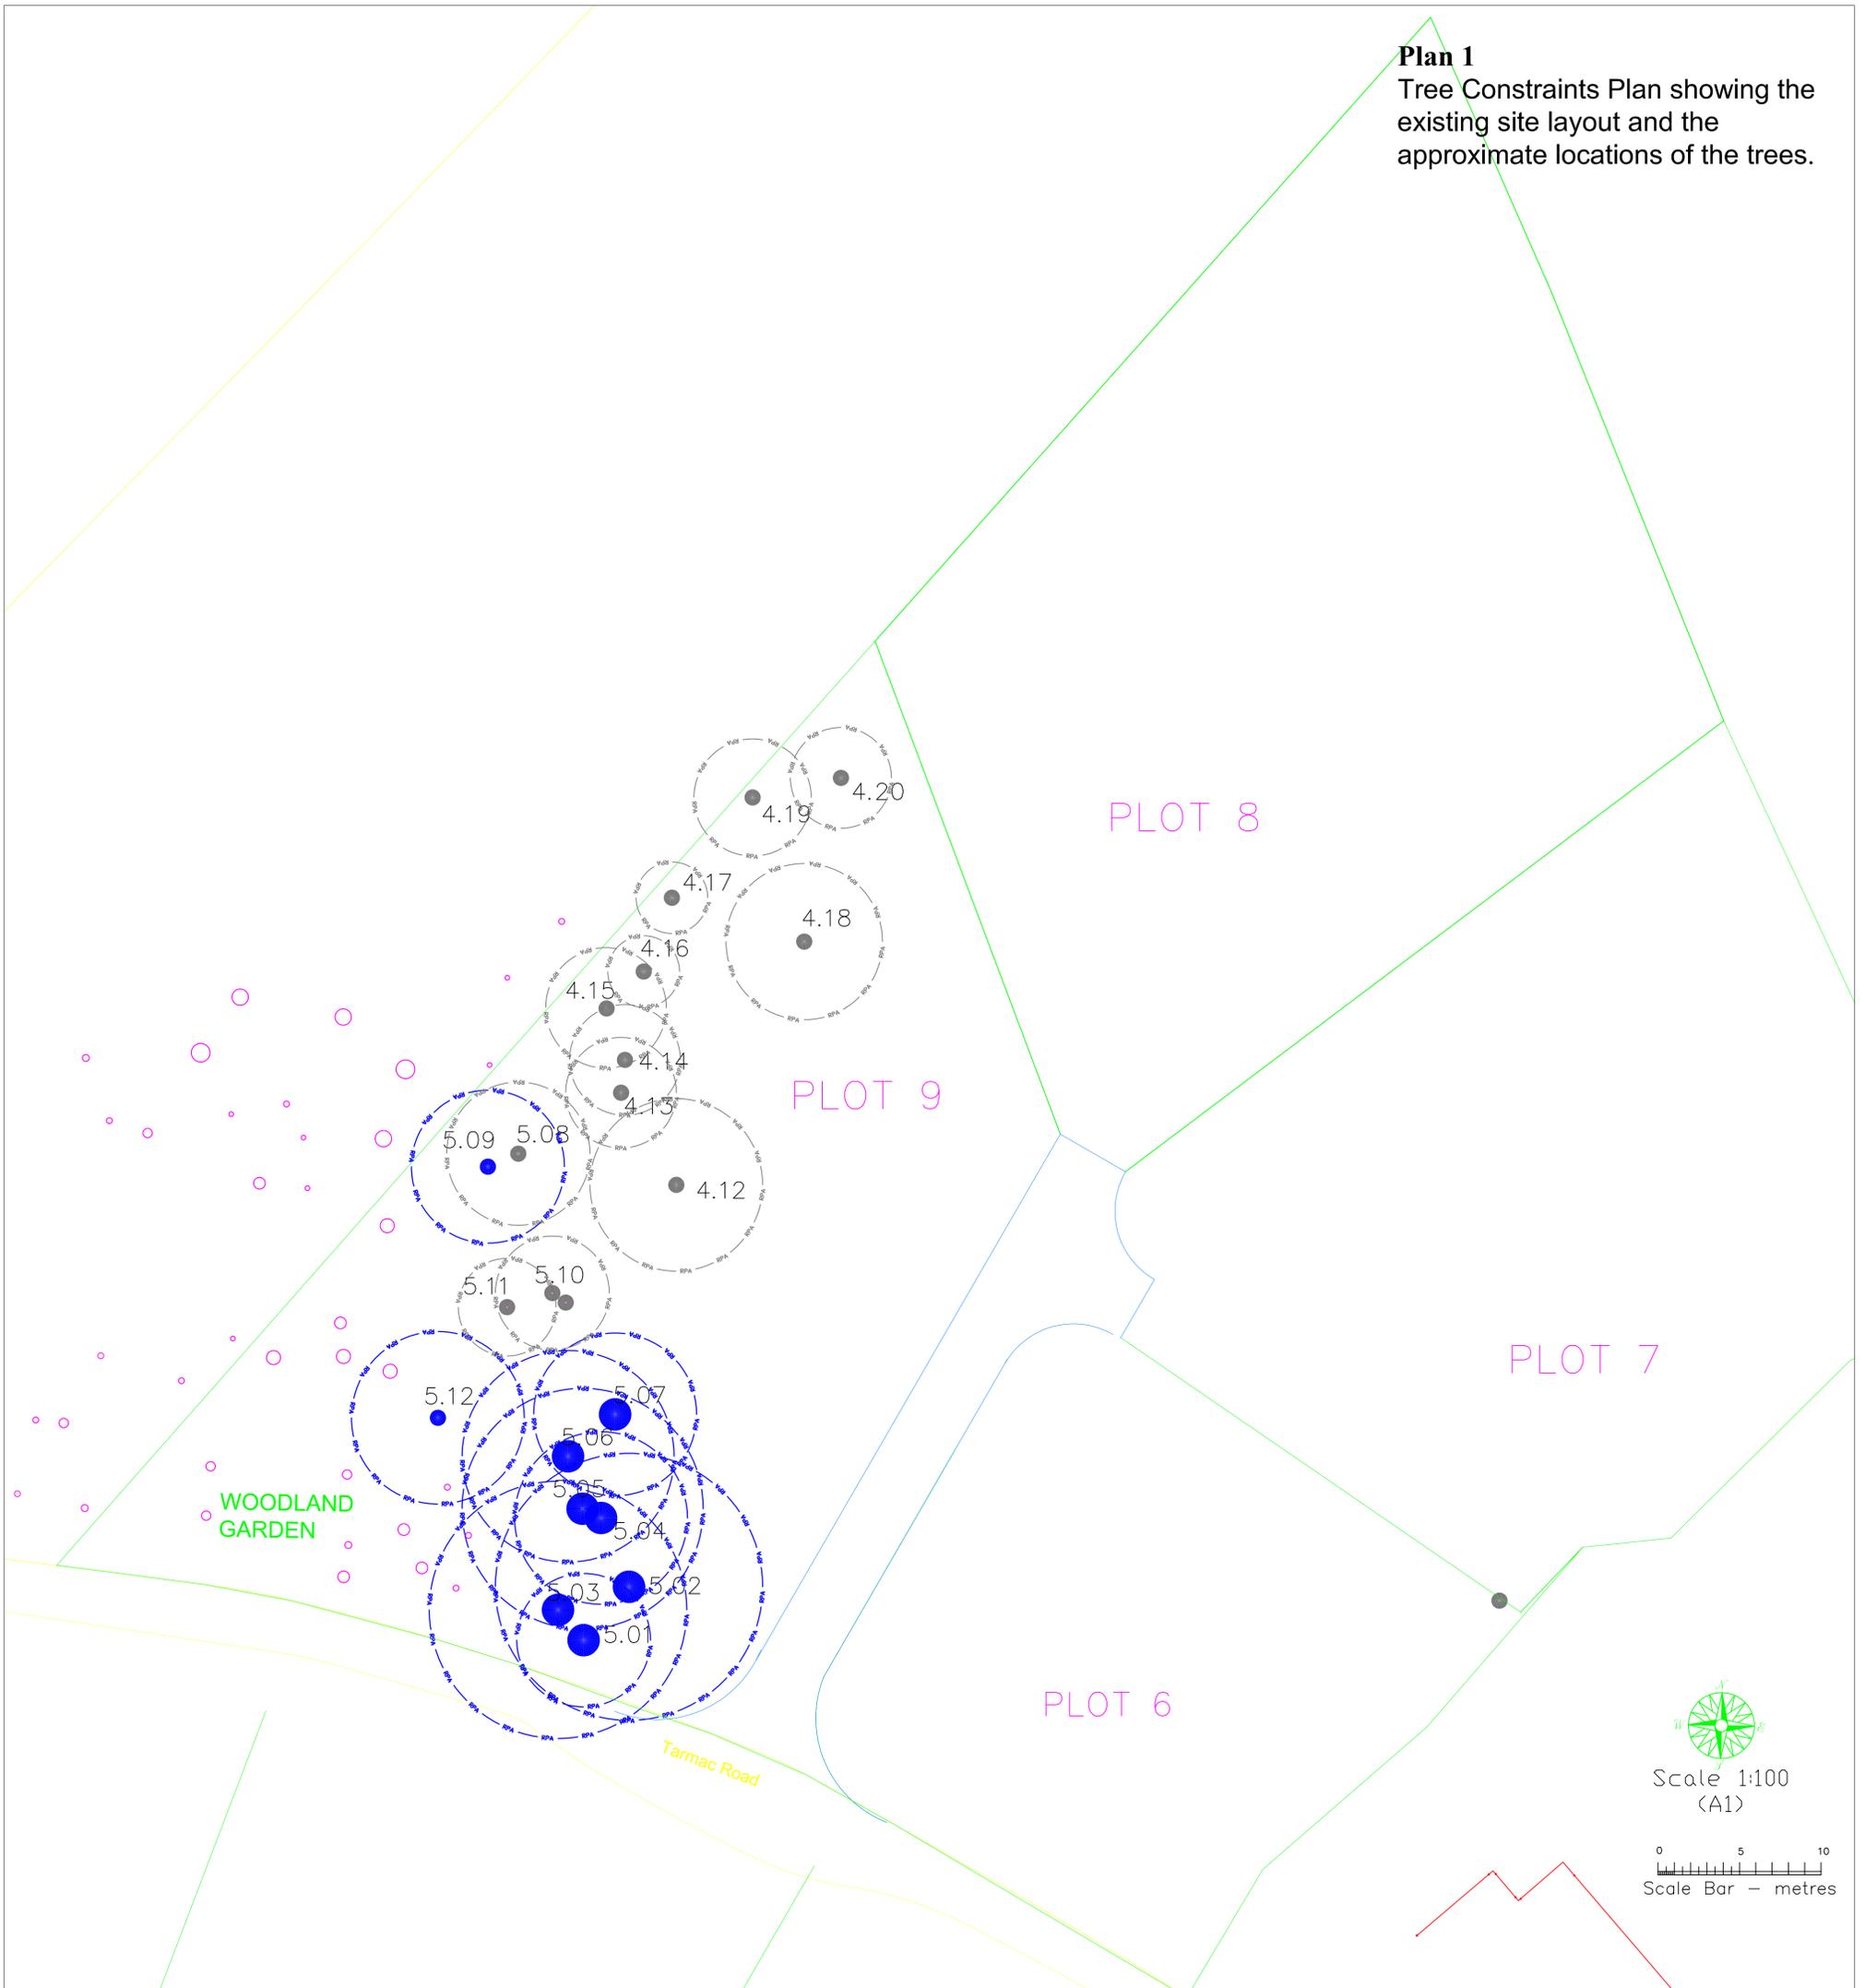
Rheda Park, Plot 9

The species, size and condition of the trees, and my management recommendations, are listed in the schedule included as Appendix 5. Plans 1 and 2 show the existing and proposed site layouts, the locations of the trees, their canopies and Root Protection Areas (RPAs) calculated using the guidance contained in the British Standard: Trees in relation to design, demolition and construction – Recommendations (BS 5837, 2012). I assessed trees 5.01, 5.02, 5.03, 5.04, 5.05, 5.06, 5.07, 5.09, and 5.12 to be in retention Category B and the rest to be in C.

Plan 1
Tree Constraints Plan showing the existing site layout and the approximate locations of the trees.

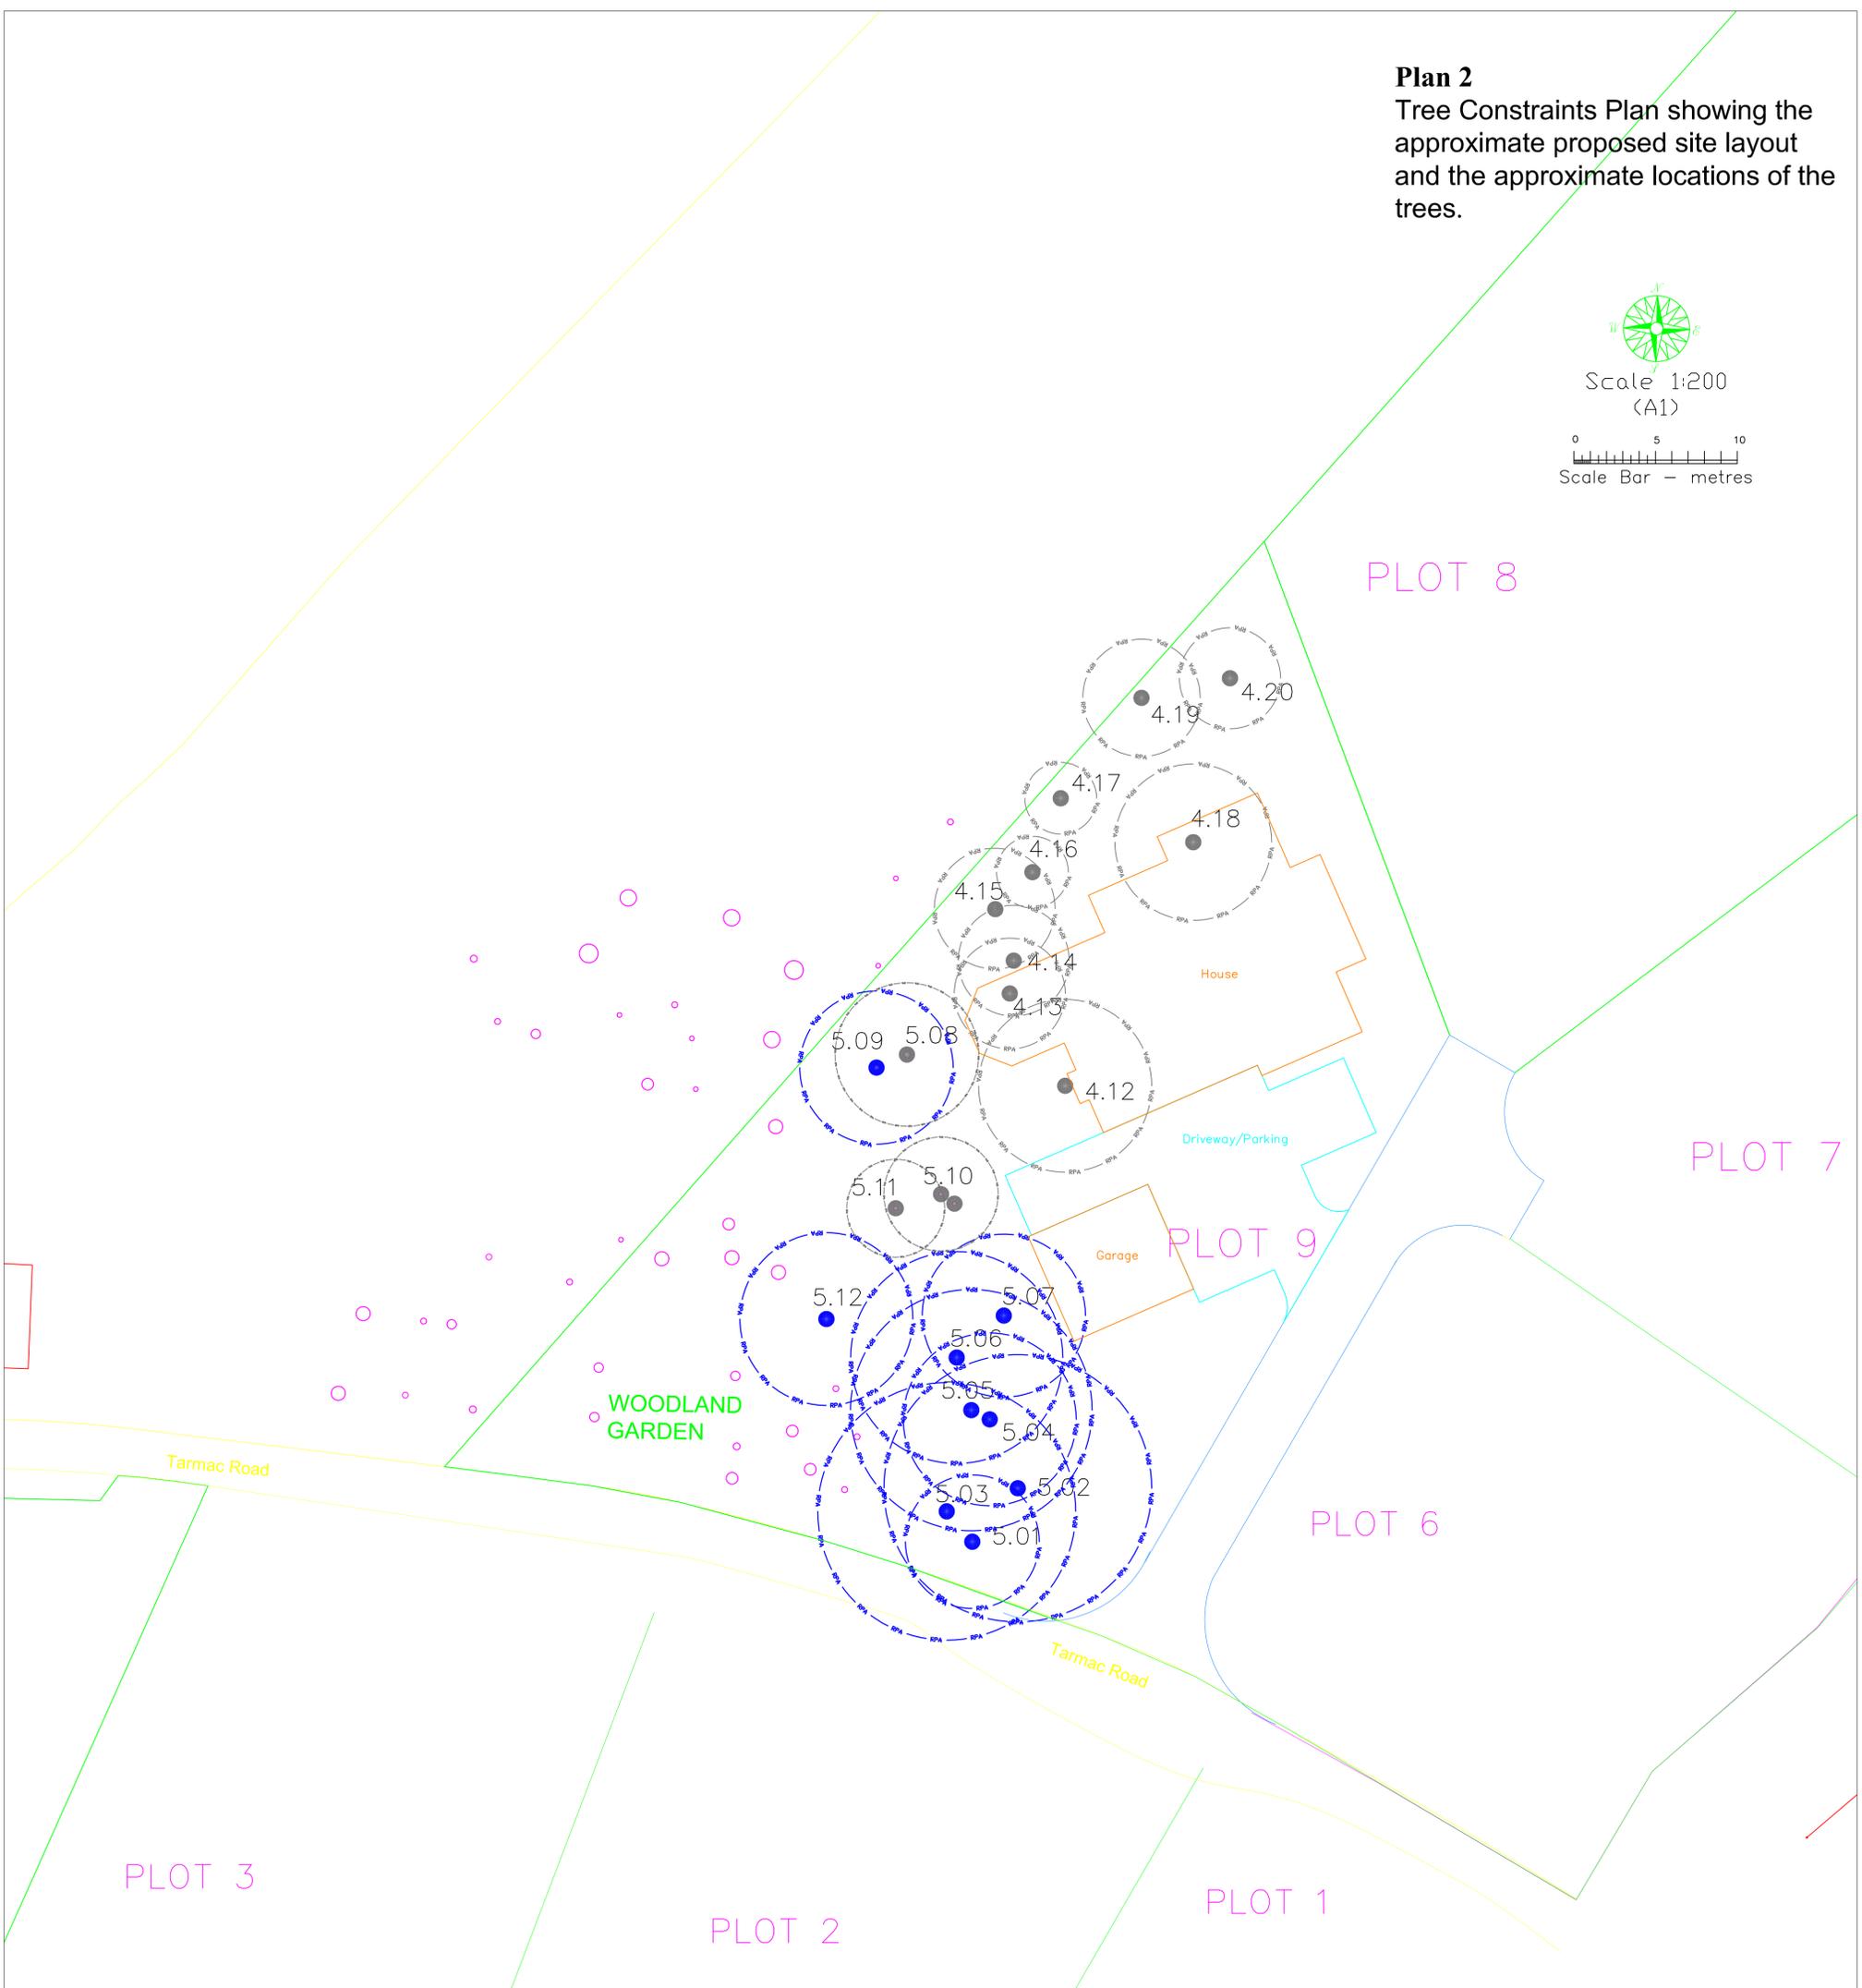
Plan 2 shows that four trees – 4.12, 4.13, 4.14, and 4.18 – are growing within, or very close to, the footprint of the proposed house. It also indicates the development will encroach into the RPA of two other trees, 5.07 and 5.08, and that the RPAs of seven other trees are within two metres. Table 1 lists the trees that could be affected by the proposed development.

Tree Constraints Plan showing the approximate proposed site layout and the approximate locations of the trees.

I recommend that trees 4.12, 4.13, 4.14, 4.15, 4.16, 4.18, 5.07, 5.08, 5.10, and 5.11 should be felled to allow the proposals to be implemented.

I also recommend that tree 5.09 be felled at the same time as those other trees being removed. Though not necessarily to enable the development this potentially very large tree will be relatively close to the proposed house.

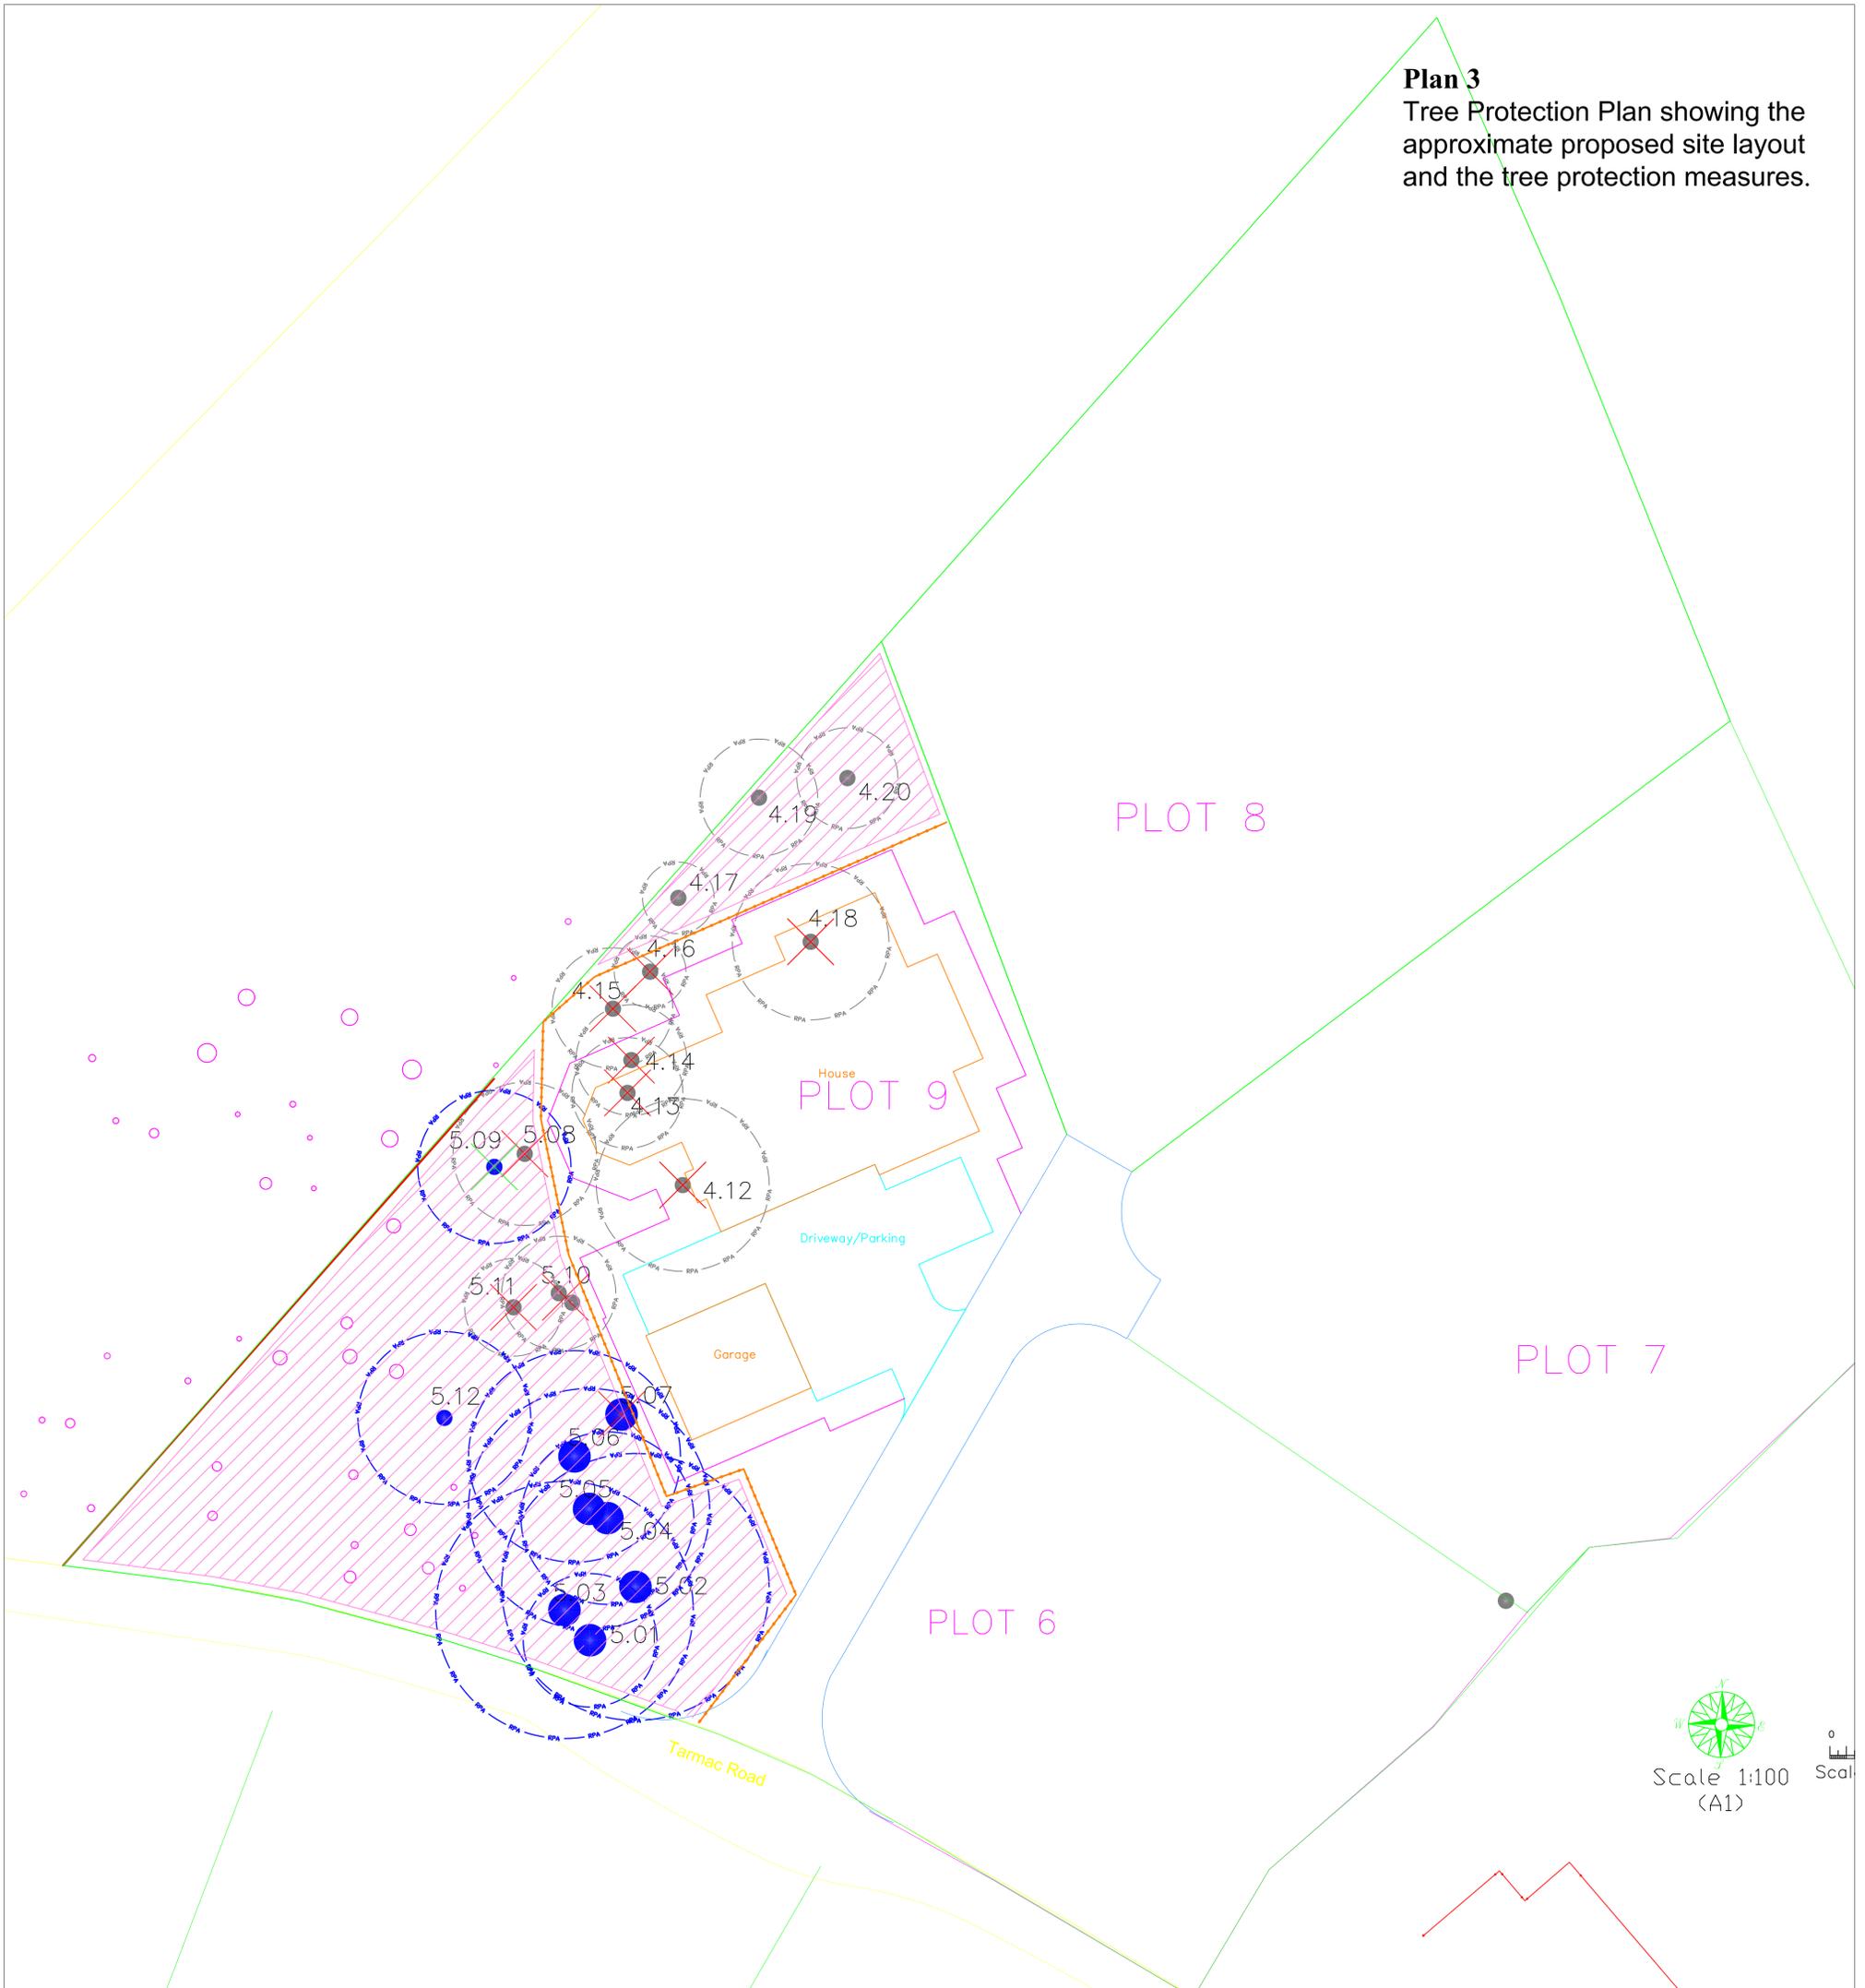
Rheda Park, Plot 9

Plan 3 is a tree protection plan that shows suggested locations of tree protection barriers. The protective measures should be installed prior to any other development activity taking place and remain in place for the duration of the construction phase.

Plan 3
Tree Protection Plan showing the approximate proposed site layout and the tree protection measures.

Temporary tree protection barriers should be erected outside the RPAs and canopies of retained trees unless the trees and soil within their RPAs can be protected by other means. Plan 3 is a Tree Protection Plan that shows suggested locations of temporary tree protection barriers. These barriers must be robust enough to withstand impacts from machinery and plant that will operate close to them. If relatively small plant is to be used, I recommend that the barriers should be constructed using:

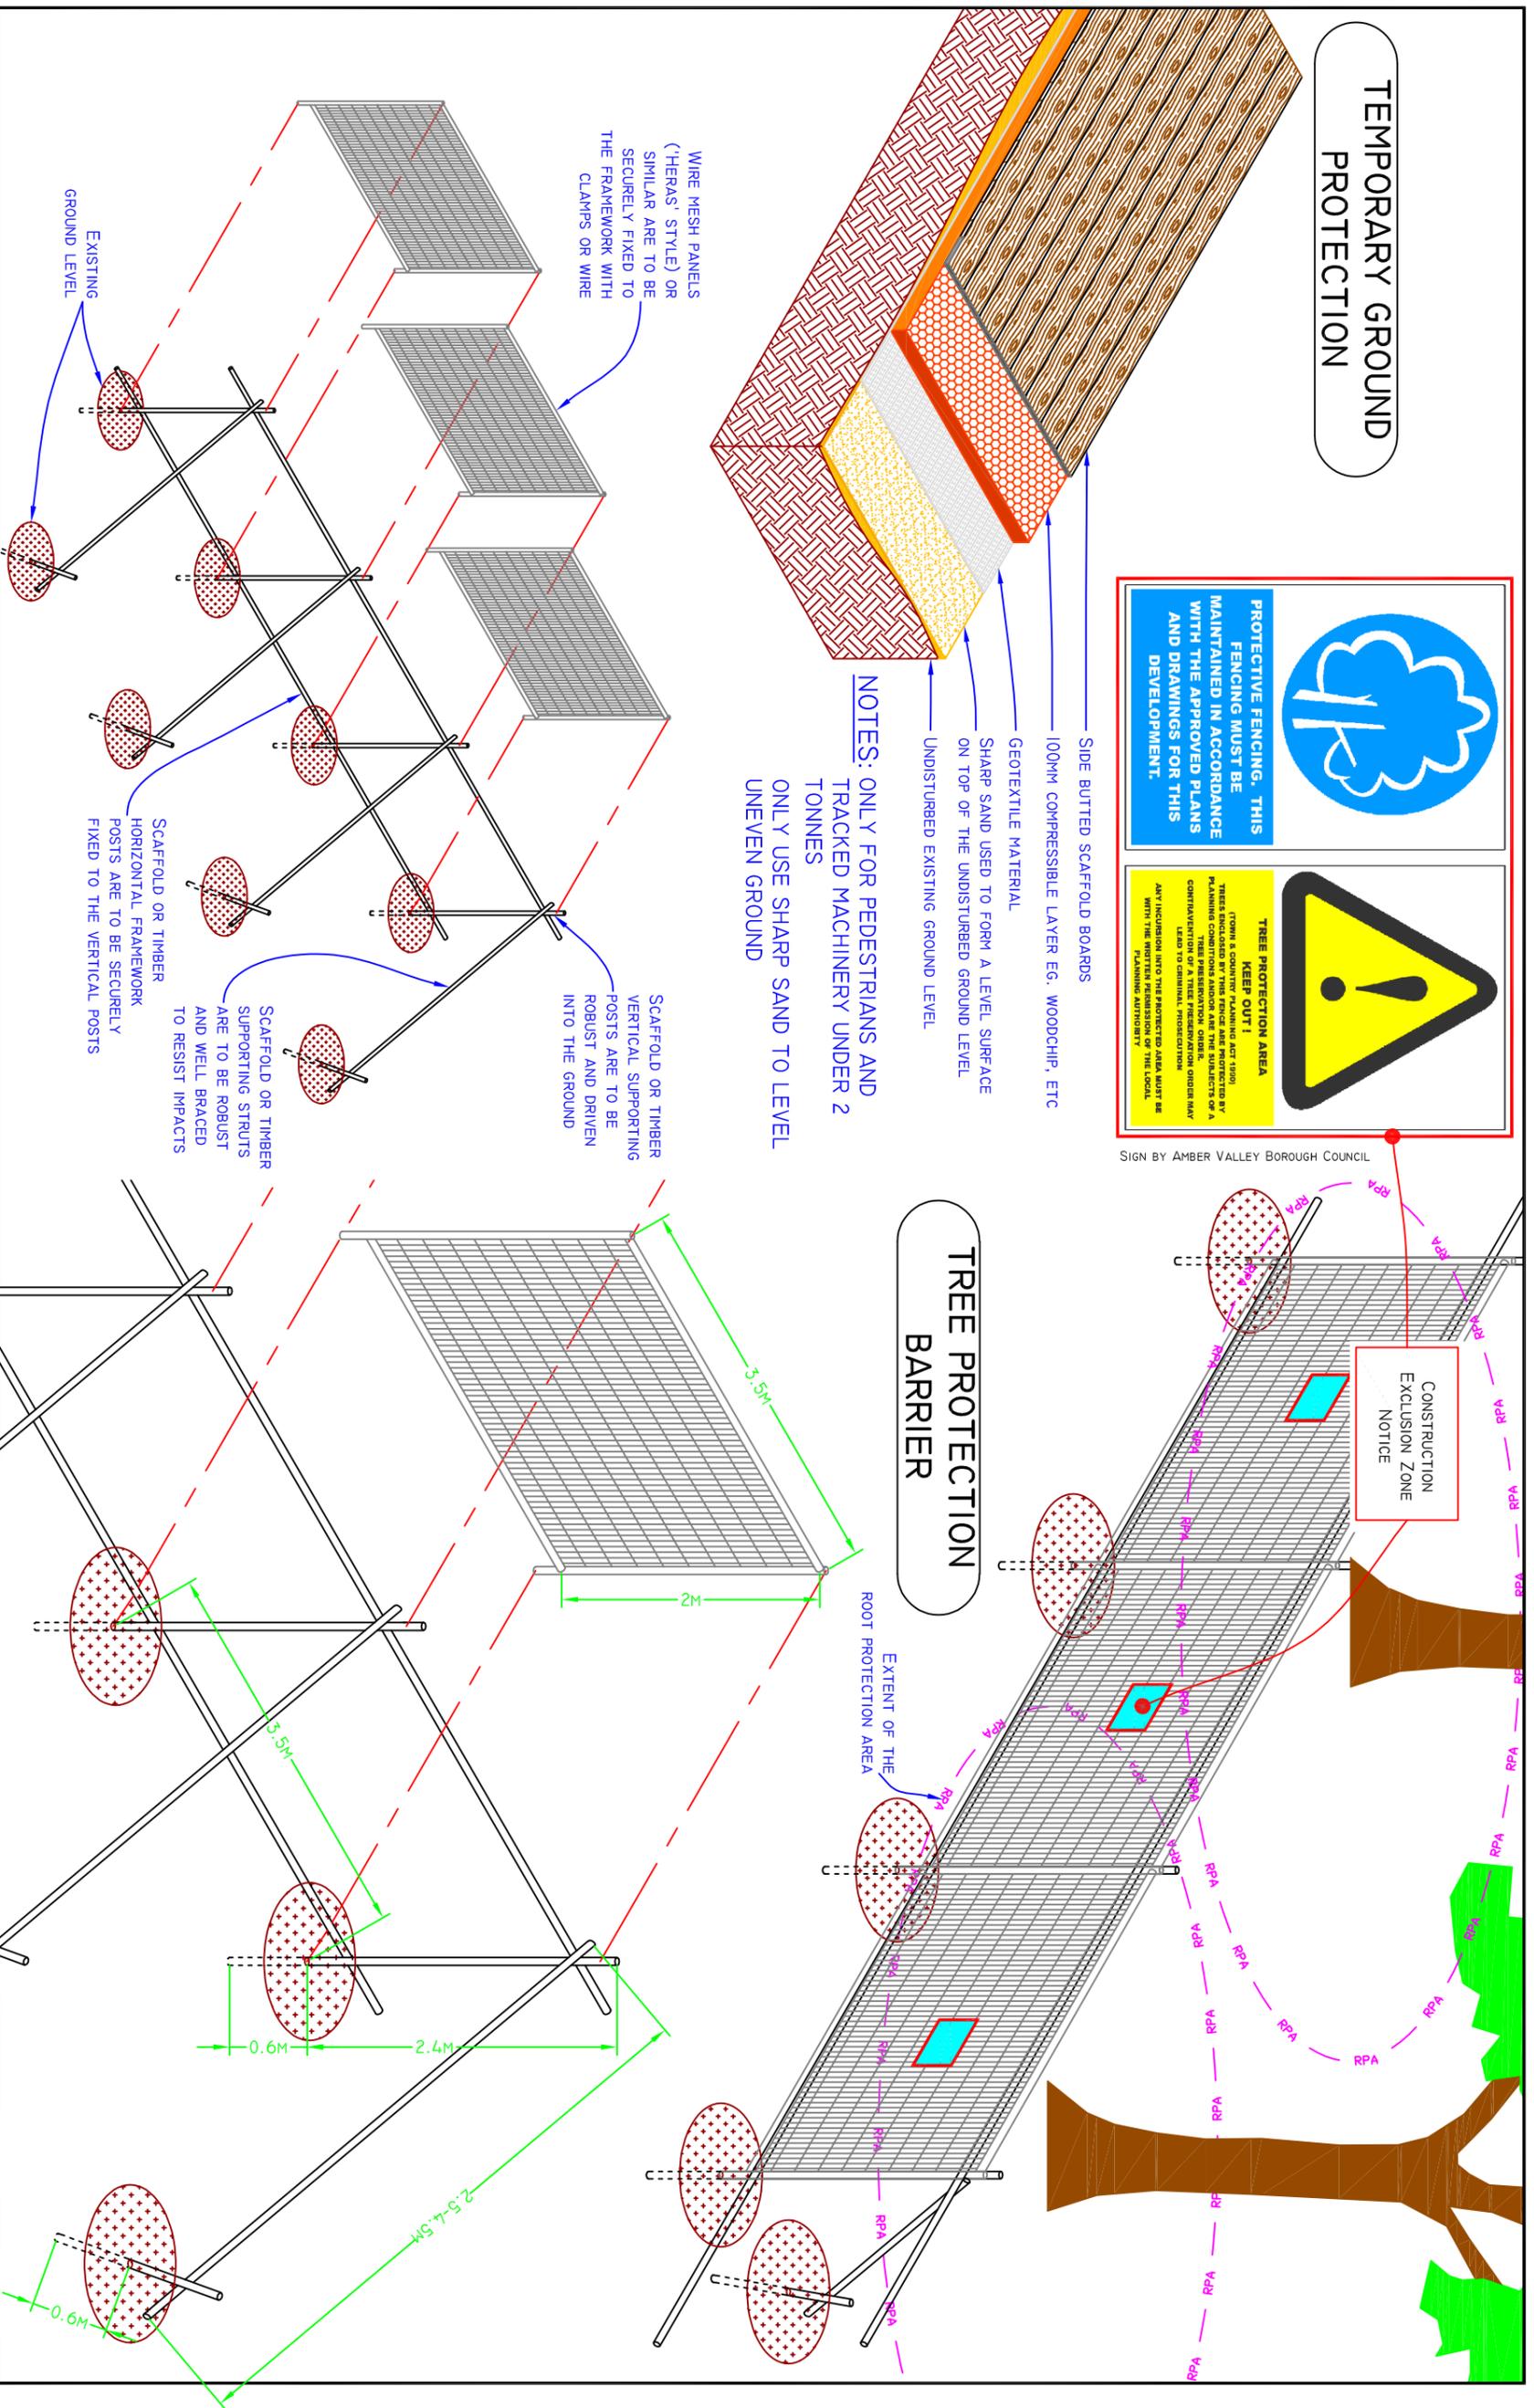
Appendix 7

British Standard: BS 5837 *Trees In Relation To Design, Demolition and Construction – Recommendations* (2012): a: Tree Protection Barrier

If large machines will operate on the site, I recommend the barrier design depicted in BS 5837 (2012) and reproduced in Appendix 7.

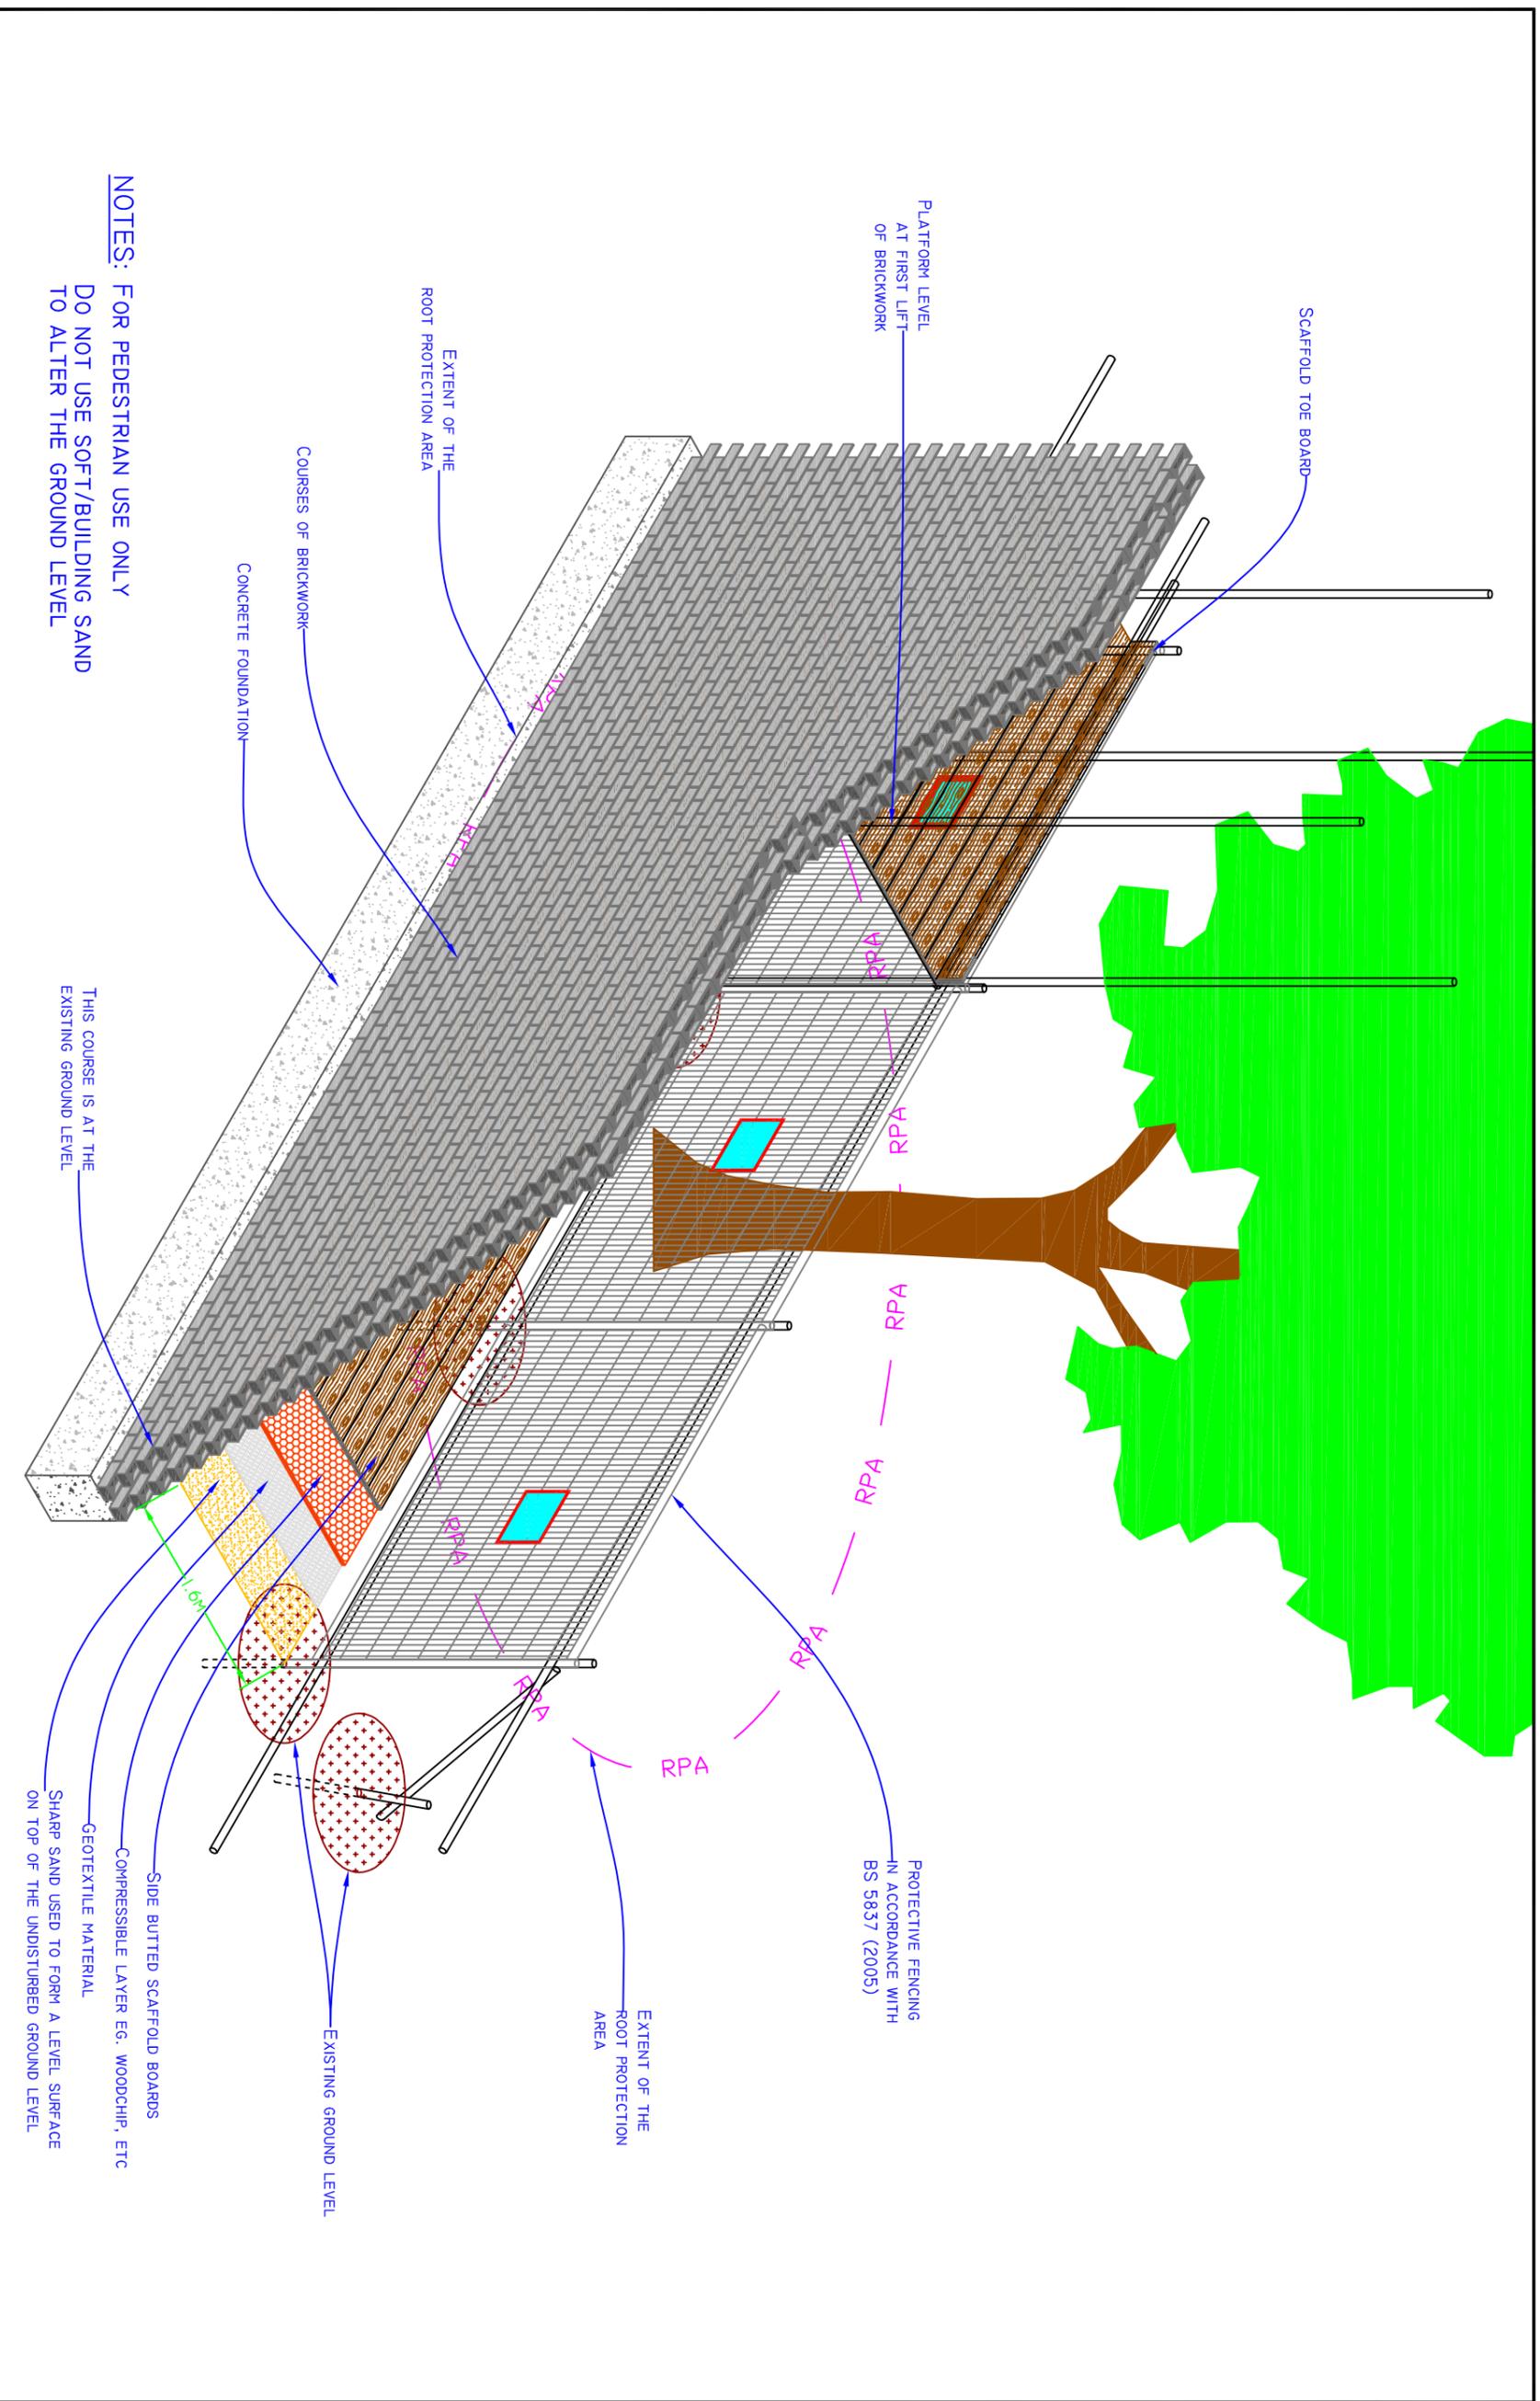
British Standard: BS 5837 Trees In Relation To Construction – Recommendations (2005): Scaffolding Construction Area

NOTES: FOR PEDESTRIAN USE ONLY
DO NOT USE SOFT/BUILDING SAND TO ALTER THE GROUND LEVEL
