Lamplugh

### Description of proposed works

Ref: VO-TPO-Lamplugh-Sycamore-Sketch-plan

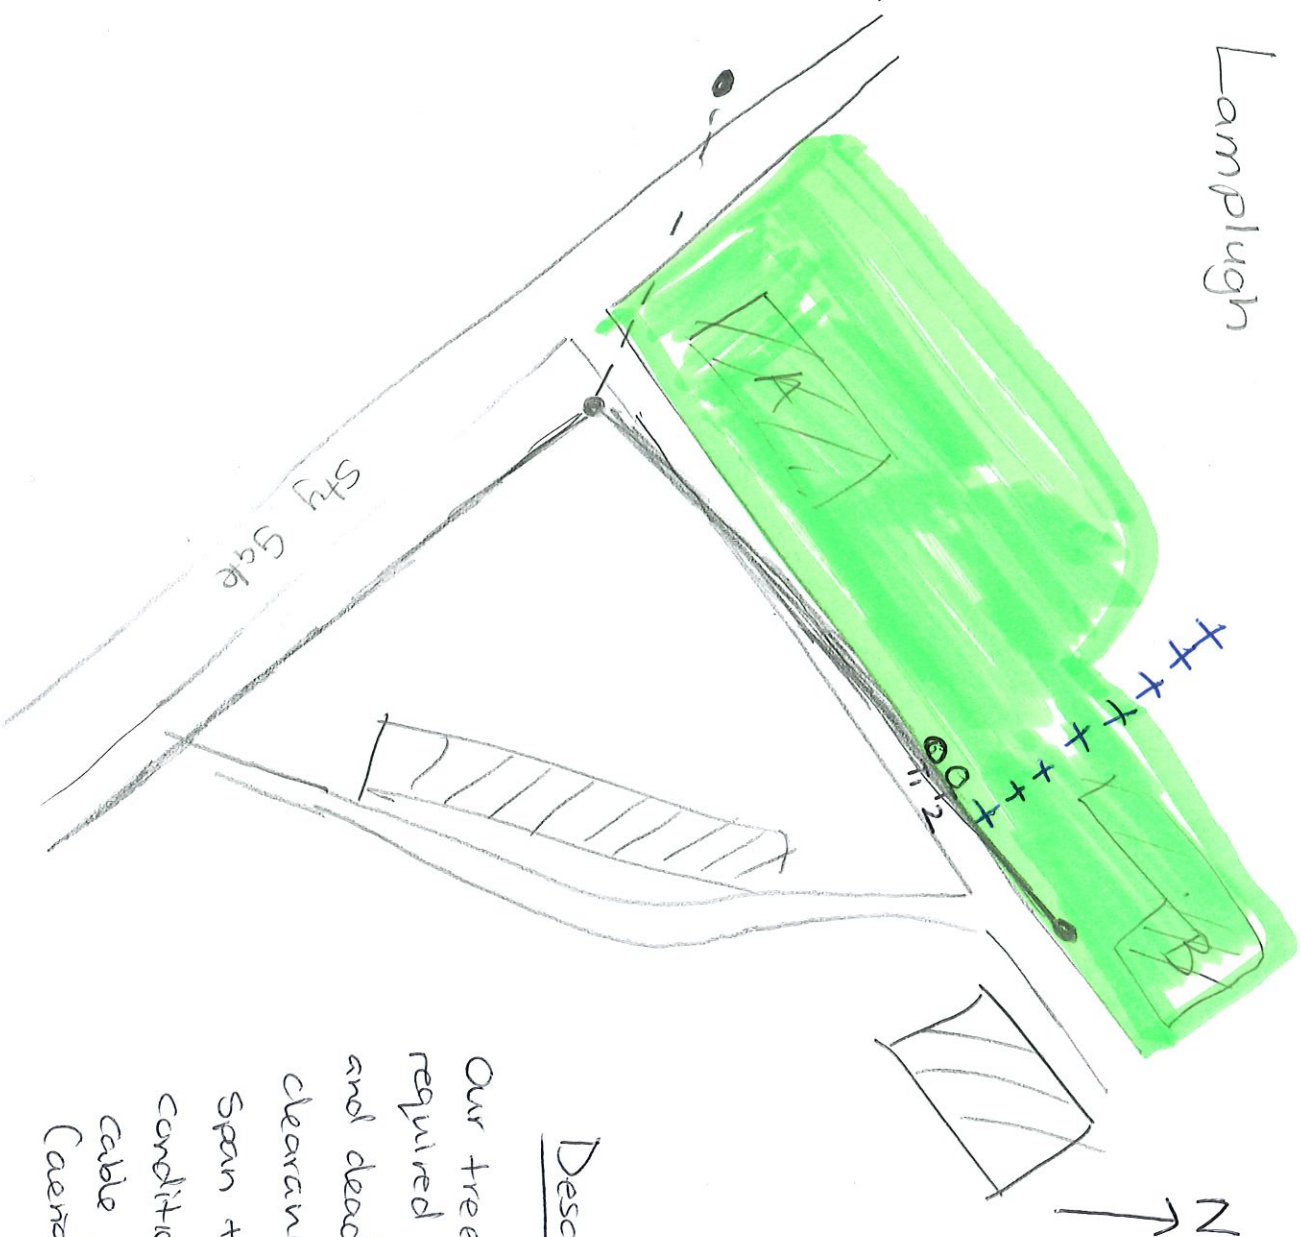
- OT<sub>2</sub> - Impacted Sycamore tree
- OT<sub>1</sub> - Impacted dead branch
- - Existing BT pole
- - - Existing aerial span
- - - Planned ducting
- ||||| - Residential building

Our tree trimming contractor would be required to prune sycamore branches (T<sub>2</sub>) and dead branches (T<sub>1</sub>) to give a 1-metre clearance of the existing aerial cable span to ensure the ~~safest~~ working conditions for feeding new fiberoptic cable along the existing cable span (aerial span).
