Flood Risk Assessment & Drainage Strategy
Proposed Residential Development, Griffin Close, Frizington

Thomas Armstrong Construction and Home Group

Ref: K41128.FRA/001

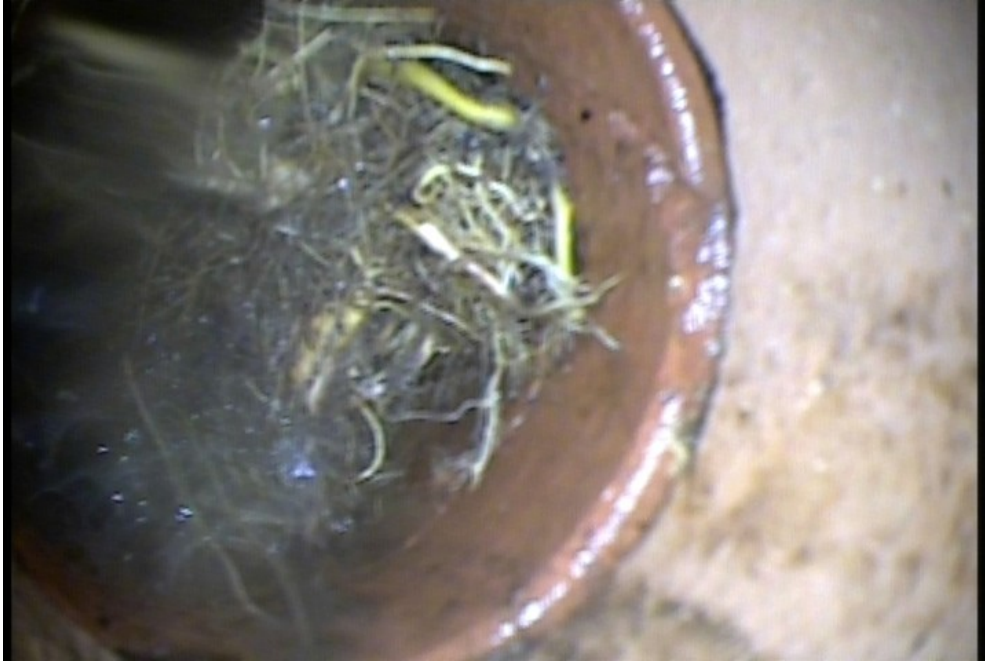
sw uncovered mh back up to surgery mh

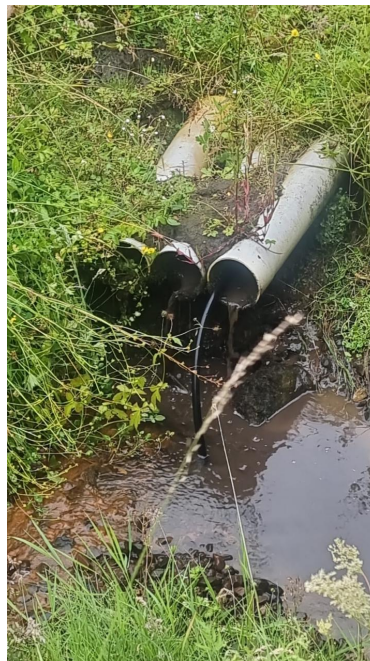
300MM SW OUTFALL INTO BECK

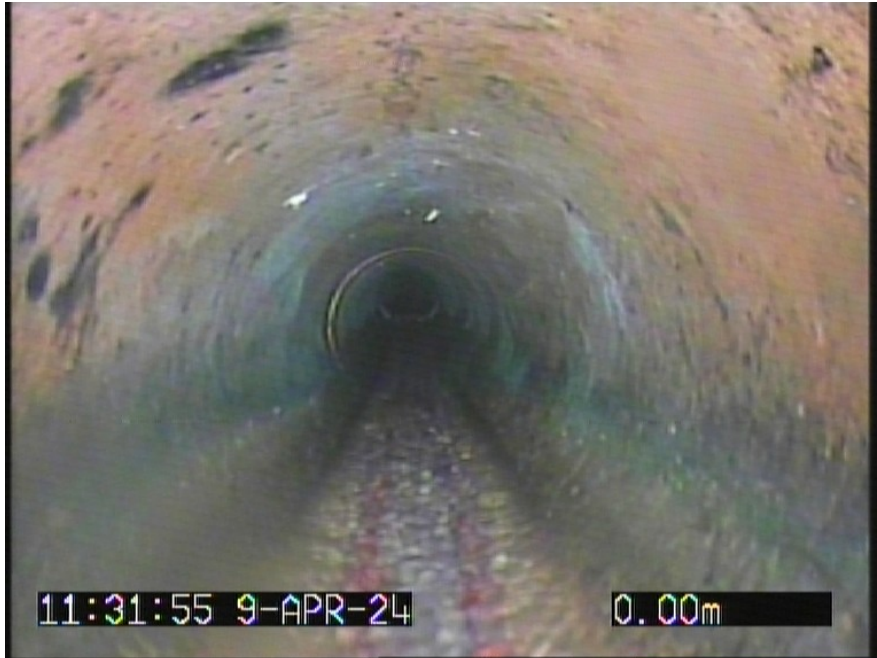
S1C1

Start node type, manhole, reference 2301

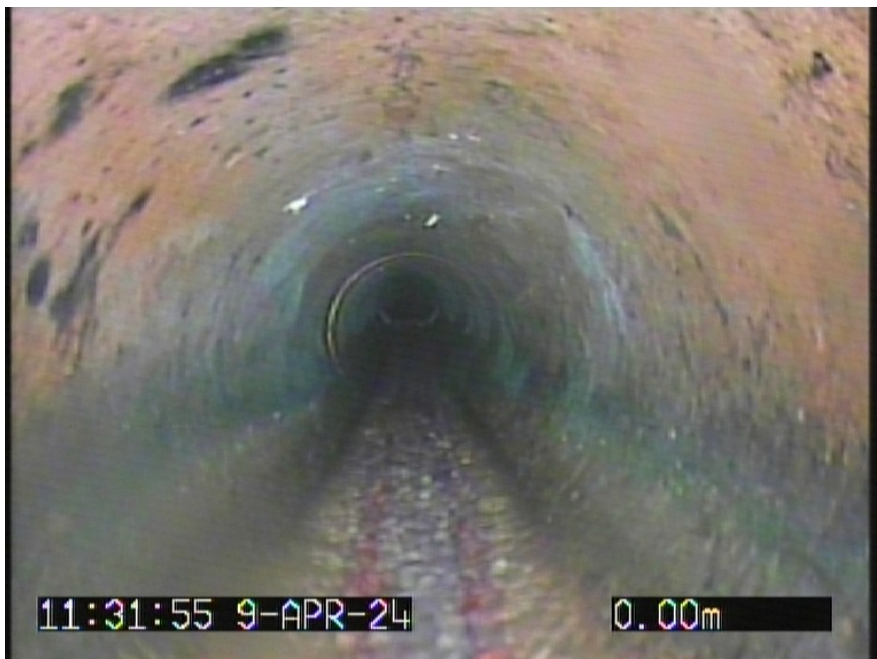
S1C2

Water level 0% height/diameter

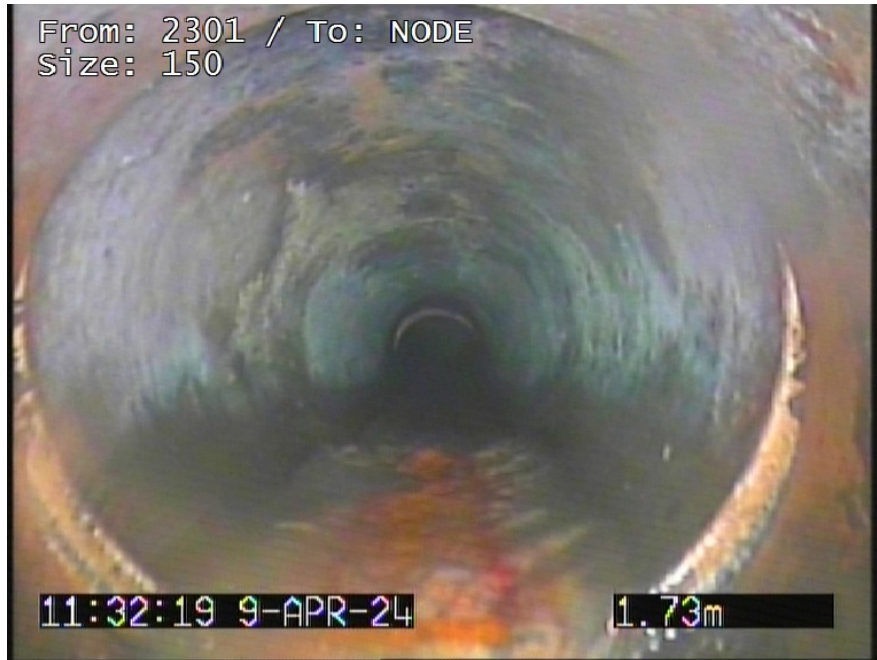
S1C3

00:00:20 - 1.72 m
Joint displaced 15mm

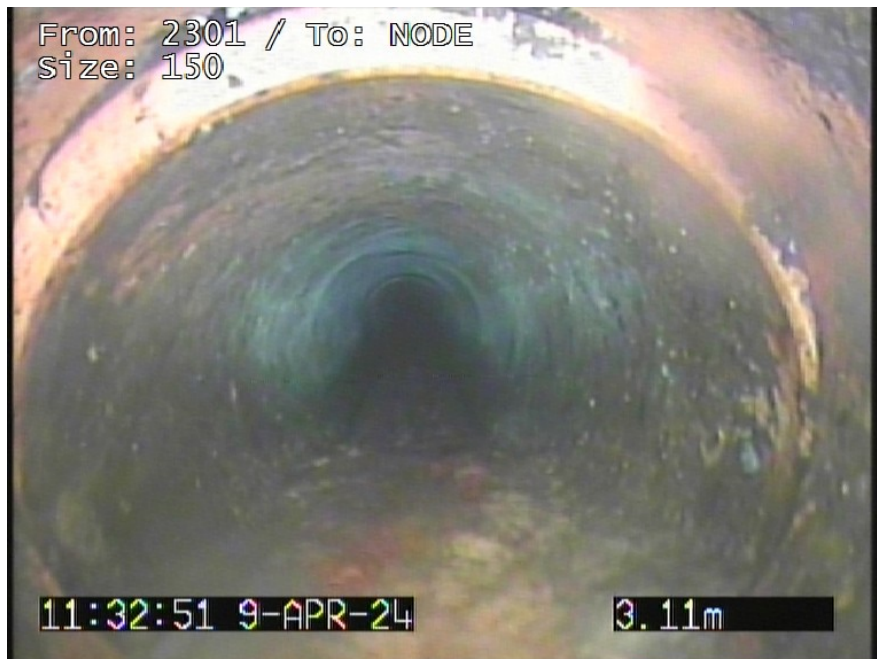
S1C4

00:00:36 - 3.12 m
Joint displaced 20mm

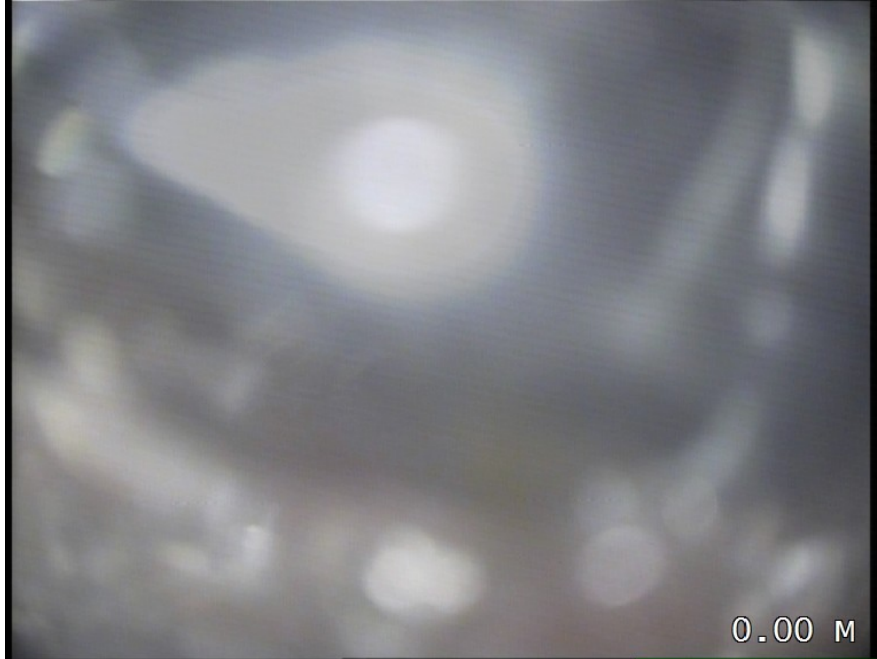
S2C1

00:00:00 - 0.00 m
Start node type, manhole, reference 2301

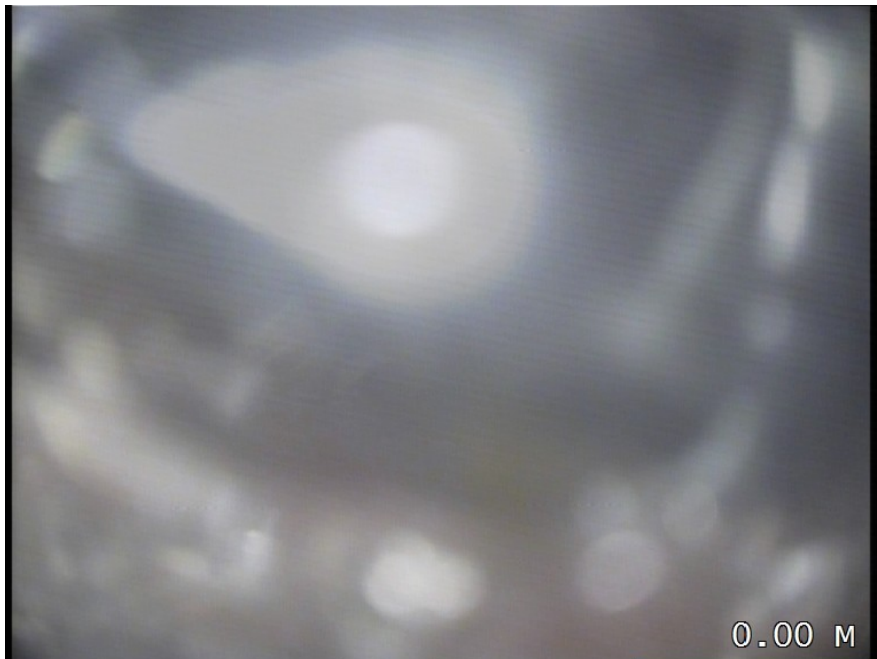
S2C2

00:00:00 - 0.00 m
Water level 10% height/diameter

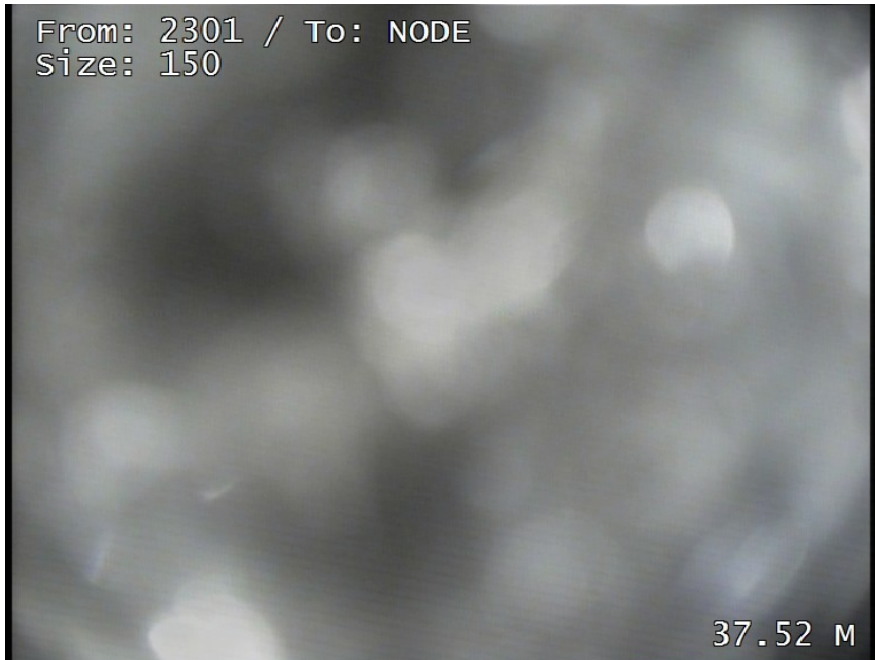
S2C4

00:02:49 - 37.07 m

Survey abandoned - Remark: UNABLE TO PUSH ROUND MH FINISH 2301A

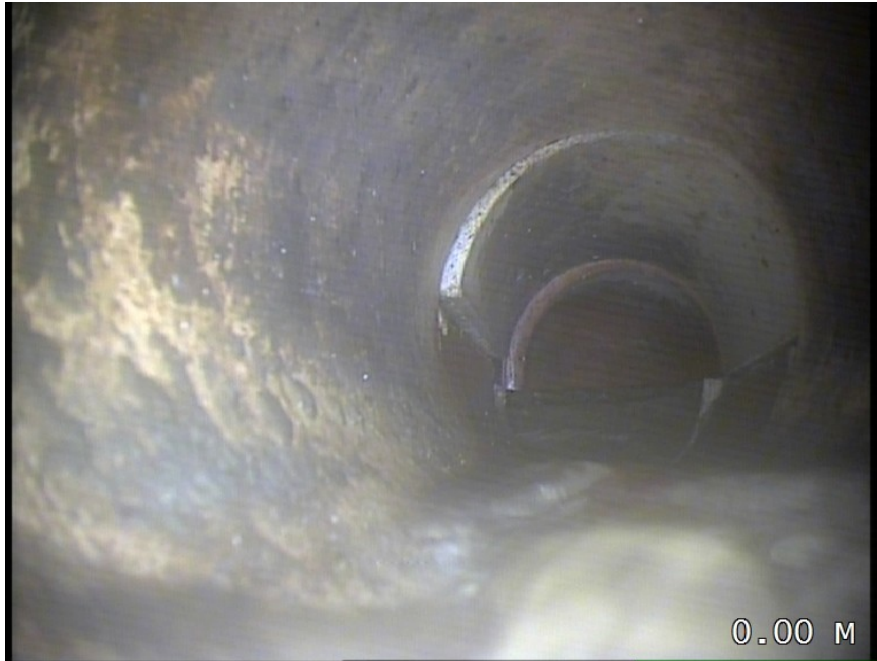
S3C1

Start node type, manhole, reference 2301

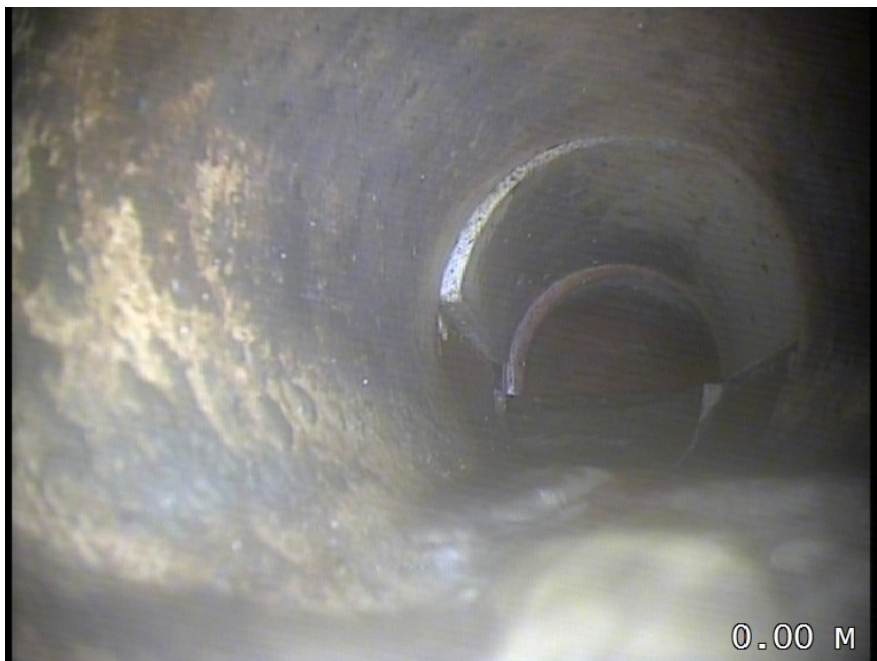
S3C2

Water level 10% height/diameter

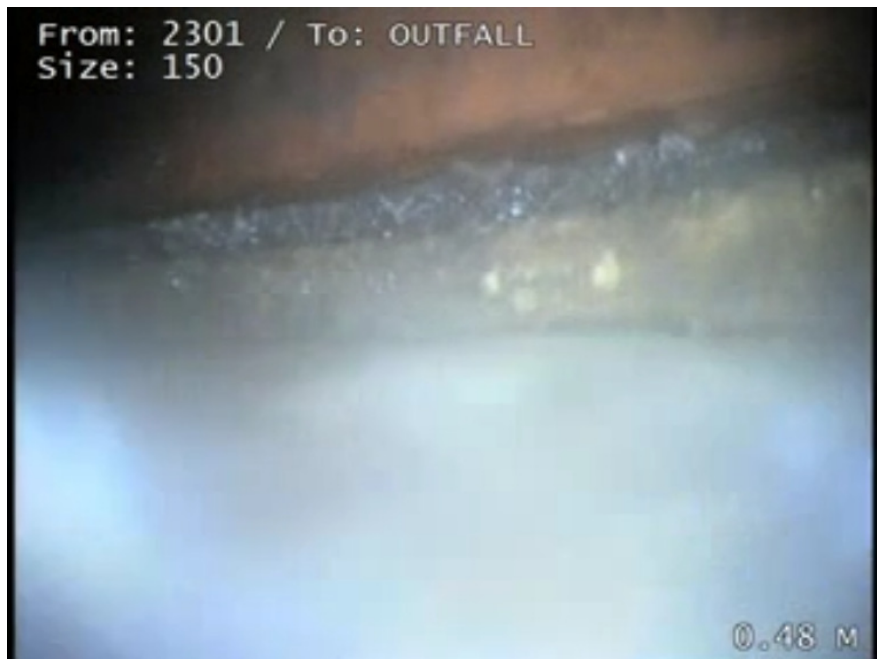
S3C4

Line of drain/sewer deviates left

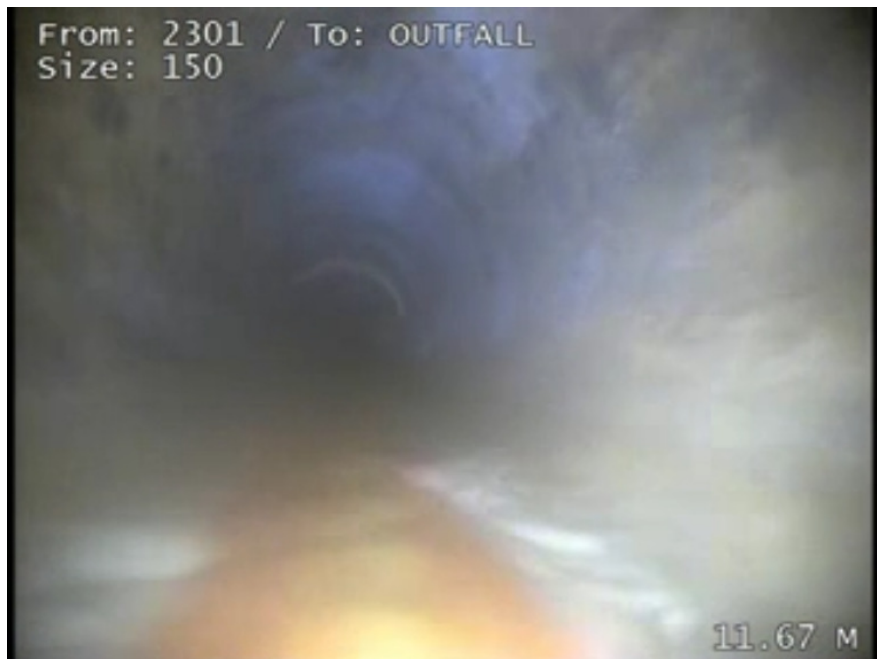
S3C6

Loss of vision, camera under water, Finished

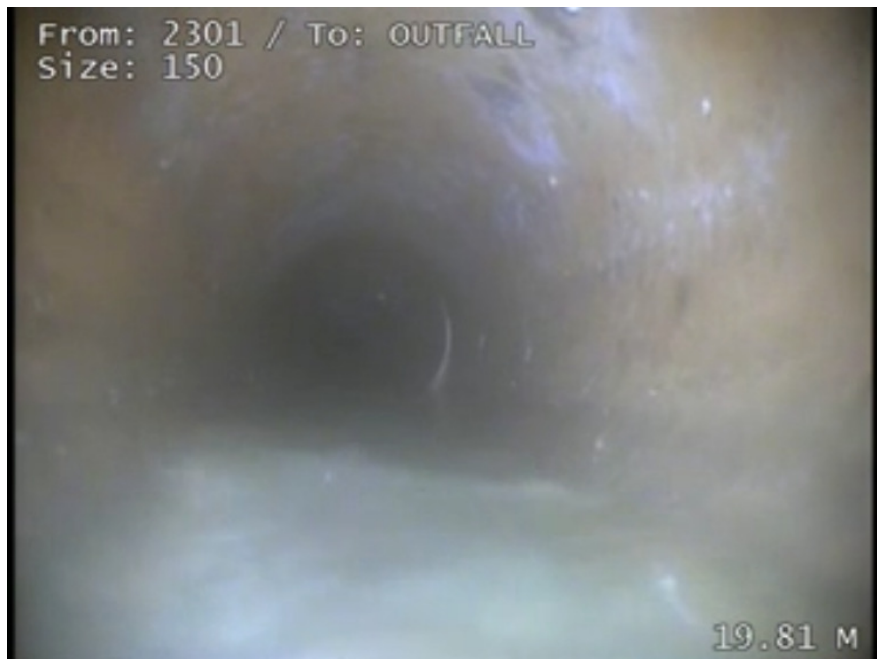
S3C8

Loss of vision, camera under water, Finished

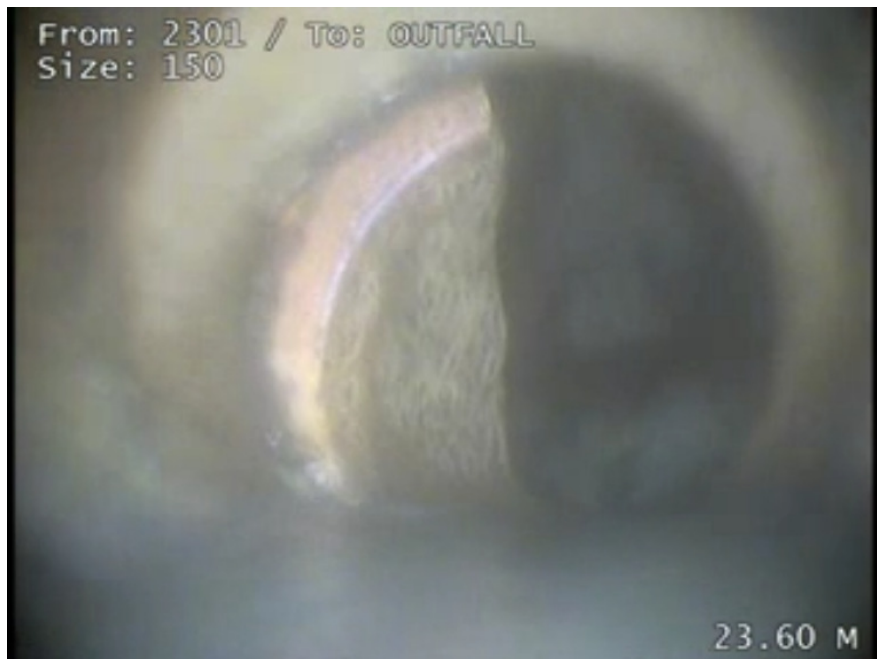
S3C10

00:02:21 - 23.60 m

Loss of vision, camera under water, Finished

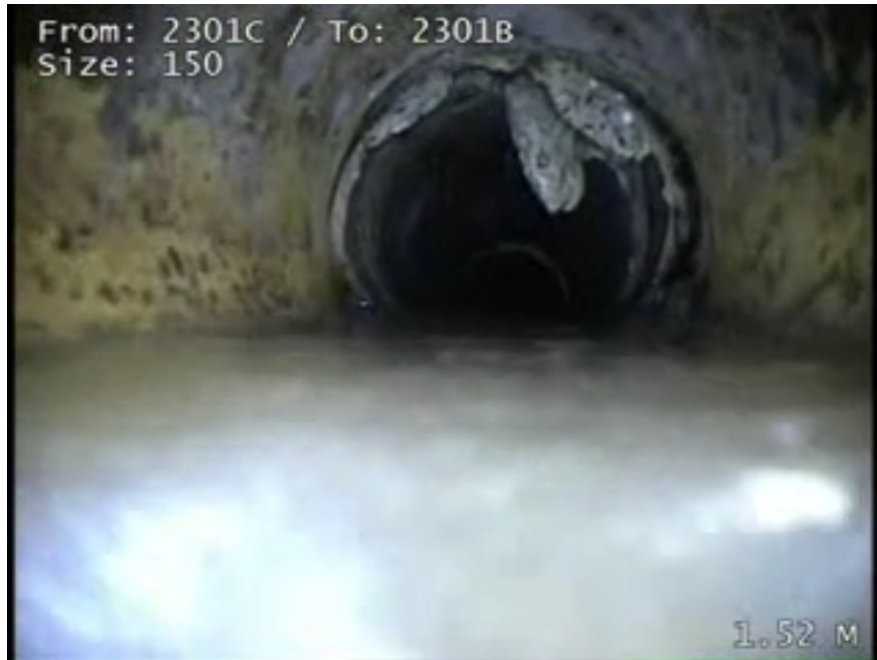
S4C5

00:00:12 - 1.52 m

Roots mass 15% cross-sectional area loss at joint

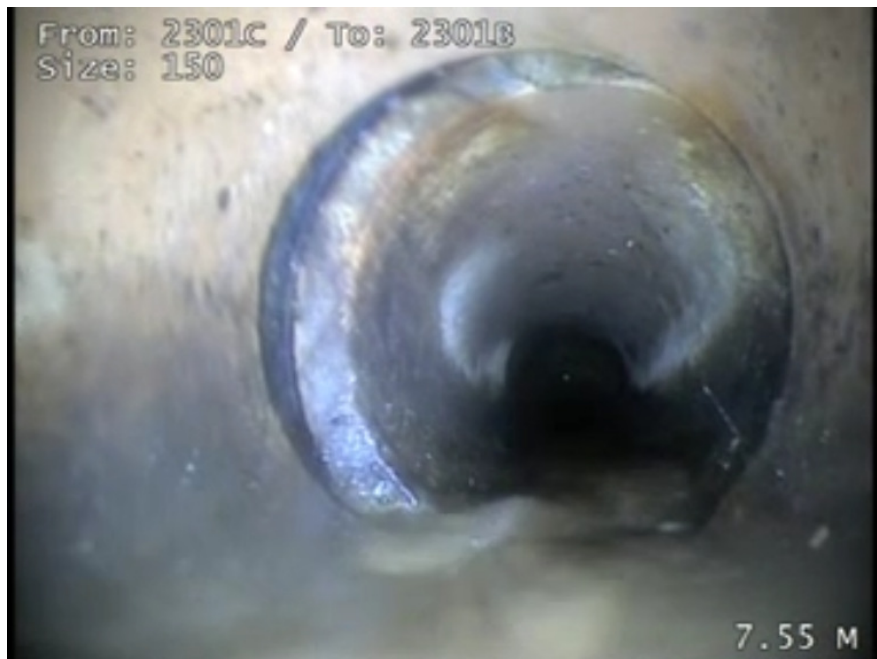
S4C6

00:00:40 - 7.55 m

Joint displaced 25mm

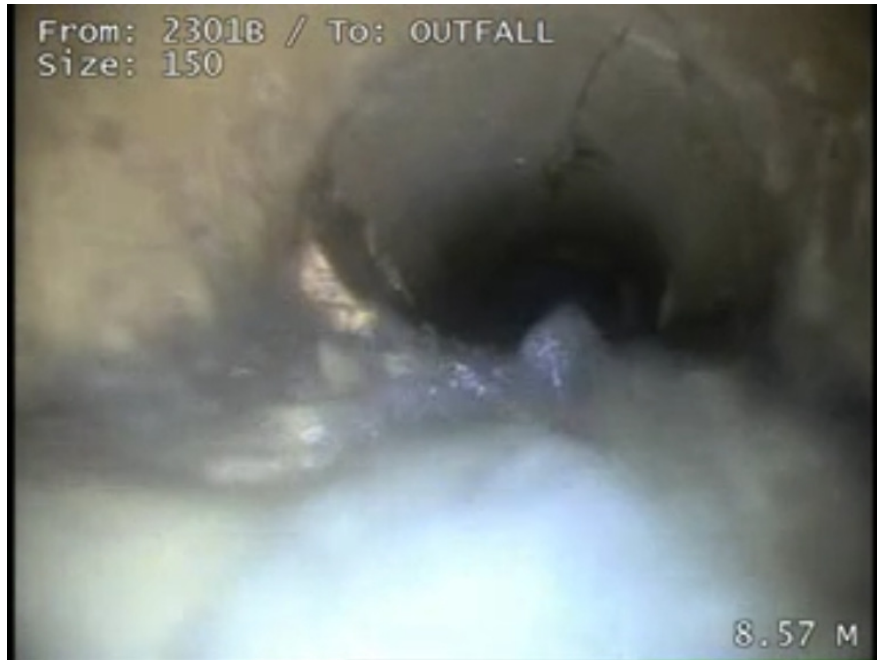
S5C3

00:00:27 - 8.57 m
Joint displaced 20mm

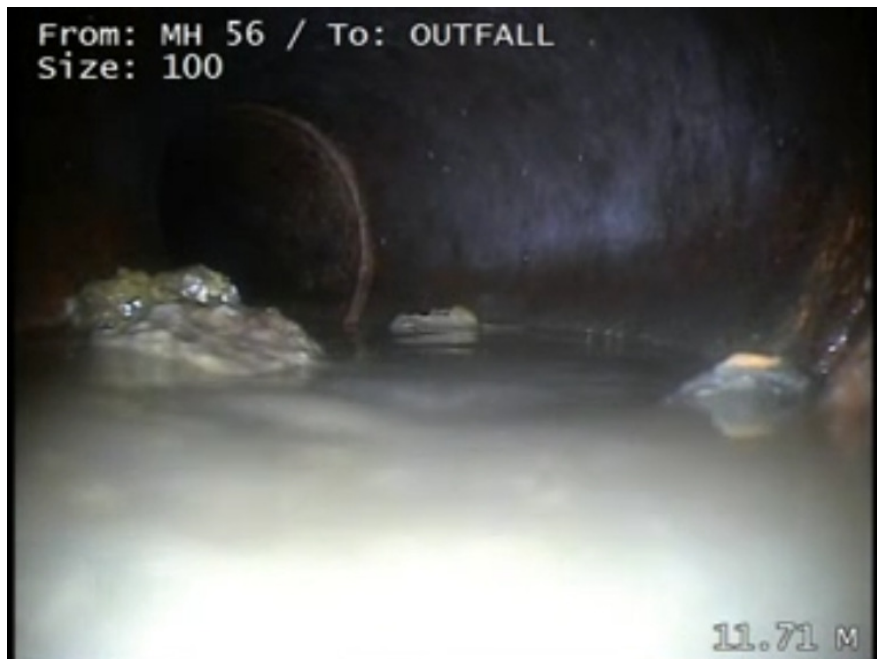
S7C5

00:02:16 - 11.71 m
Other settled deposits 30% cross-sectional area loss - Remark: Waste

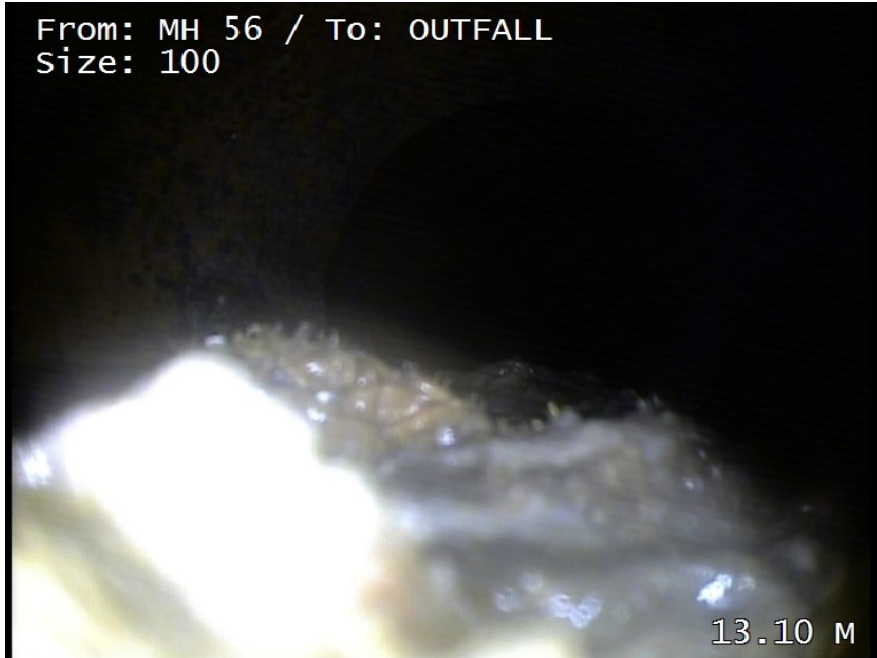
S7C6

00:02:37 - 13.10 m

Survey abandoned - Remark: Unable to pass waste

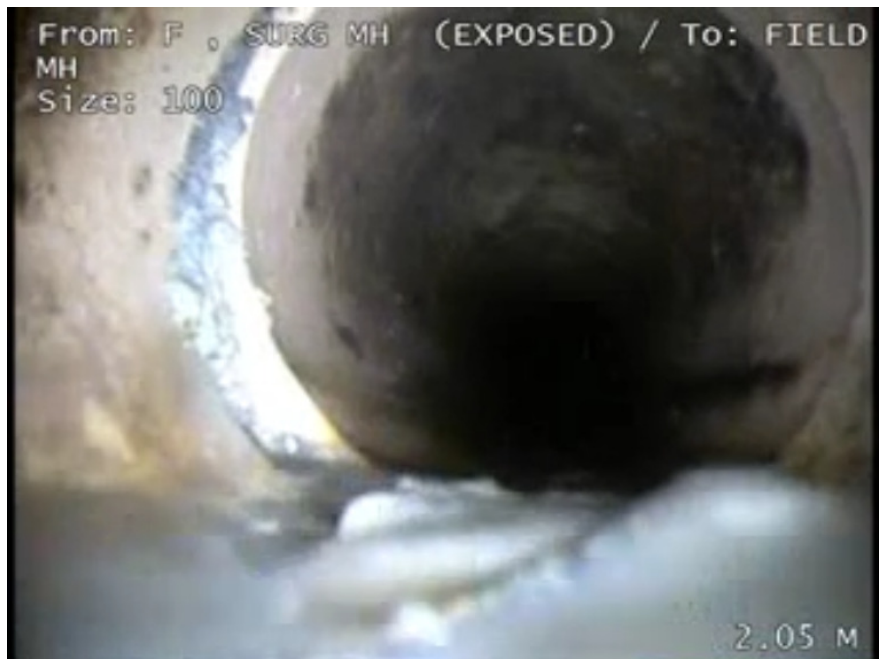
S8C4

00:00:39 - 2.05 m

Joint displaced 20mm

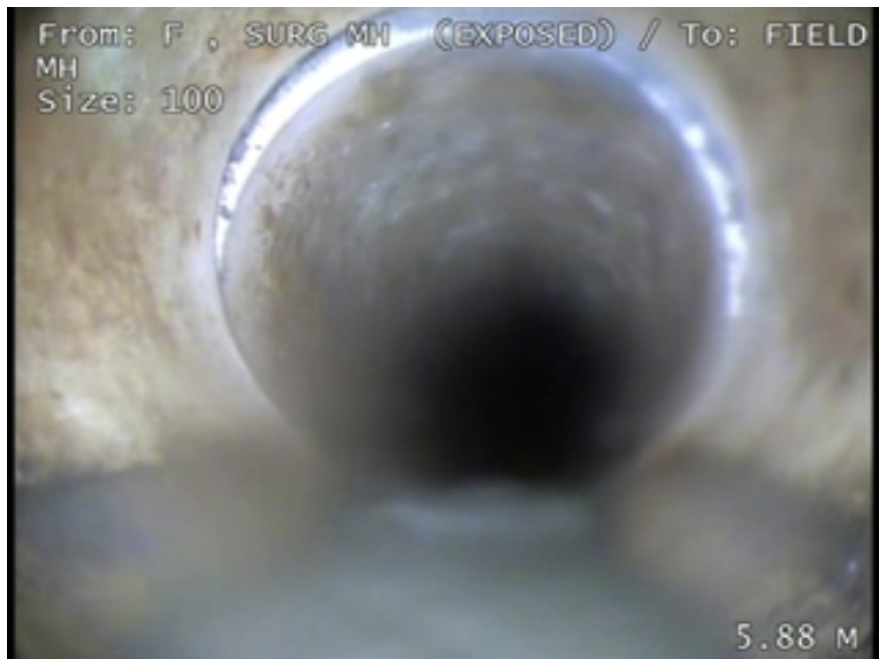
S8C6

00:01:32 - 5.88 m

Joint displaced 10mm

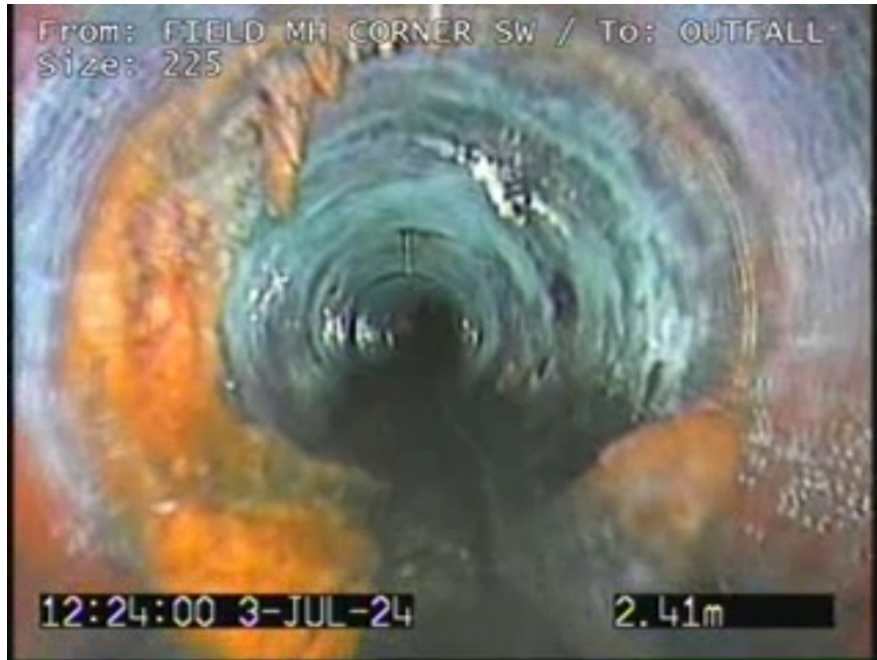
S11C3

00:02:00 - 2.41 m

Attached deposits, encrustation from 3 to 12 o'clock 10% cross-sectional area loss at joint

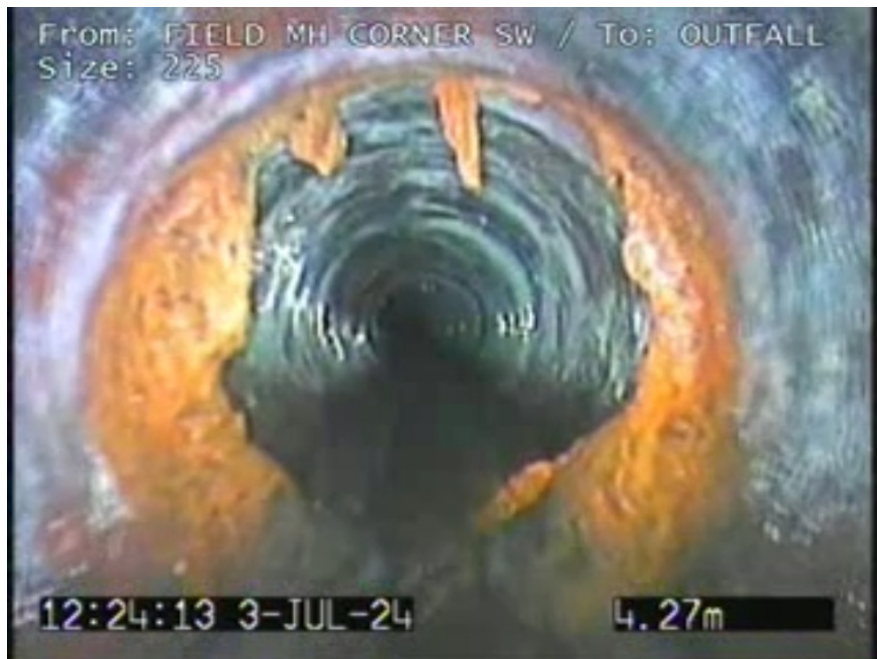
S11C4

00:02:14 - 4.27 m

Attached deposits, encrustation from 1 to 12 o'clock 15% cross-sectional area loss at joint

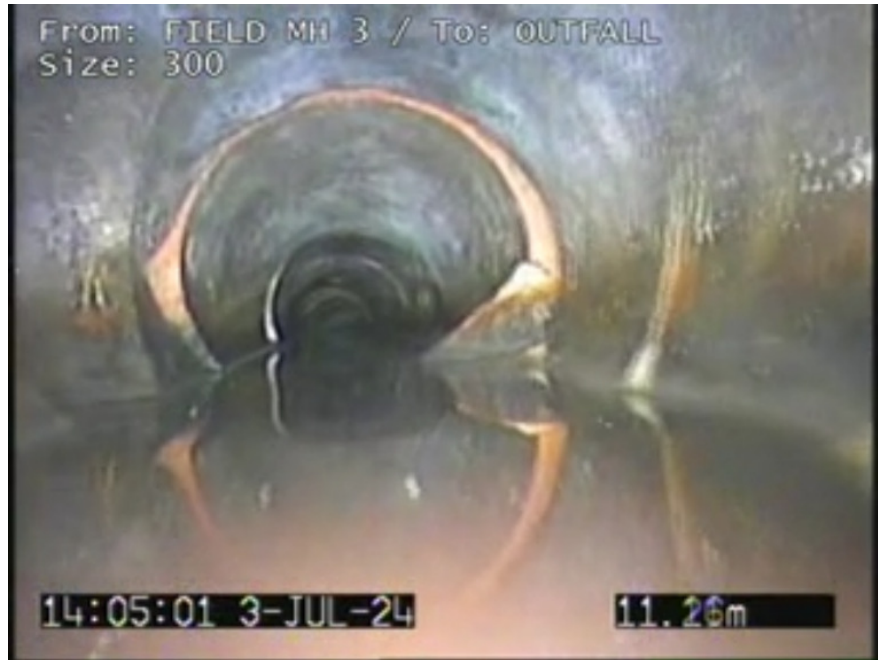
S13C3

00:00:50 - 11.22 m
Junction at 9 o'clock, diameter 150mm

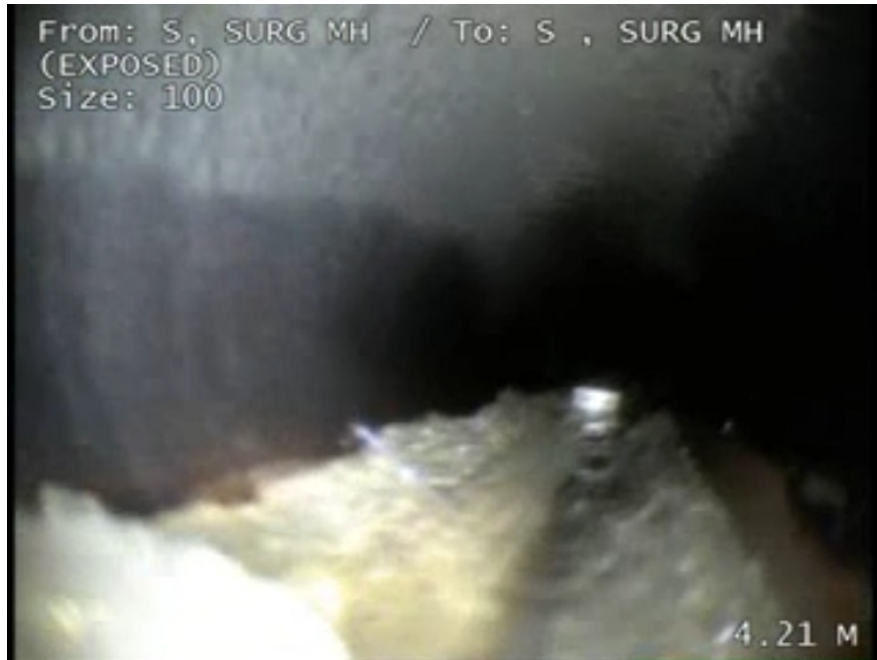
S14C3

00:00:22 - 4.21 m

Other attached deposits from 4 to 8 o'clock 25% cross-sectional area loss - Remark CEMENT, Start
