## Flood Risk Assessment & Drainage Strategy

Proposed Residential Development, Griffin Close, Frizington

Thomas Armstrong Construction and Home Group

Ref: K41128.FRA/001

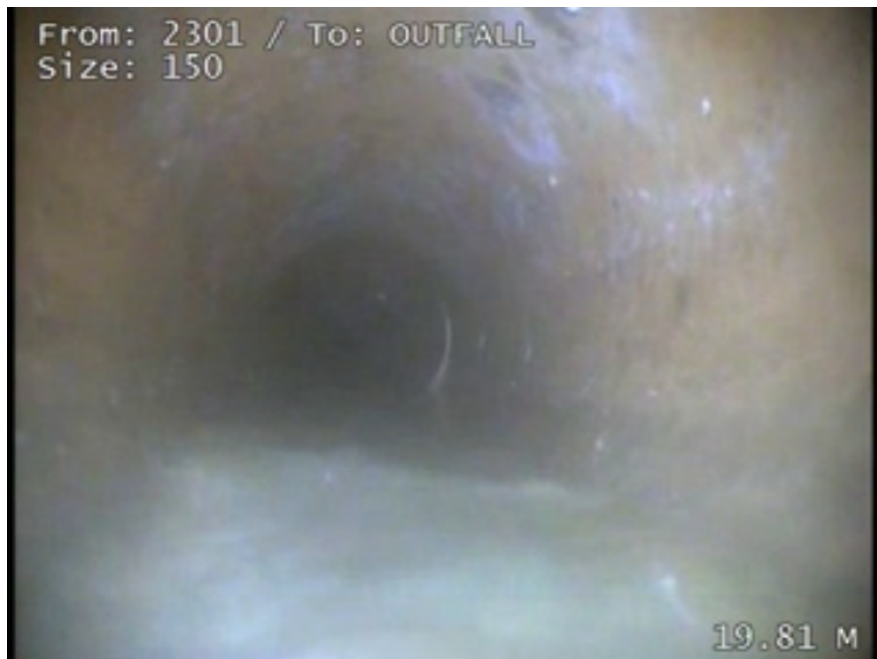
S3C8

Loss of vision, camera under water, Start

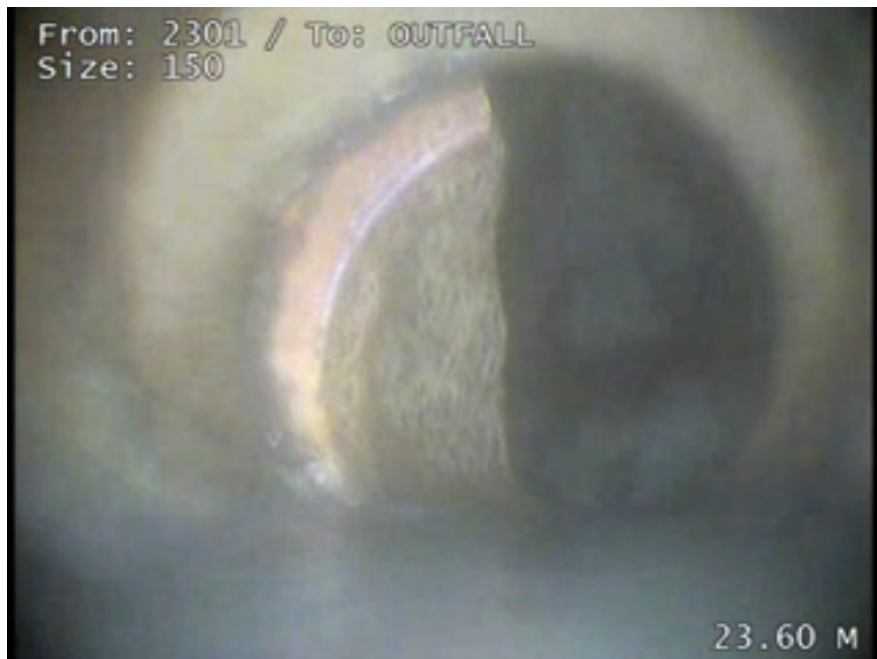
S3C10

Loss of vision, camera under water, Start

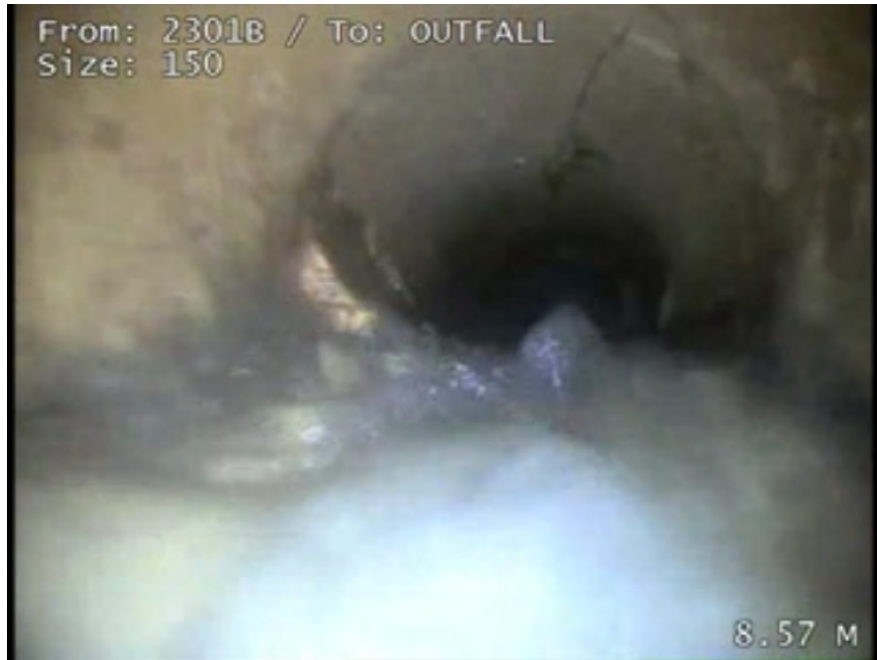
S5C3

00:00:27 - 8.57 m  
Joint displaced 20mm

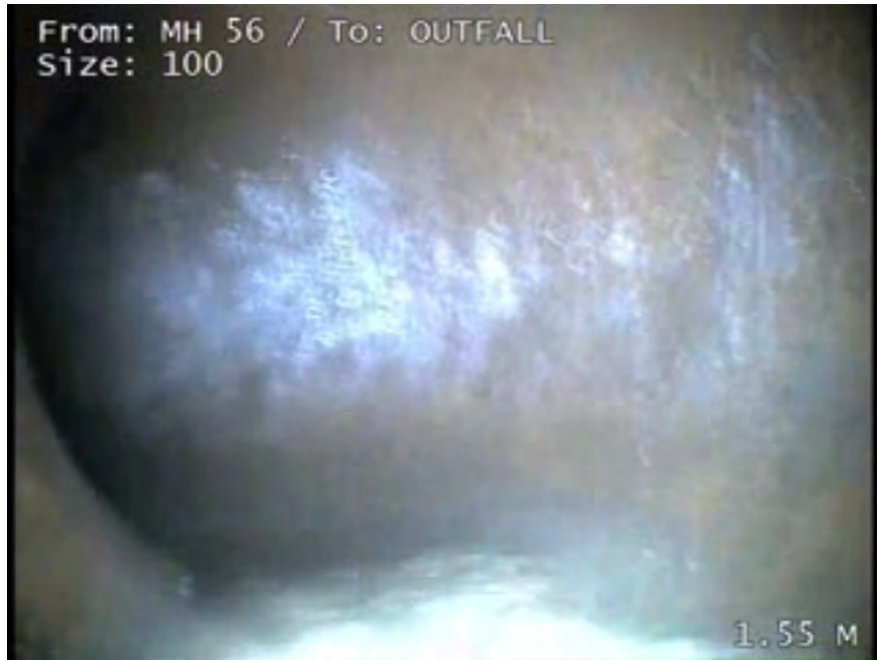
S7C4

00:01:14 - 1.55 m  
Line of drain/sewer deviates left

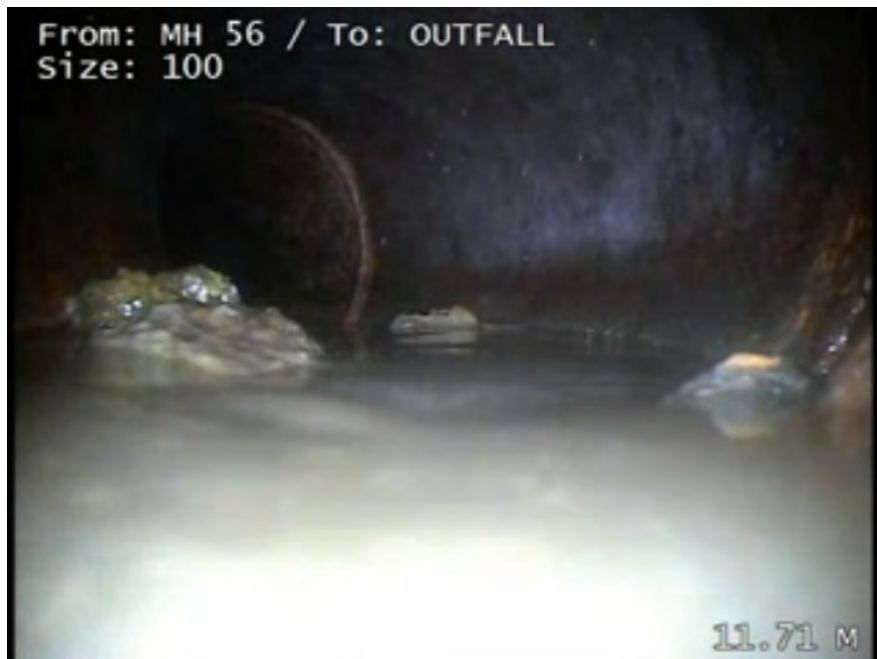
S7C5

00:02:16 - 11.71 m  
Other settled deposits 30% cross-sectional area loss - Remark: Waste

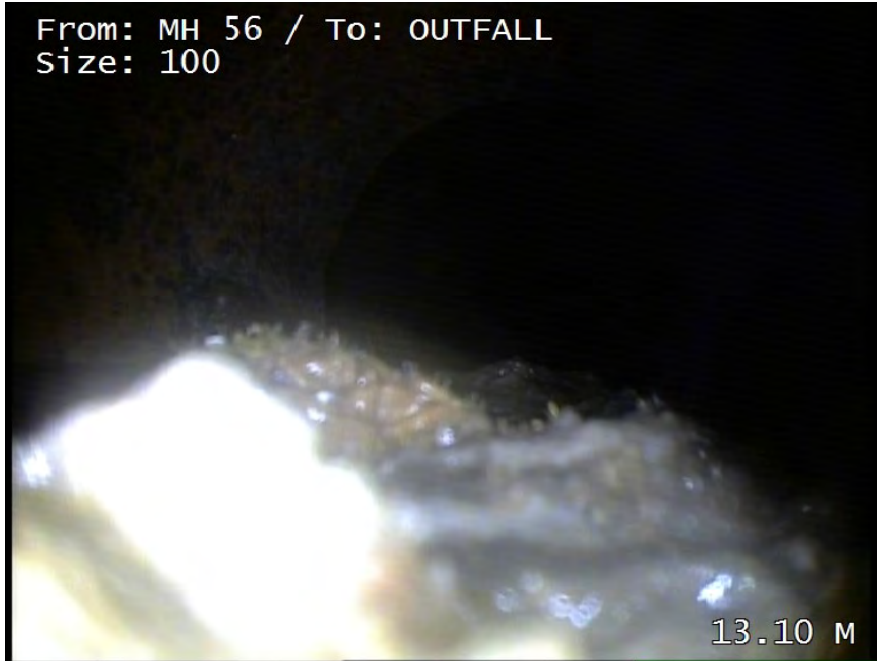
S7C6

Survey abandoned - Remark: Unable to pass waste

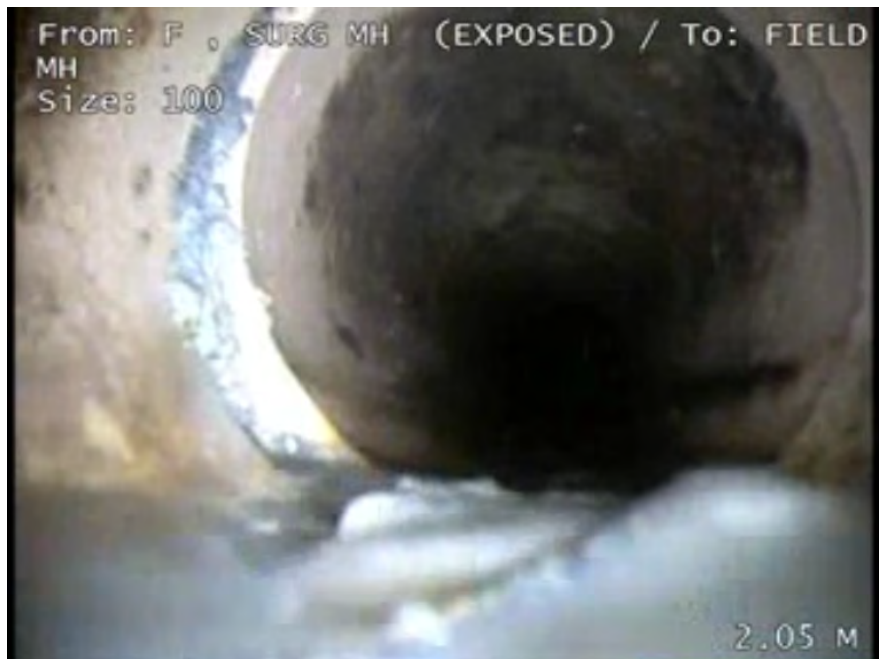
S8C4

Joint displaced 20mm

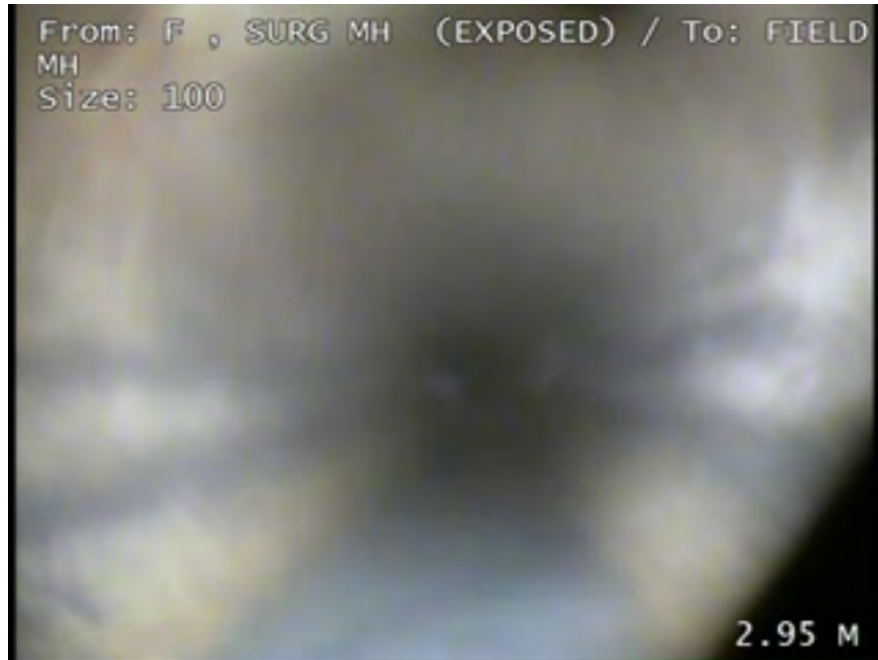
S8C5

Other attached deposits from 6 to 9 o'clock 5% cross-sectional area loss - Remark CONCRETE, Finished

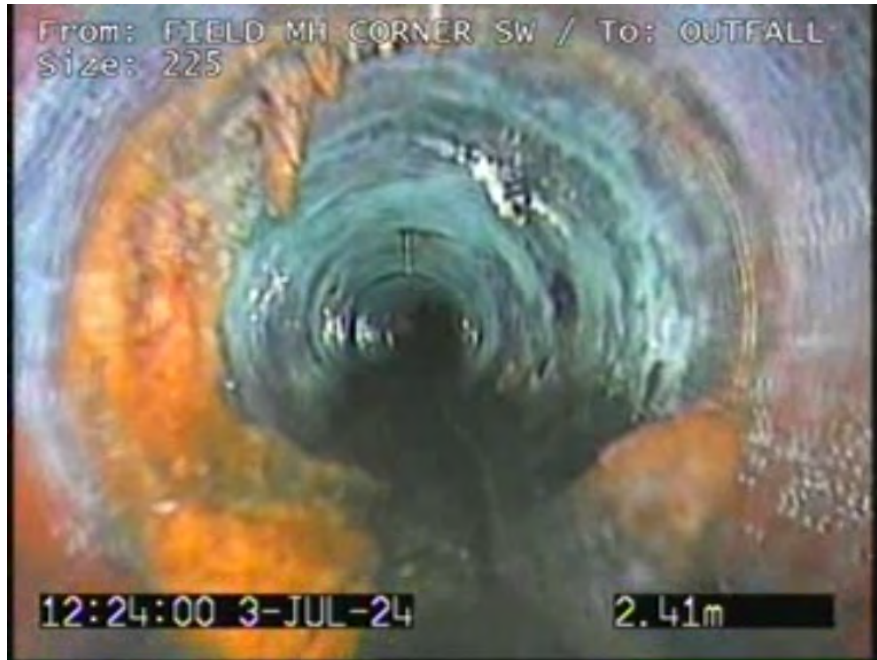
**S11C3**

00:02:00 - 2.41 m

Attached deposits, encrustation from 3 to 12 o'clock 10% cross-sectional area loss at joint

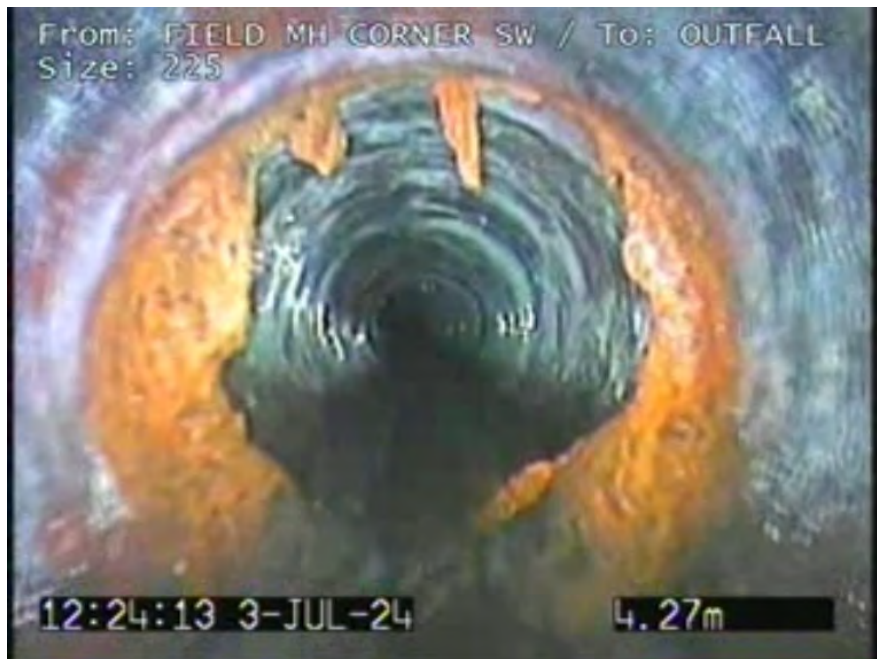
**S11C4**

00:02:14 - 4.27 m

Attached deposits, encrustation from 1 to 12 o'clock 15% cross-sectional area loss at joint

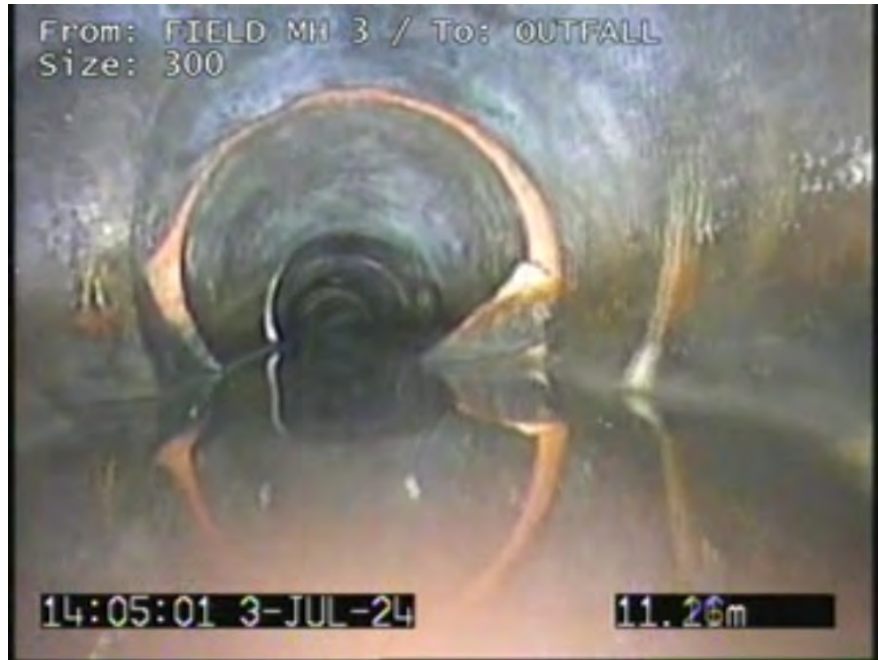
**S13C3**

00:00:50 - 11.22 m  
Junction at 9 o'clock, diameter 150mm

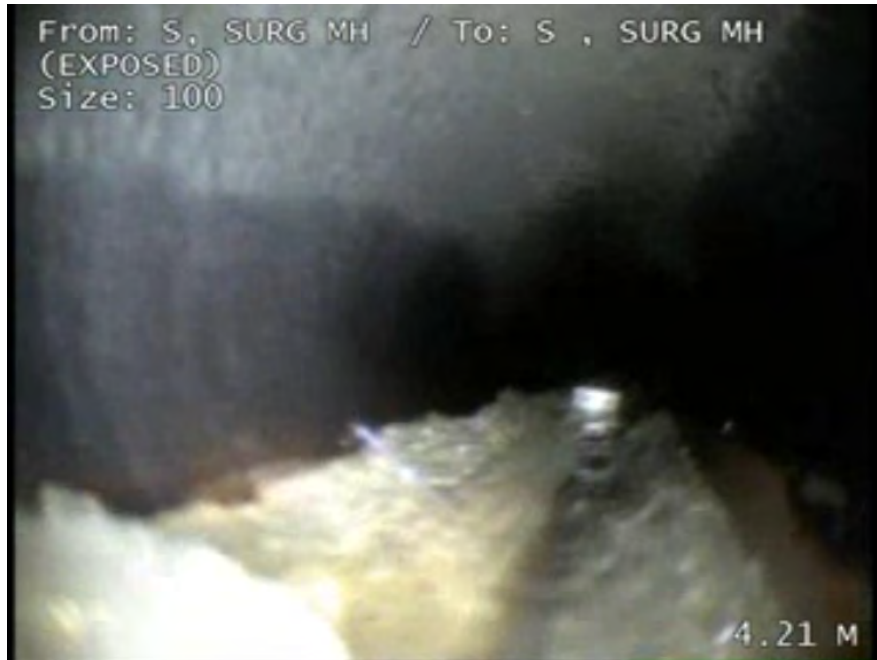
S14C3

00:00:22 - 4.21 m

Other attached deposits from 4 to 8 o'clock 25% cross-sectional area loss - Remark CEMENT, Start
