**CCTV Inspection Report**

**FOUL AND SURFACE WATER OUTFALLS FROM SITE COMPOUND  
WEST CUMBERLAND HOSPITAL  
HOMWOOD ROAD  
WHITEHAVEN**

**11/02/2022**

**Job Number: SK-S 160/21 WCH GRAHAMS (updated 11/02/2022)**

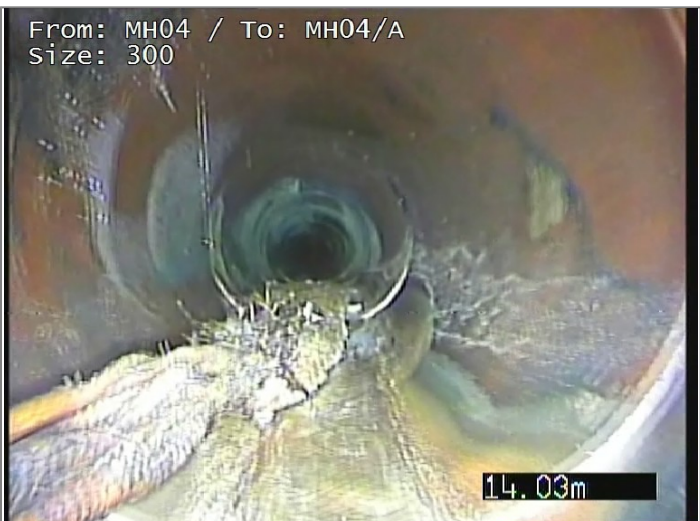
Roots mass 20% cross-sectional area loss, Start

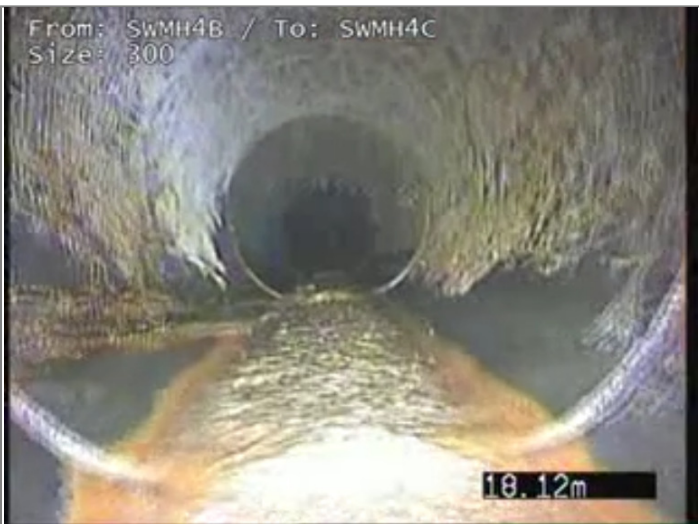
Roots tap at joint - Remark: 8 OCLOCK

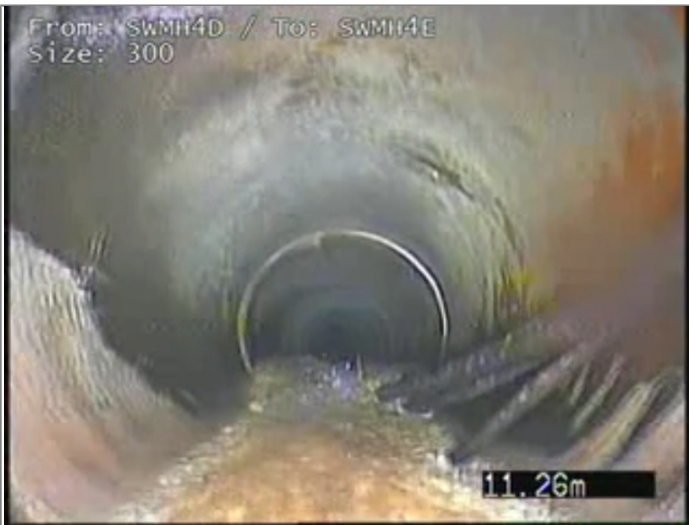
Roots tap

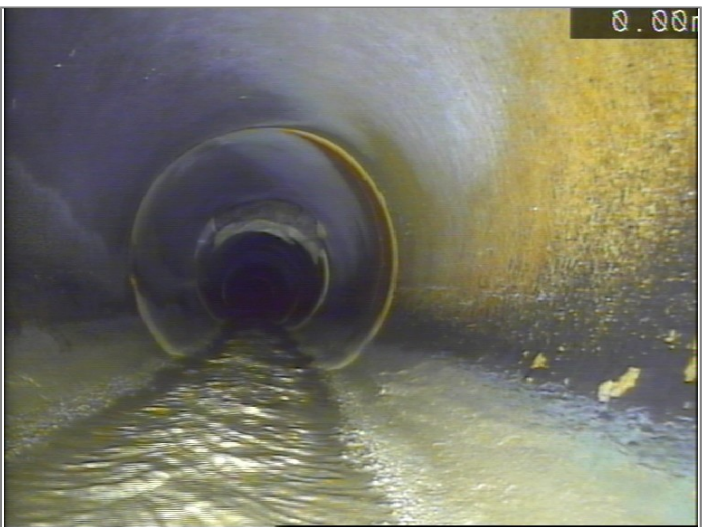
Crack circumferential from 1 to 5 o'clock, at joint
